2581 SH26
MORRINSVILLE
PLAN CHANGE

PRELIMINARY
GEOTECHNICAL
REPORT

PROJECT NO: HD2441
WARRICK AND MARION STEFFERT
REFERENCE: PGR-1 REV A
10 OCTOBER 2022

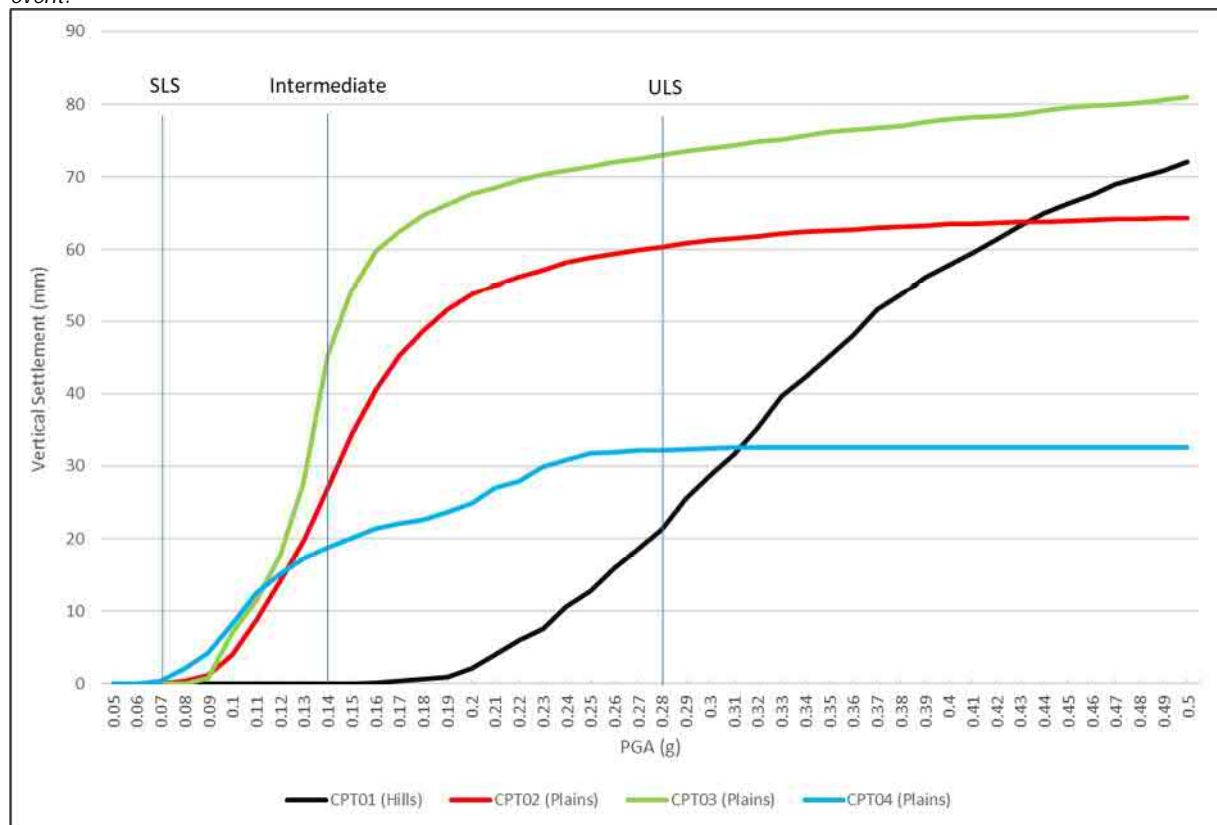
Figure 1: Vertical settlement vs Peak Ground Acceleration (PGA), vertical lines show the acceleration for each assessment event.

By plotting predicted vertical settlement with peak ground acceleration (PGA), we can assess that the majority of liquefaction is induced at lower accelerations in the plains terrain than the hills terrain. The CPTs within the plains show that liquefaction is triggered between a 1 in 50 and 1 in 100-year earthquake event (PGA between 0.09 and 0.14). In contrast, the hills terrain CPT shows liquefaction triggering at approximately the 1 in 250-year event (0.21g).

The marked difference in liquefaction response between the hills and plains is due to differences in geology. CPT01 indicates a layer of non-liquefiable clay above dense sand deposits that are less susceptible to liquefy, reducing the likelihood of surface expression in the hills.

The figure above shows the variability of the site's liquefaction response. CPT04, while located in the plains terrain, shows significantly less liquefaction potential than CPT02 and CPT03 due to thinner layers of liquefiable material (more clay dominated soil profile).

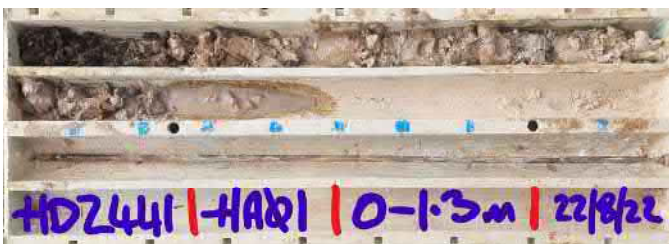
End of borehole at 1.3 meters_ target depth not achieved. repeated hole collapse.

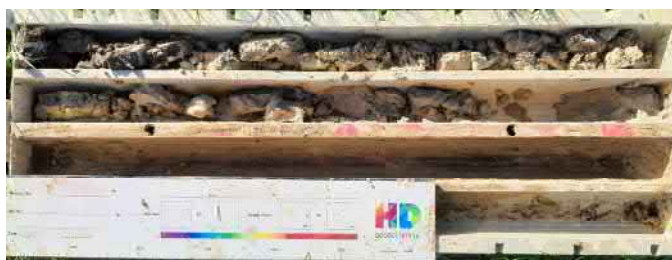
End of Hole 2.0 m - target depth not reached due to borehole collapse. DCP unable to penetrate 2.7 m

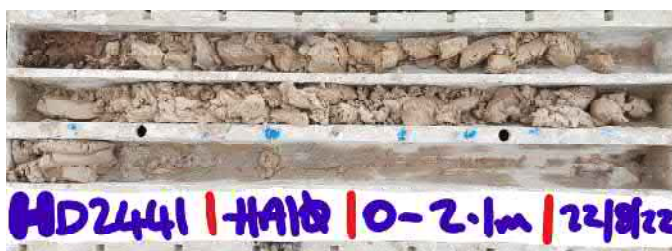
End of hole at 2.1 meters target depth not achieved. borehole kept squeezing closed.
