**Arboricultural Report
Relating To:**

**Assessment Of Effects Of A Proposed Building On
Two Mature Oak Trees located on Hetana Street
Matamata**

**For
XYST Ltd
Attention: Anna McElrea**

Date: December 2022

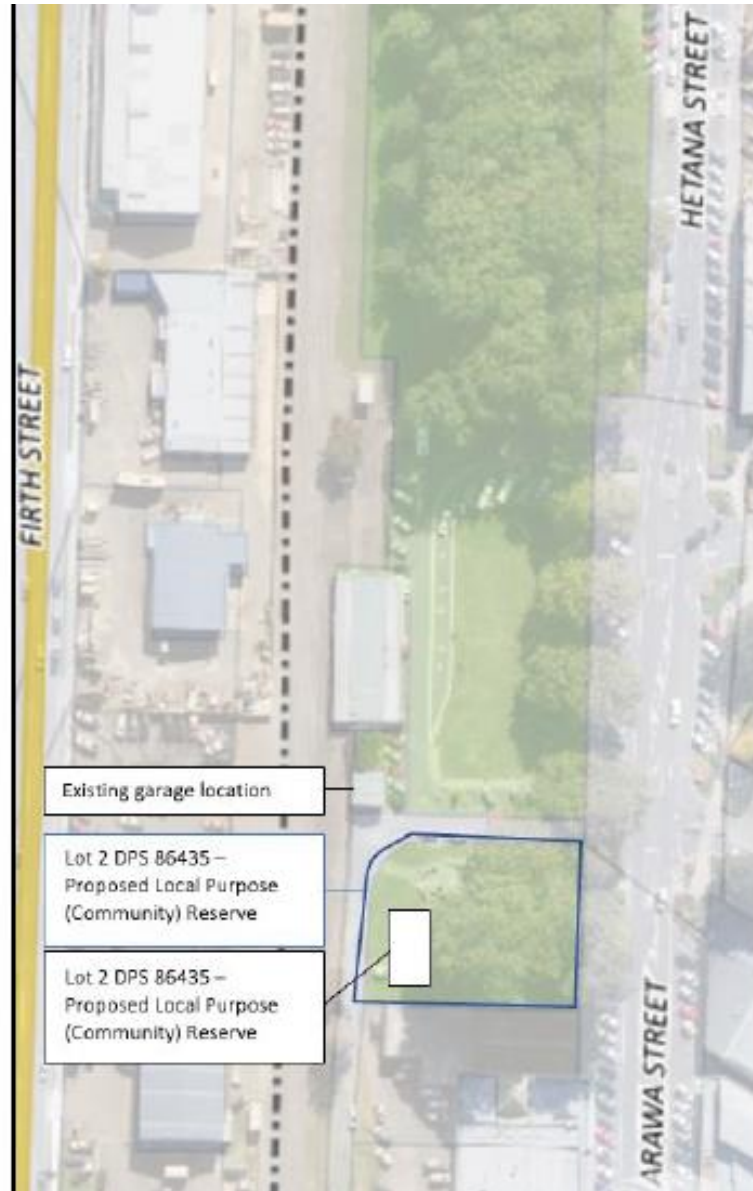
The proposal is to relocate the existing MSHST building and construct an extension to the building within the dripline of the two English Oak Trees as shown in the site map below.

The proposed building location is 12 metres off the Kiwi Rail fence and the building is about 7 metres wide. This will result in the building being approximately 9 metres from the trees trunk centre at the closest point.

This will be between 1 and 1.5 metres within the dripline of these trees.

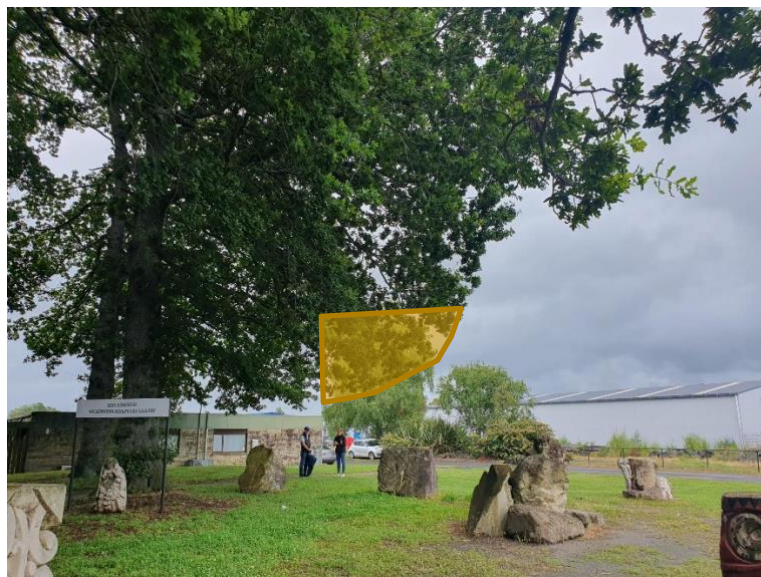
The crown of these trees is quite low and the tree will require some crown lifting/side reduction pruning to allow for the construction of the building. See photo below for an indication of the required pruning to locate the building.

The minimum pruning required is very minor and will not adversely effect the health or life expectancy of these trees.
