## **Ingham Enterprises (NZ) Pty Ltd - Freshwater Ecological Assessment**

Tonkin & Taylor Ltd (T&T) was engaged by Bloxam Burnett & Olliver to undertake an assessment of the natural freshwater resources in an unnamed tributary of the Waipuna Stream. The freshwater assessment is required to support a proposal to the Matamata-Piako District Council to vary Ingham Enterprises' Development Concept Plan for its Factory Site on Waiheka Rd, Waitoa.

The following report has been prepared in accordance with our Letter of Engagement dated 25 February 2013 and outlines the results from a freshwater ecological assessment carried out at the site on 28 February 2013.

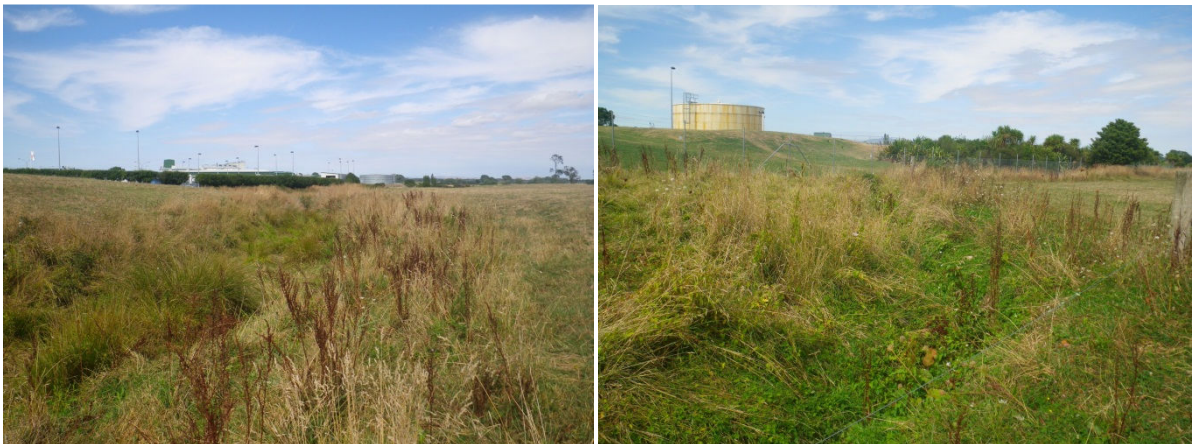
The unnamed tributary is approximately 650 m in length with its headwaters beginning at Seddon Road then draining through farmland to its confluence with the Waipuna Stream (refer to Figure 1). On the day of the site visit the entire length of the tributary was dry indicating the tributary is intermittent (only flows for part of the year). Based on the nature of the channel the upper 300 m of the unnamed tributary appears to be ephemeral, thus only flowing during periods of high rainfall (refer to Figure 1). The stream channel in this upper section is wide with low gradient banks. The stream bed is approximately 2 – 3 m wide and is covered in pastoral grass (Photograph 1).

From around 300 m downstream of Seddon Rd the channel becomes more channelised where sections of the tributary have been straightened. Along this section the channel is generally between 0.1 – 1.5 m wide.

*Photograph 1 and 2: upstream and mid reach of the unnamed tributary of the Waipuna Stream 28 February 2013.*

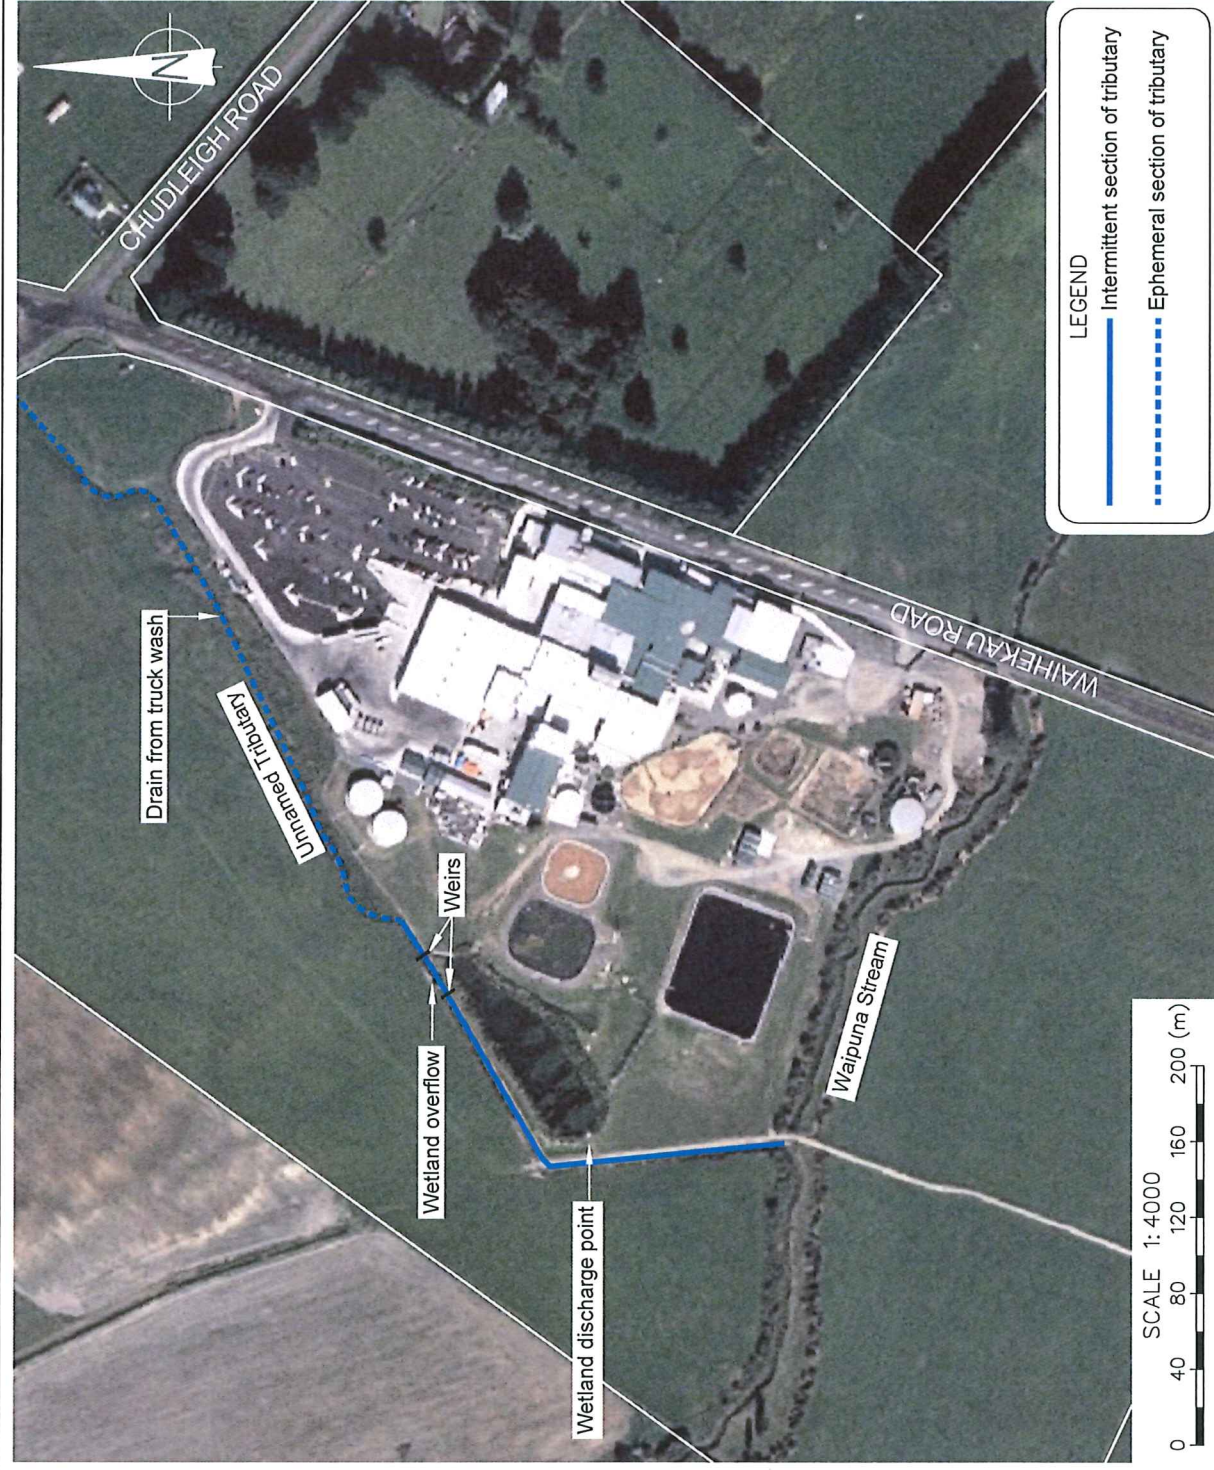
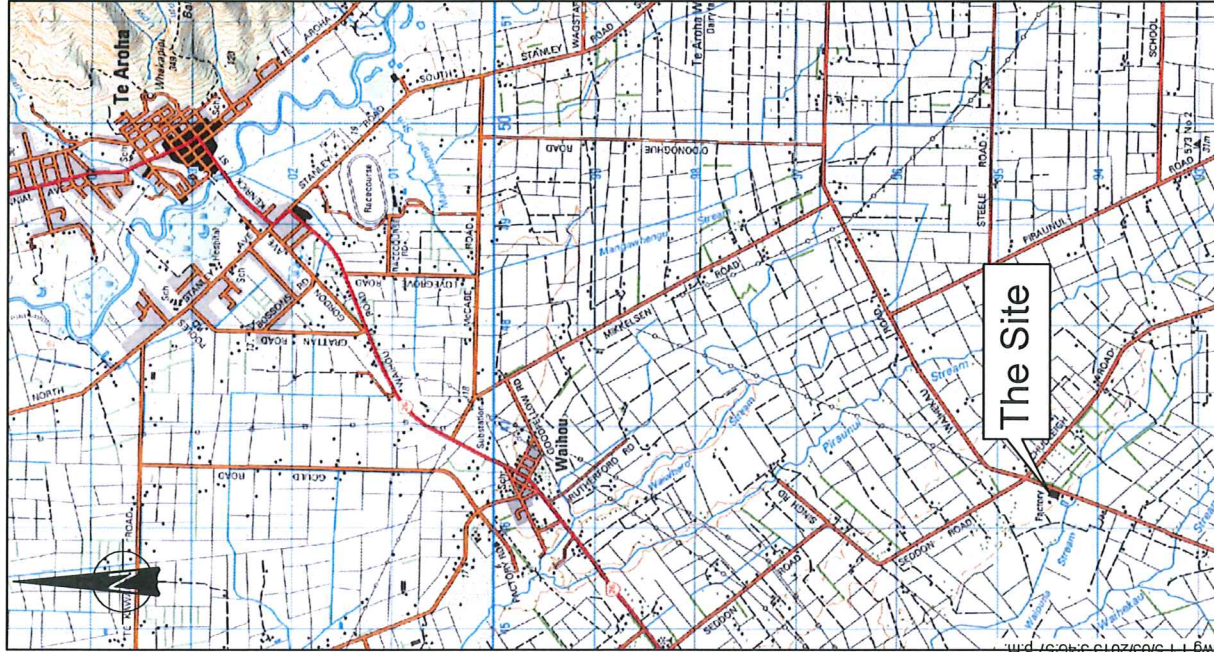
Figure 1.

The main surface water drainage feature in the vicinity of the site is the Waipuna Stream which originates around 2 km upstream of the site and runs from east to west through the site (see Figure 1).

The only surface water observed in the unnamed tributary during the site visit comprised two small pools. One at the discharge point of a culvert draining the truck wash area (see Figure 1), and the other downstream where the wastewater treatment wetland overflows into the stream. Two weirs are located within the stream channel directly upstream and downstream of where the wetland overflow enters the tributary.
