Rings Scenic Tours Ltd - Development Concept Plan Updated Transportation Review

Matamata-Piako District Council

ISSUE 2, 11 MARCH 2019

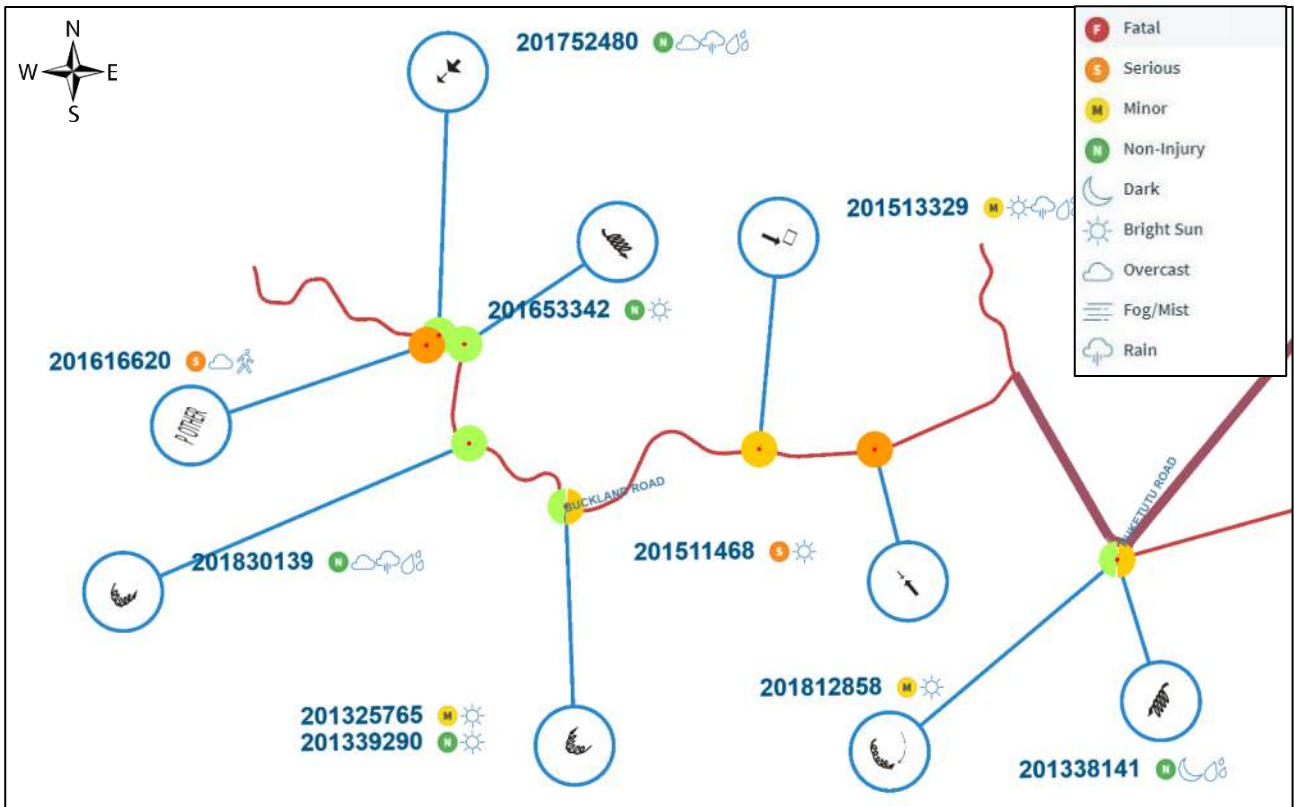
Figure 3: Crash Diagram for Buckland Road (east)

- = The crash rate has increased:
 - o on Buckland Road;
 - o at the Buckland Road/ Puketutu Road intersection; and
 - o at the Buckland Road/ Karapiro Road intersection;
- = There have been no reported crashes at property accesses along Buckland Road;
- = The number of crashes attributed to tourists has increased over the last five years; and
- = Traffic volumes on Buckland Road have increased and this is likely to contribute to the increase in crashes.

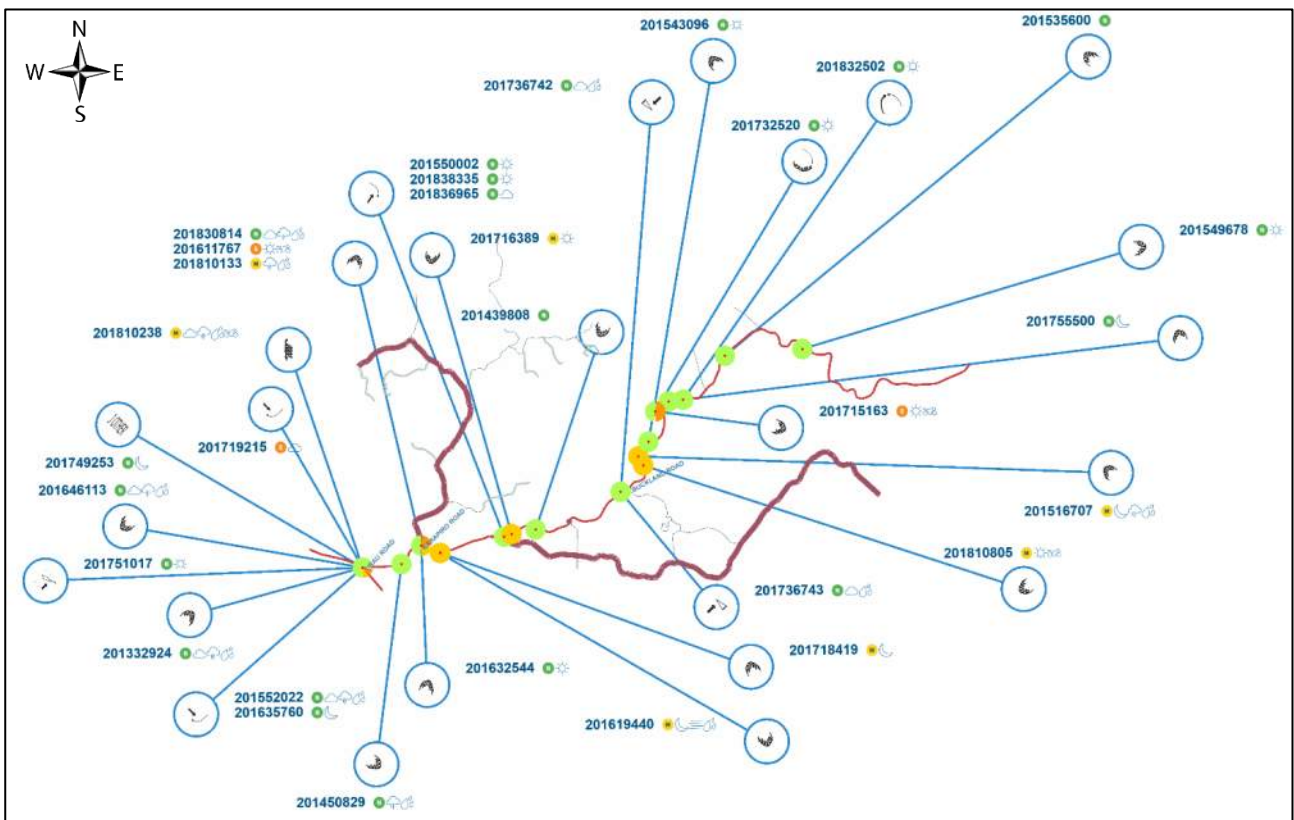
Figure 4: Crash Diagram for Buckland Road (west)

Both the head-on crashes occurred on a narrow section of Buckland Road where the centreline is already marked.

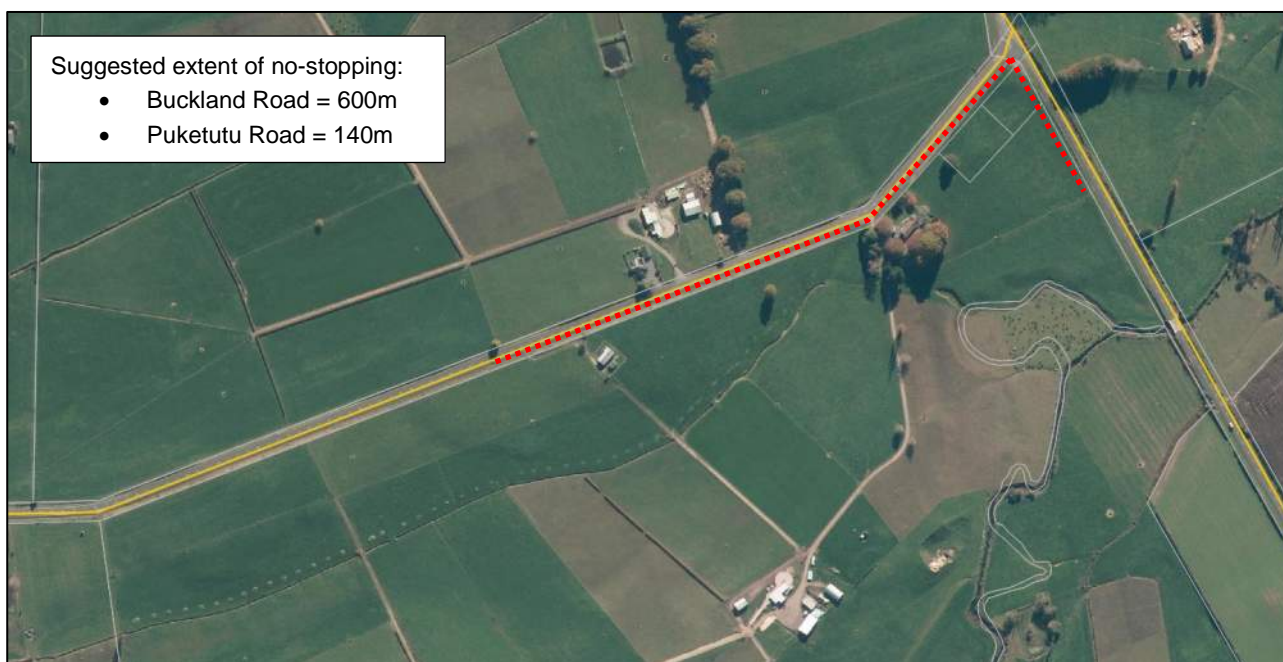
Figure 9: Potential No-Stopping Markings – 21 Buckland Road

We understand that the owners of 21 Buckland Road have amenity, privacy and biosecurity concerns about drivers parking in their driveway. There do not appear to be any specific transportation (safety or efficiency) effects from this type of driver behaviour, marking no-stopping lines and erecting sign along their property frontage may assist in reducing amenity effects. A security gates should minimise biosecurity concerns.

There are no destinations or features that should lead to demand for on road parking in this area. It is possible that drivers are stopping to reconfirm directions or take photos. This could be minimised by installing a new direction sign or relocating an existing sign closer to the intersection. This would provide visitors with confirmation that they are on the correct route.

There would be no adverse transportation effects from marking no-stopping lines and erecting signs as indicated in the figure below. Installing additional no-stopping lines and signs would require additional parking enforcement by Council.

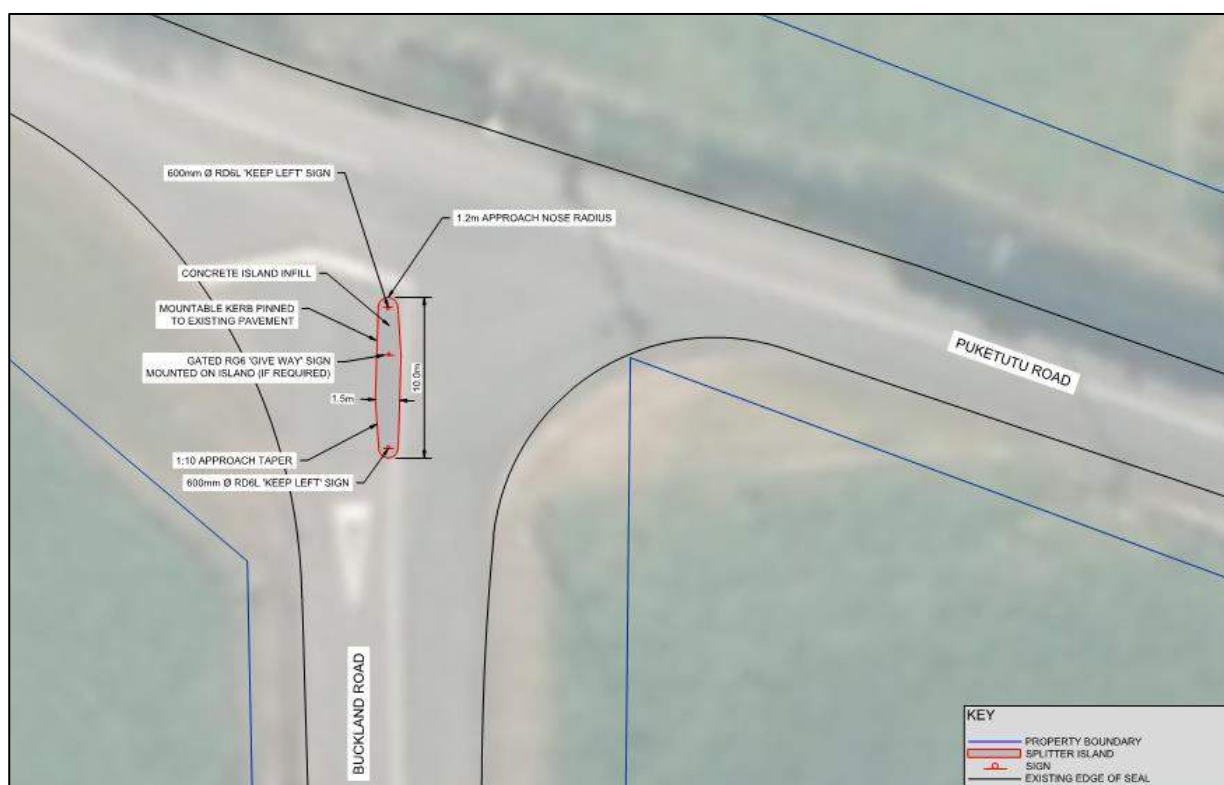
Figure 10: Splitter Island Concept

Concerns have been raised with location of signs and layout of the Puketutu Road/ Buckland Road intersection. Currently there is:

Submitters state that there have been loss of control crashes at the intersection, as a result of vehicle turning left from Puketutu Road in Buckland Road. In 2014, there were two reported non-injury crashes within 250m of the intersection, both involved vehicles losing control while turning left into Buckland Road and hitting the fence. On a recent site visit (1 February 2019) we observed one vehicle miss the left-turn into Buckland Road and u-turn on Puketutu Road before continuing on towards Hobbiton. Typical crash rates and intervention strategies generally take account of under-reporting of crashes¹.

- = Modifying the advanced signage and line marking.
- = Realigning the Buckland Road approach so that it is perpendicular to Puketutu Road. This would assisting in managing vehicle speed and improve visibility. This will require land purchase.
- = Providing a splitter island on Buckland Road – would reduce speed of vehicles turning right from Buckland Road into Puketutu Road and vice versa.

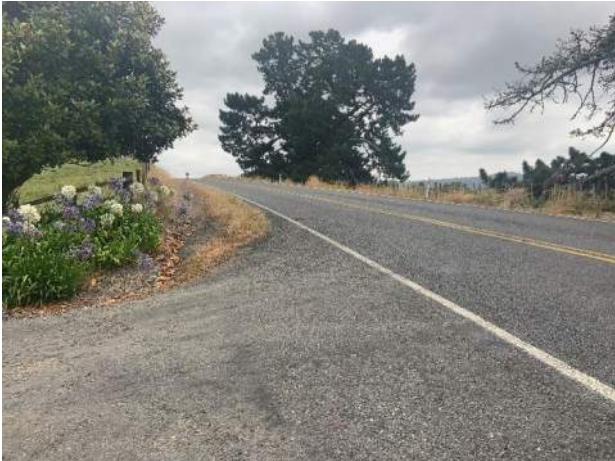
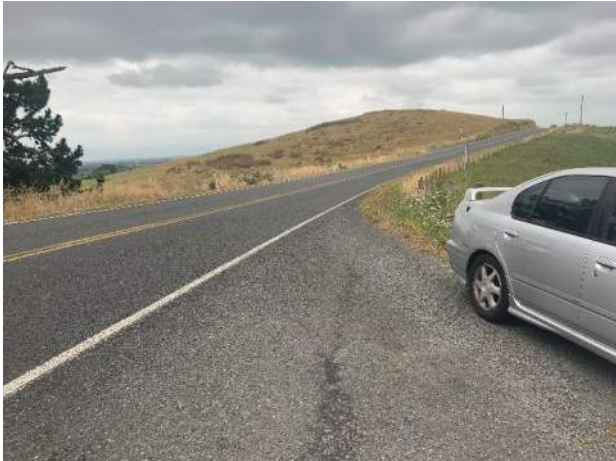
Table 4: Sight distance at 385 Buckland Road

Looking Left (approx. 65m)	Looking Right (approx. 140m)

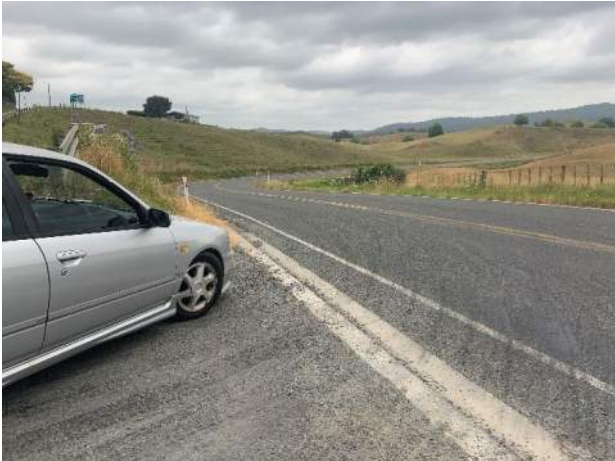
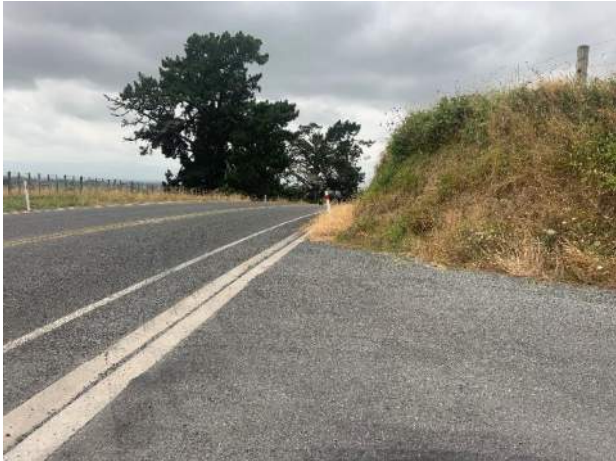
Table 5: Sight distance at 399 Buckland Road (140m sight distance required)

Looking Left (approx. 110m)	Looking Right (approx. 45m)

The Crash Estimation Compendium method uses the sum of the sight distance in both directions. The existing vertical crest and bank on Buckland Road currently limits sight distance at 399 Buckland Road to a sum of approx. 155m, a deficiency of 125m. The sum of the deficiency at 385 Buckland Road is approx. 35m. As shown below, the proposed increase in traffic increases the crash rate for right-turns out of 399 Buckland Road by approx. 12%. No mitigation is proposed as part of the application.
