162 Studholme Street Development Ecological Assessment

Submitted to:
Lockerbie Estates Limited

182 Studholme Street Plan Change Ecological Assessment

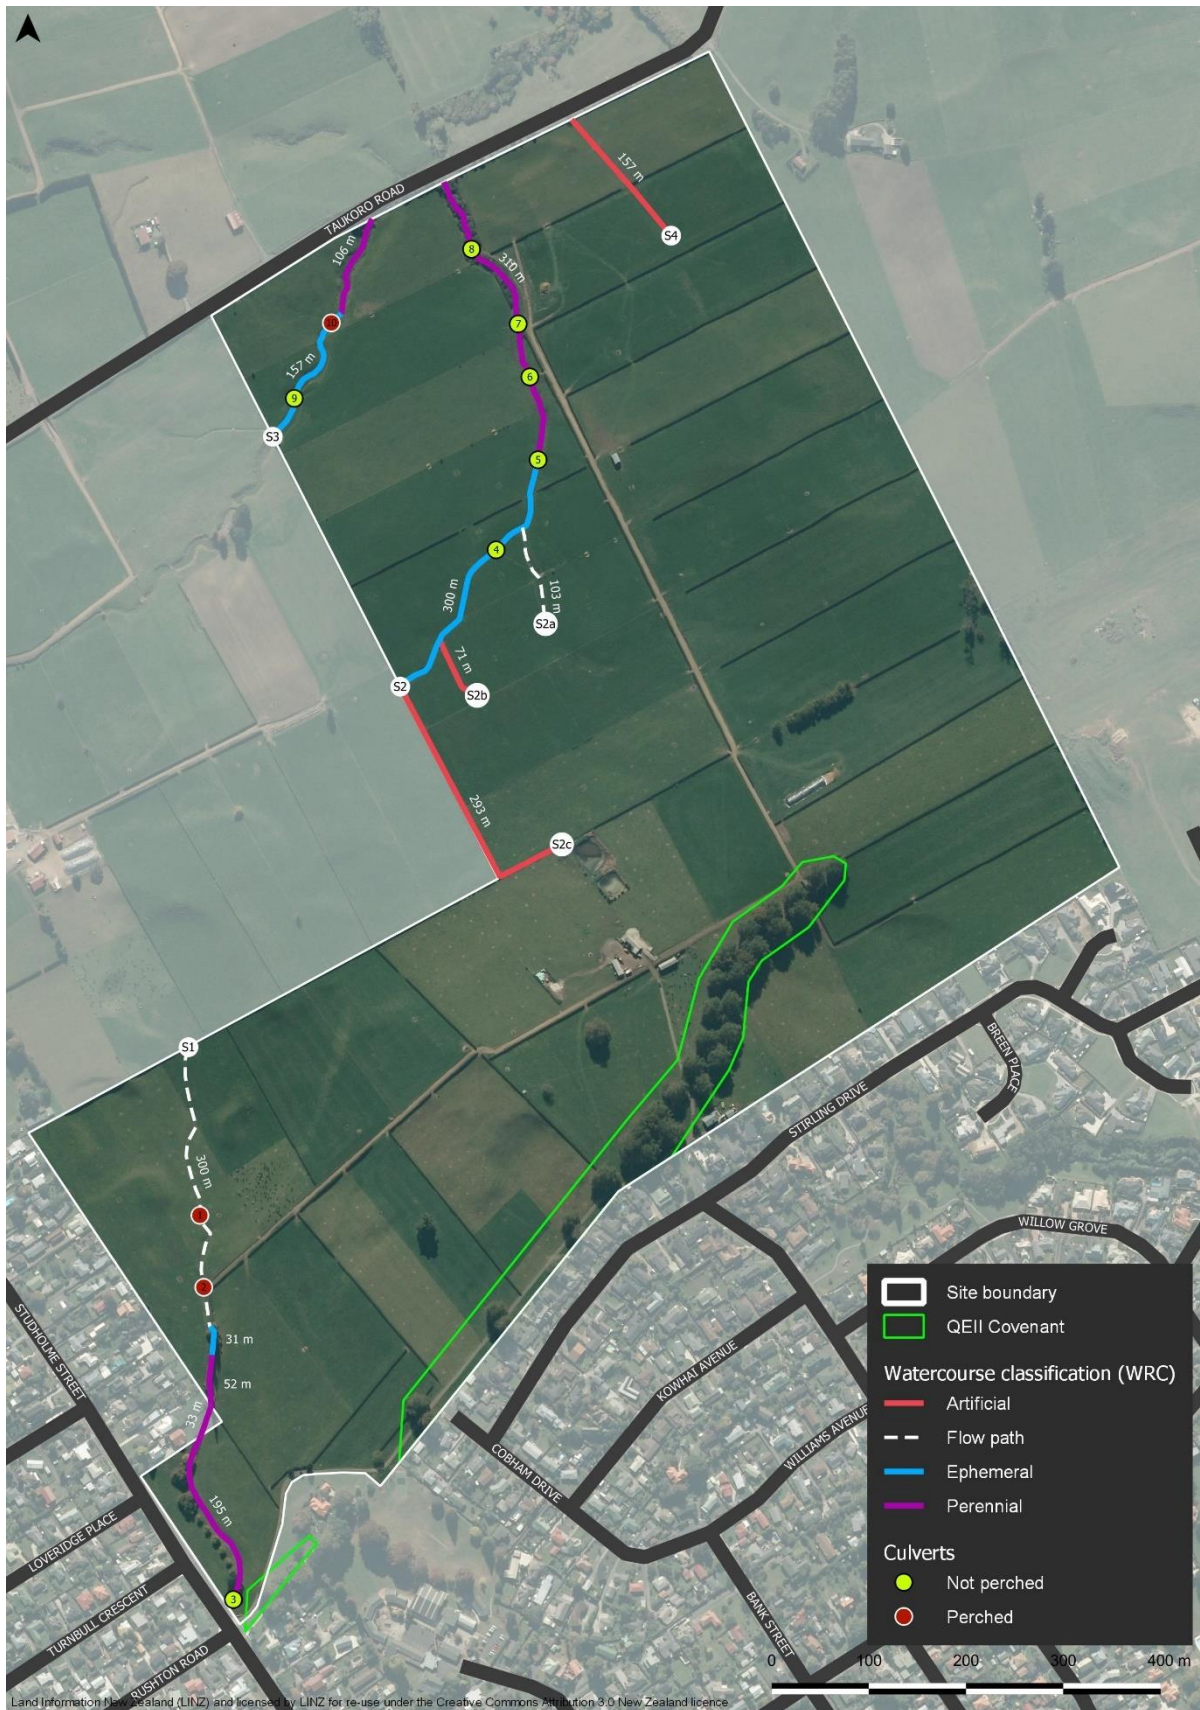
Figure 3: Stream classifications based on WRP definitions.

Watercourses within the site were classified in accordance with definitions outlined in the WRP (see Section 3.0). Aerial photographs from 1940 and 1941 were inspected to check historical and current channel alignments. Overall, watercourses within the site and shown on historical photographs matched up with present-day alignments. Stream classifications based on WRP definitions are shown on Figure 3 and summarised in Table 3.

Watercourse S1 has a total length of 610 m within the site and comprises 300 m of headwater flow path, 31 m of ephemeral stream and 280 m of perennial stream (33 m of which occurs on 280 Studholme Street). Watercourse S2 originates near the western site boundary and has an upper 300 m ephemeral reach and lower 310 m perennial reach. Watercourse S2a is a 103 m long flow path whilst S2b and S2c are artificial farm drainage canals. Watercourse S3 has an upper 157 m ephemeral reach and 106 m perennial reach. Watercourse S4 is an artificial farm drainage canal.

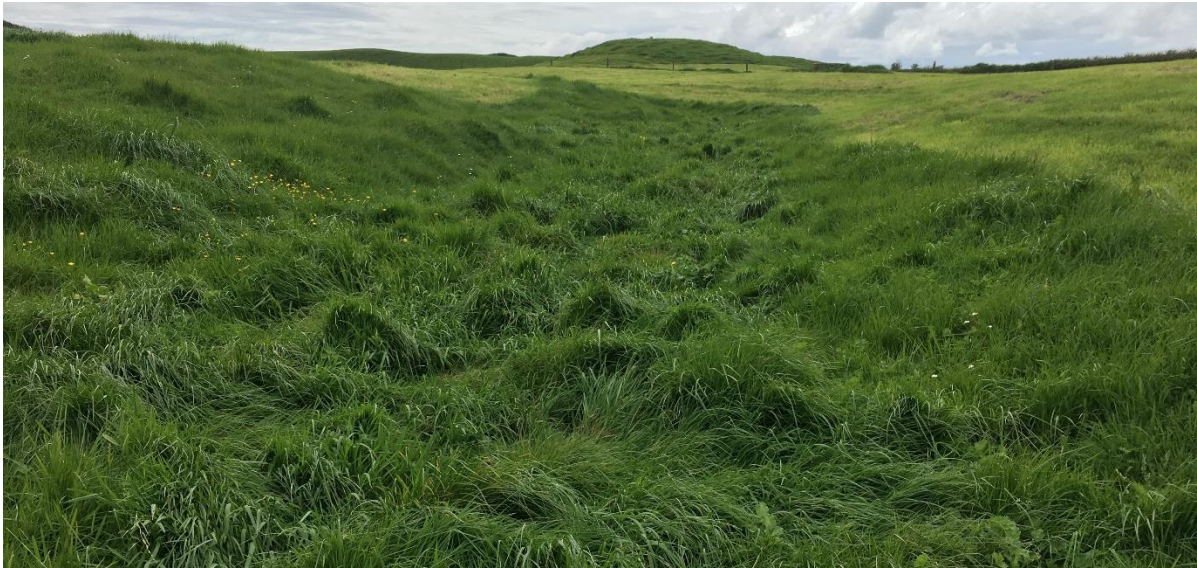
Figure 4: Flow path in upper reaches of S1.

The upper 300 m of Watercourse S1 was assessed as being a modified overland flow path that drains a flat area of grazed pasture and lacking riparian vegetation (Figure 4). The flow path has been artificially widened and deepened, lacked a defined channel, was unfenced and grazing damaged, lined with grass and was dry at the time of the survey. There are two perched culverts (1 and 2) on the flow path however this section does not provide habitat for fish so they are not considered barriers to fish.

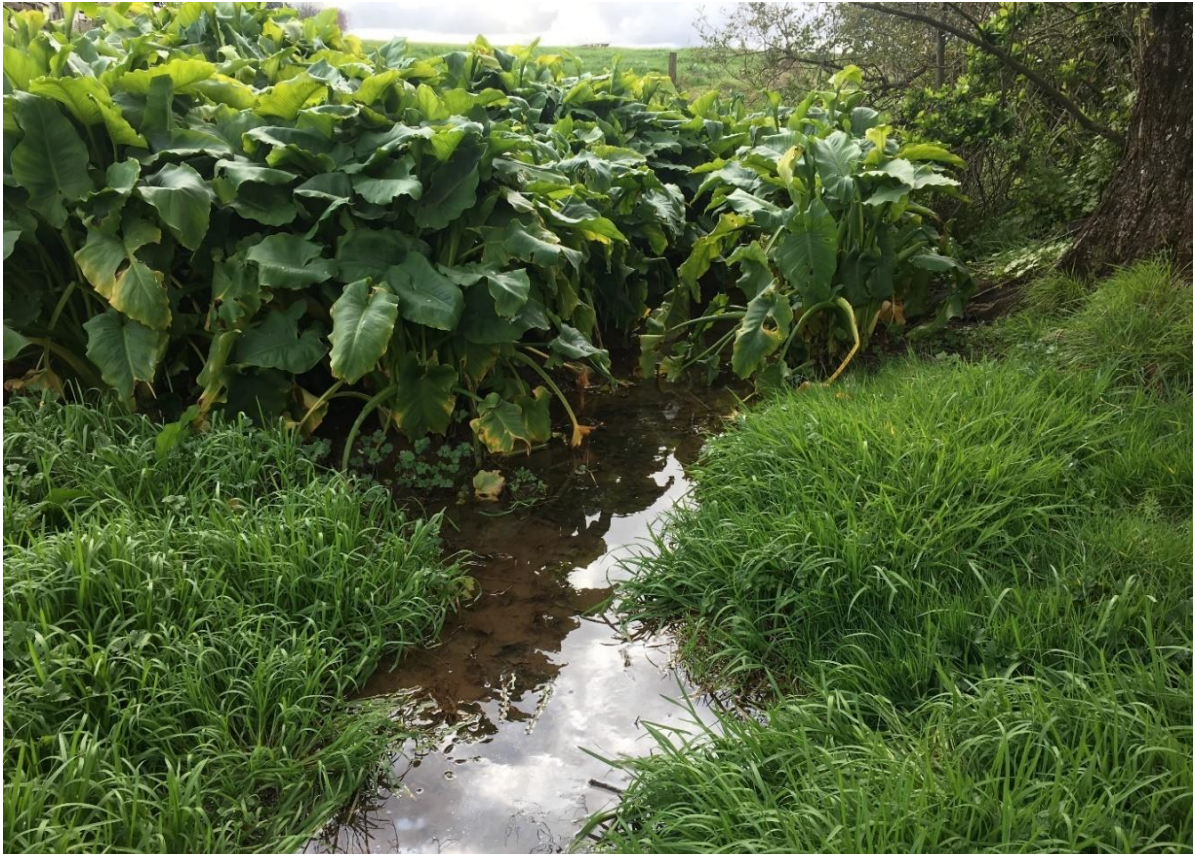
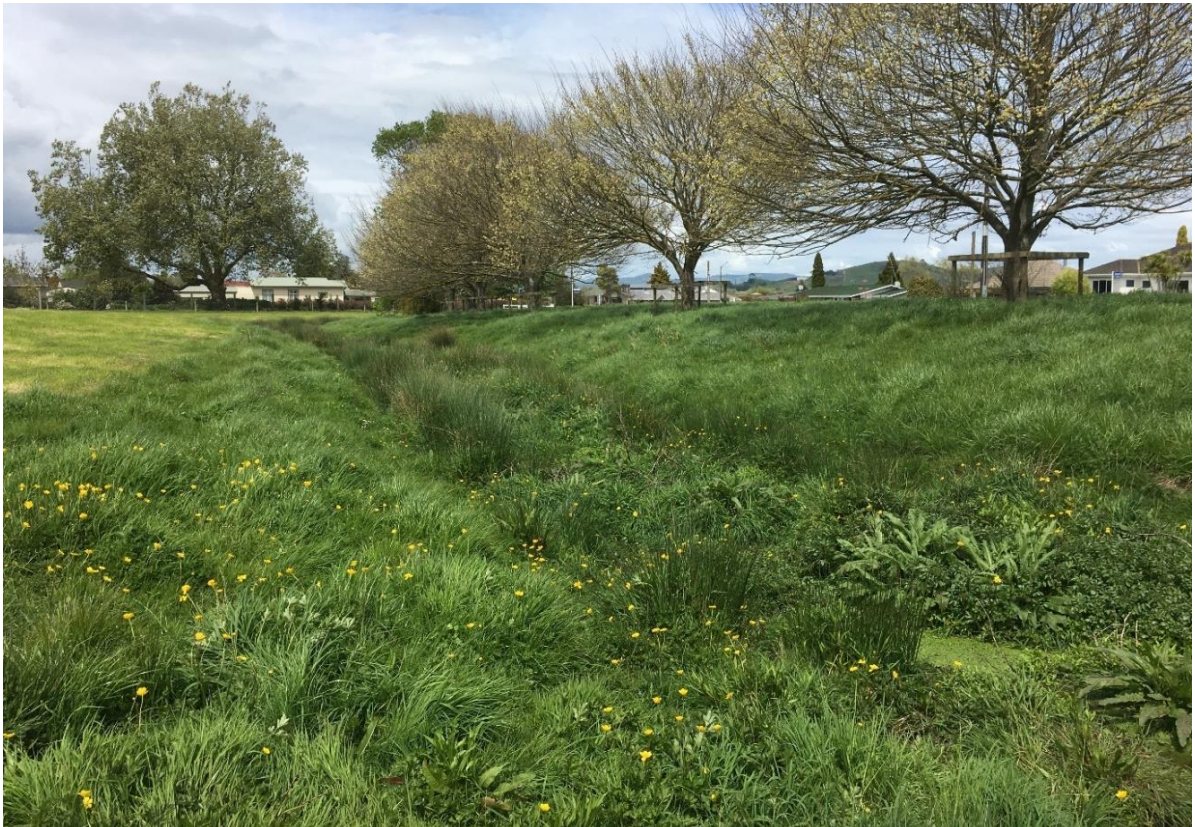
Figure 5: Habitat along upper (top) and lower (below) perennial section of S1.

The lower perennial section of Watercourse S1 flowed within a shallow depression that had been artificially widened over time after a long history of channel and floodplain widening, weed/macrophyte clearance and direct grazing damage causing pugging and poor channel definition (Figure 5). There was a single unperched culvert (3) in the lower reaches that was not a barrier to fish passage. The lower section had a wide floodplain (3–8 m), wetted channel width of 0.75 m was swampy in character and choked with grass and emergent macrophytes such as watercress (*Nasturtium officinale*) and willow weed (*Persicaria* sp.). Other macrophytes recorded along the lower section included spearwort (*Ranunculus flammula*), starwort (*Callitriche stagnalis*) and duck weed (*Lemna minor*).

There was little to no flow in the lower perennial section at the time of the survey, which reflected the diffuse spread of shallow water across the broad floodplain and the choked nature of the channel. The lower section was open and generally poorly shaded with occasional weeping willow (*Salix babylonica*) and a mature elm (*Ulmus* sp.) providing some shade. Sections of the stream where willow grew were wide and swampy as is typical. The perennial section provided stable but poor-quality habitat for invertebrates and fish.

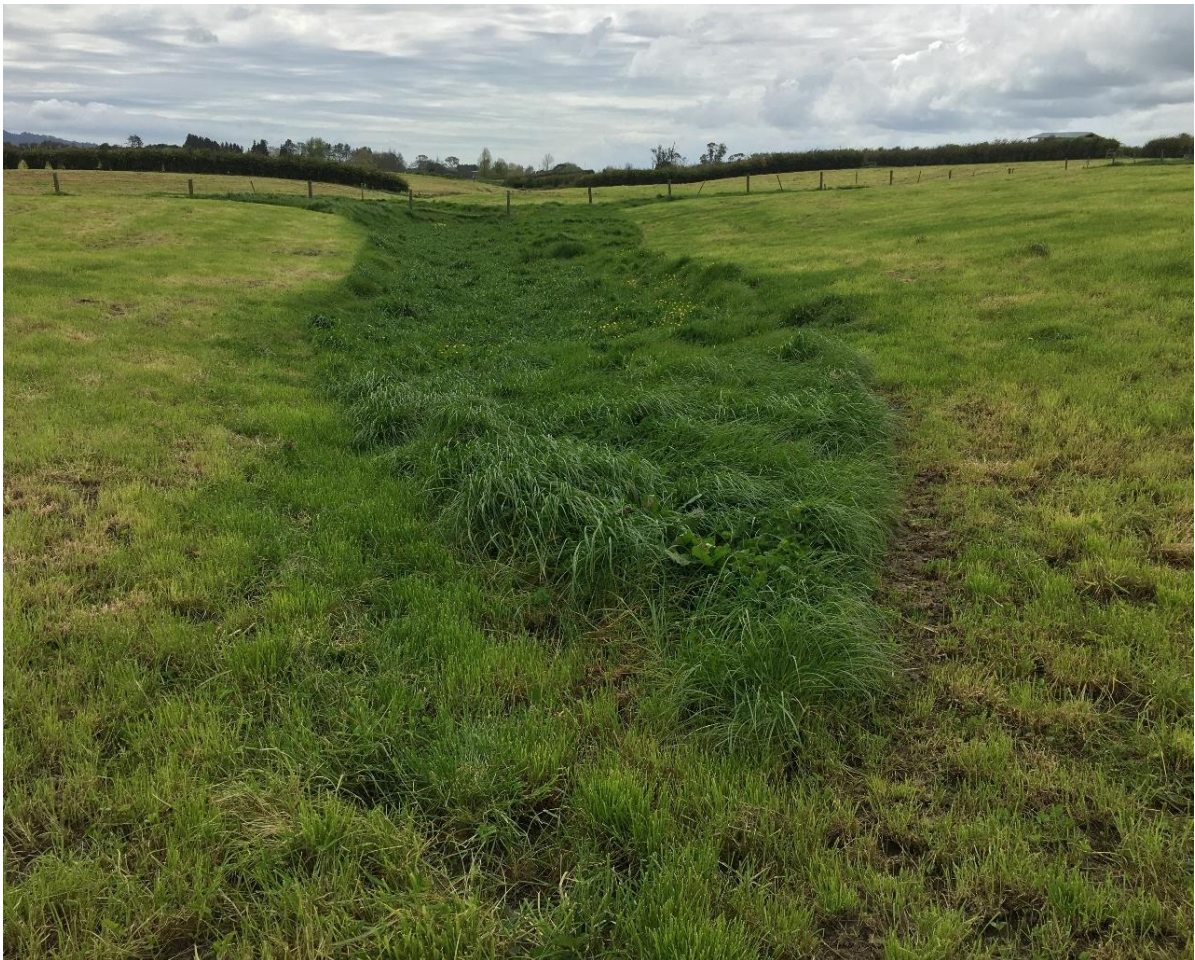
Figure 6: Modified flow path of Watercourse S2a.

Watercourse S2a is approximately 103 m in length and is a flow path that drains a gentle sloping broad gully within a grazed pasture paddock. Watercourse S2a drains into the mainstem Watercourse S2 and has been artificially widened and deepened to an extent that the water table is at or near the base of the shallow depression and resulting in diffuse and shallow surface water. Watercourse S2a is choked with grass, *Glyceria*, grazed, lacks a defined channel and does not provide aquatic habitat. Watercourse S2a was not classed as an ephemeral or perennial stream due to its highly modified state and small catchment.

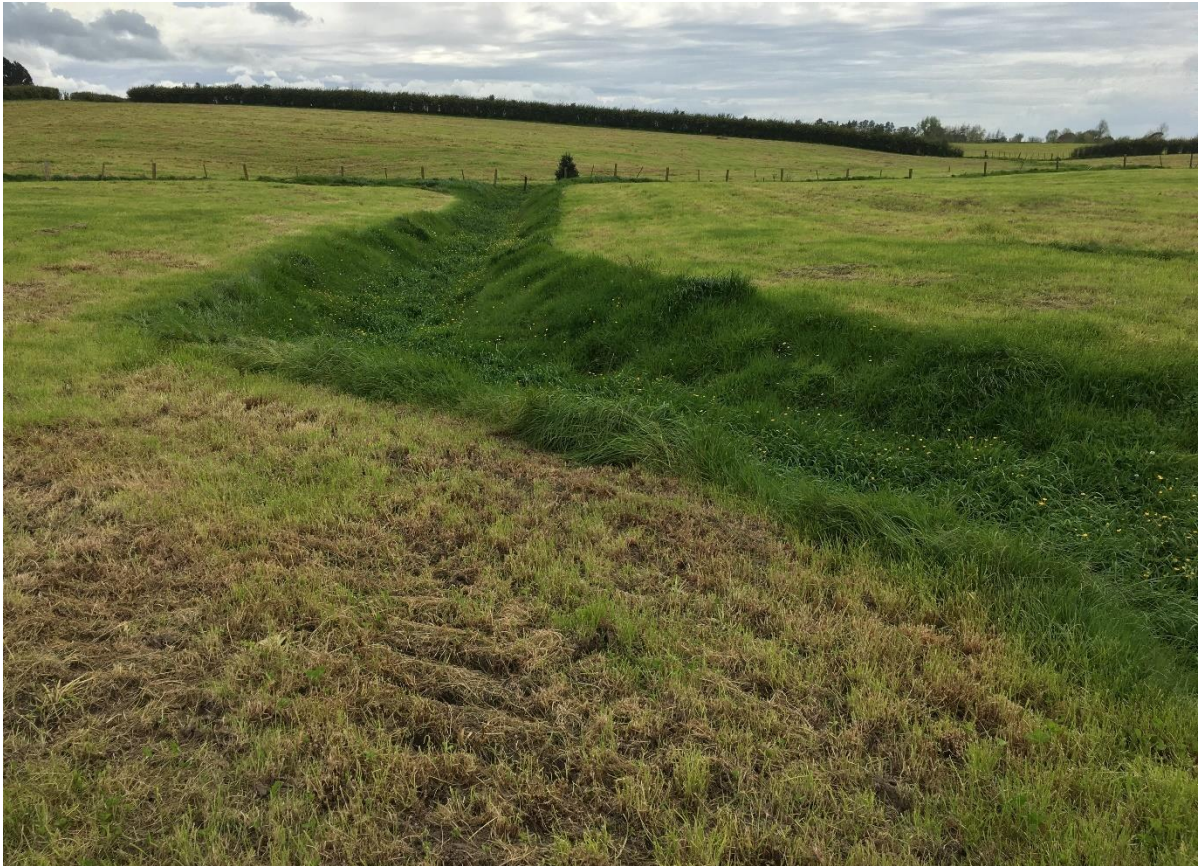
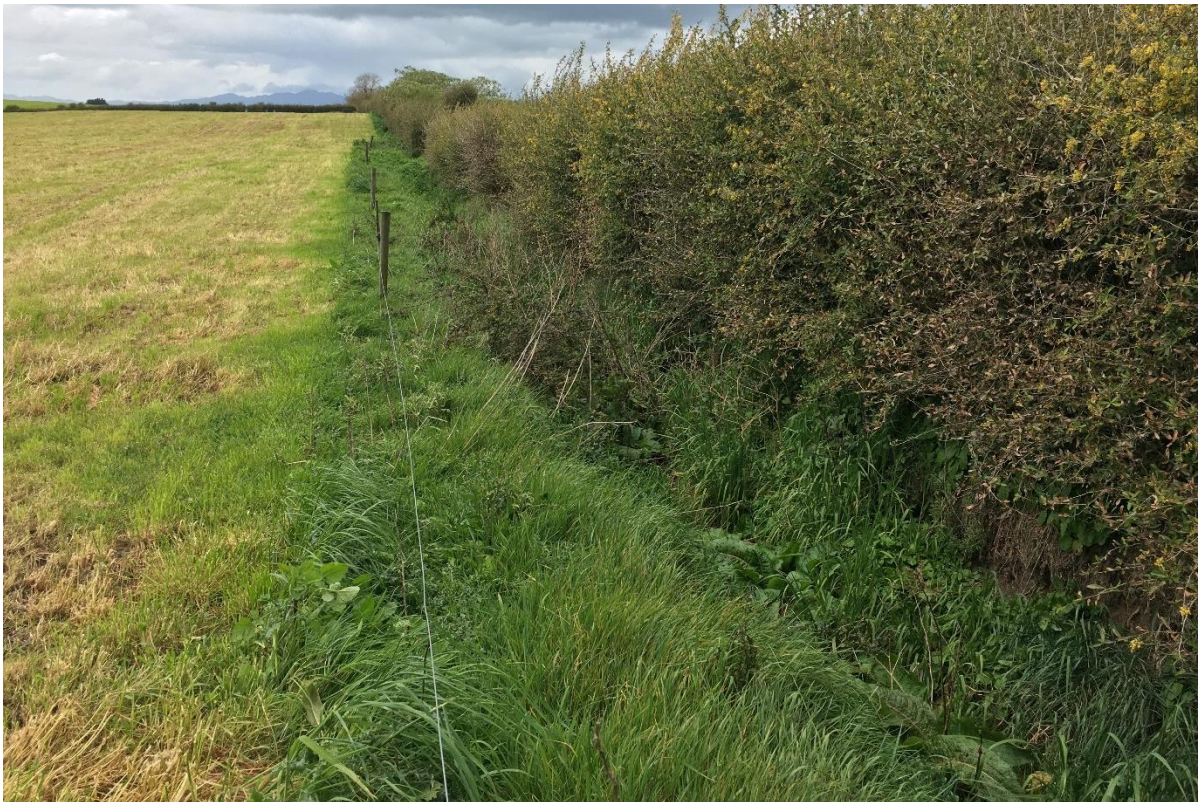
Figure 7: Artificial farm drainage canal S2b (top) and S2c (below).

Watercourses S2b and S2c were classified as artificial drains. Watercourse S2b is a 71 m long farm drain that drains a grazed pasture paddock, has a straight alignment, is lined with exotic grass, *Glyceria* and watercress, held a small amount of shallow non-flowing surface water and drains into the upper ephemeral section Watercourse S2 (Figure 7).

Watercourse S2c is a 293 m long farm drain that feeds into the uppermost extent of the natural section of Watercourse S2 (Figure 8). Watercourse S2c has been dug along the western boundary fence and up to two ponds. There was no surface water in Watercourse S2c during the survey.

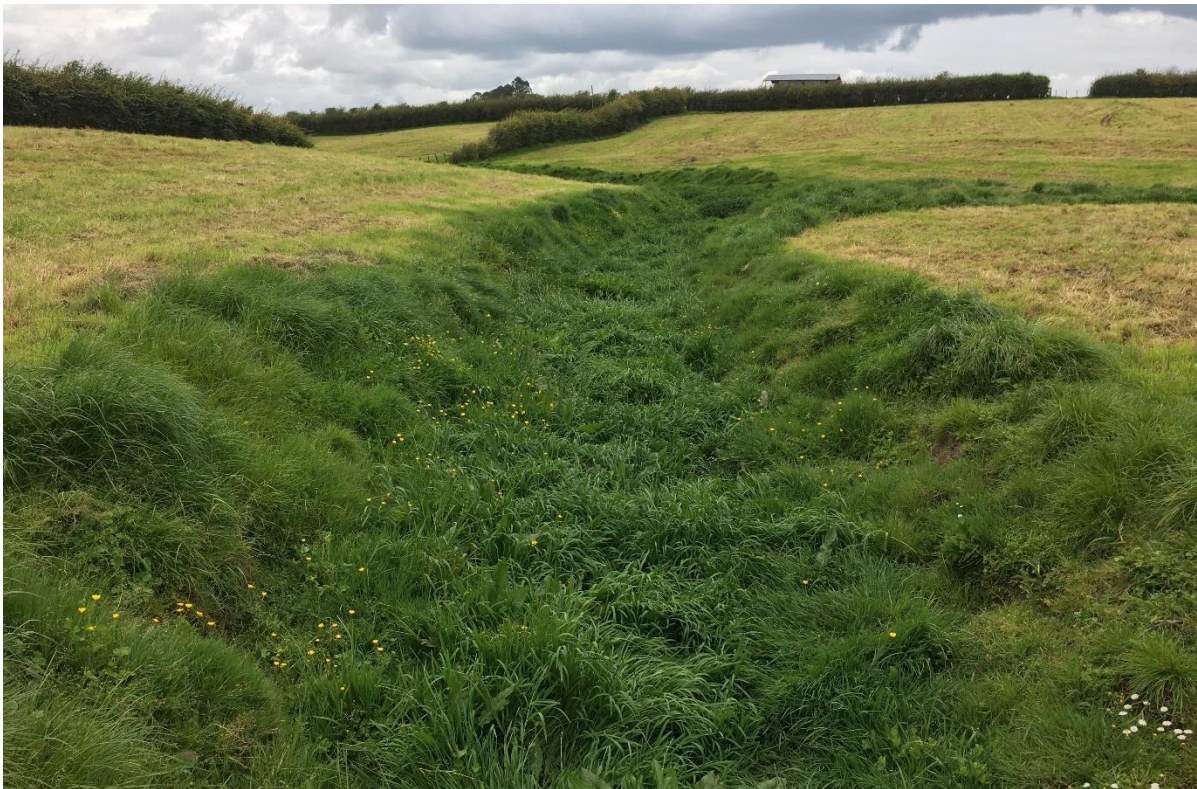
Figure 8: Habitat along upper ephemeral section of S2.

The upper ephemeral section of Watercourse S2 is 300 m in length and has been artificially widened and deepened, is damaged by grazing and lacks a defined channel (Figure 8). The broad base of the depression (immediate floodplain) ranged in width between 2–4 m with diffuse and shallow (<0.02 m) surface water spread across it. The wetted width was estimated to be 0.7 m and was choked with *Glyceria*, exotic grass and watercress with occasional areas of open water with streambed sorting of the silt bed. The channel was unfenced, lacked riparian vegetation and poorly shaded. There are two unperched culverts on the ephemeral reach (4 and 5 = 6 m and 7 m in length). The ephemeral section provided marginal habitat for invertebrates and fish.

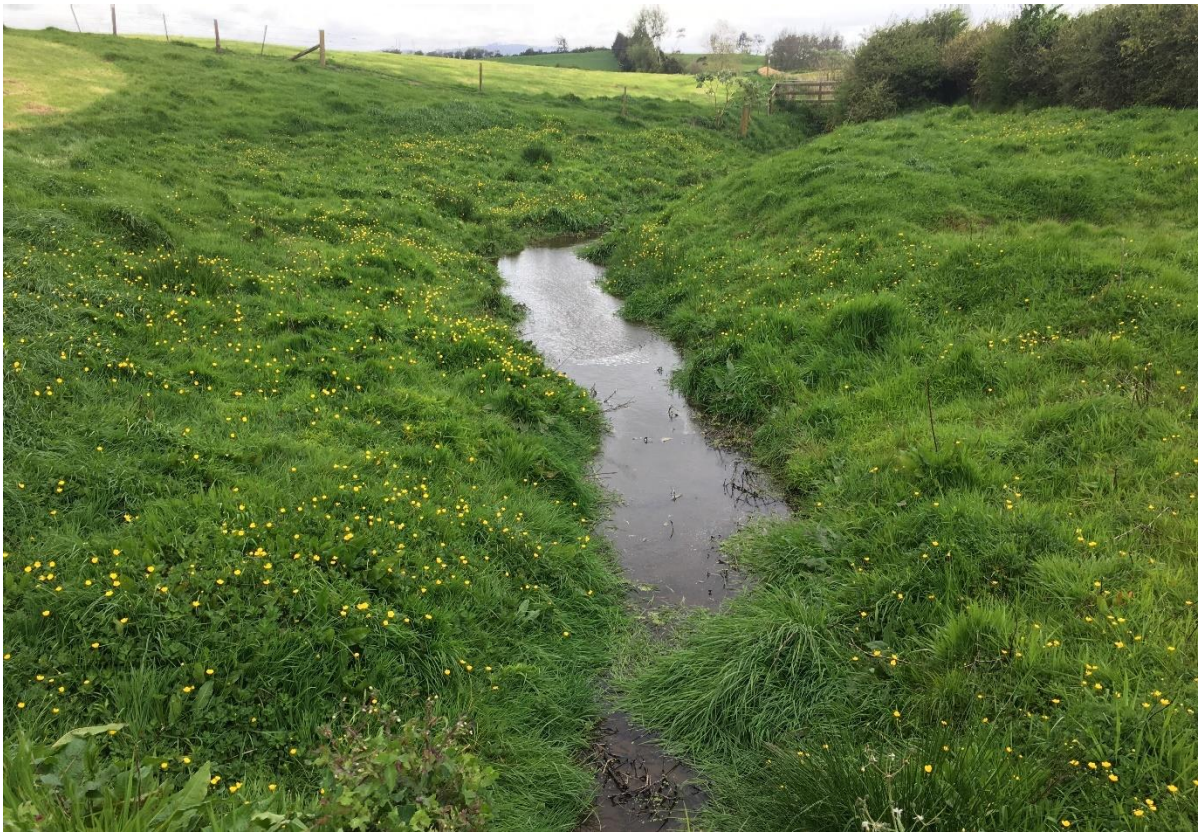
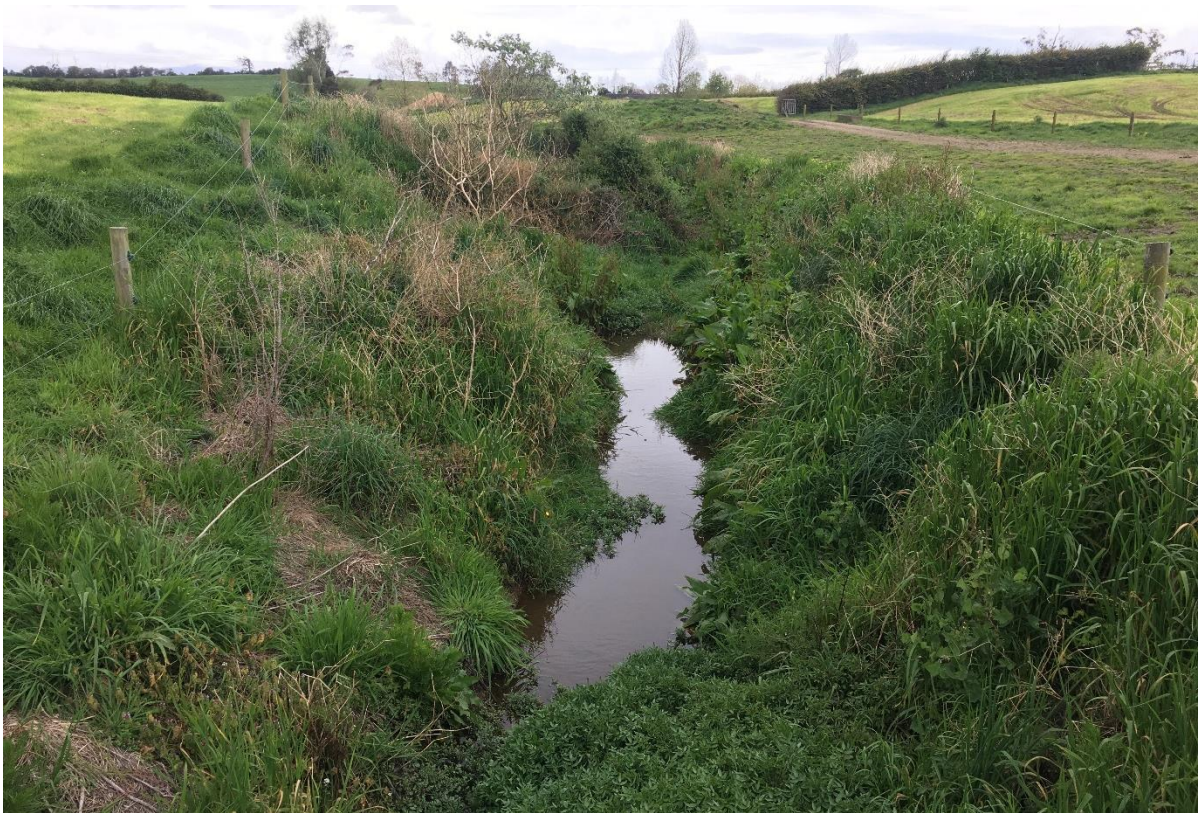
Figure 9: Habitat along upper unfenced section (top) and fenced lower section of perennial Watercourse S2.

The lower perennial section is 310 m in length and drains a broad depression that becomes an increasingly steep V-shaped gully that meanders in a northerly direction towards the northern site boundary along Taukoro Road (Figure 9). The perennial section becomes increasingly more well-defined as it flows northwards with the lower 170 m section draining an incised, V-shaped gully with steep sides and is fenced on both banks. The upper unfenced perennial section is lined with grazed pasture grass whilst the lower fenced section has a riparian margin comprising weedy species (e.g., woolly nightshade, Chinese privet, ivy onion weed). The channel is generally poorly shaded with macrophytes recorded including *Glyceria*, willow weed, watercress and duckweed whilst long green filamentous was common in some areas. The perennial section channel has an average wetted width of 1.4 m and has depths ranging between 0.2–0.5 m with habitat comprising sluggish runs and pools. Watercourse S2 provides aquatic habitat of low quality for aquatic biota. There are three unperched culverts on the perennial reach (6, 7, 8; 5.5 m, 6.5 m, 6 m in length).

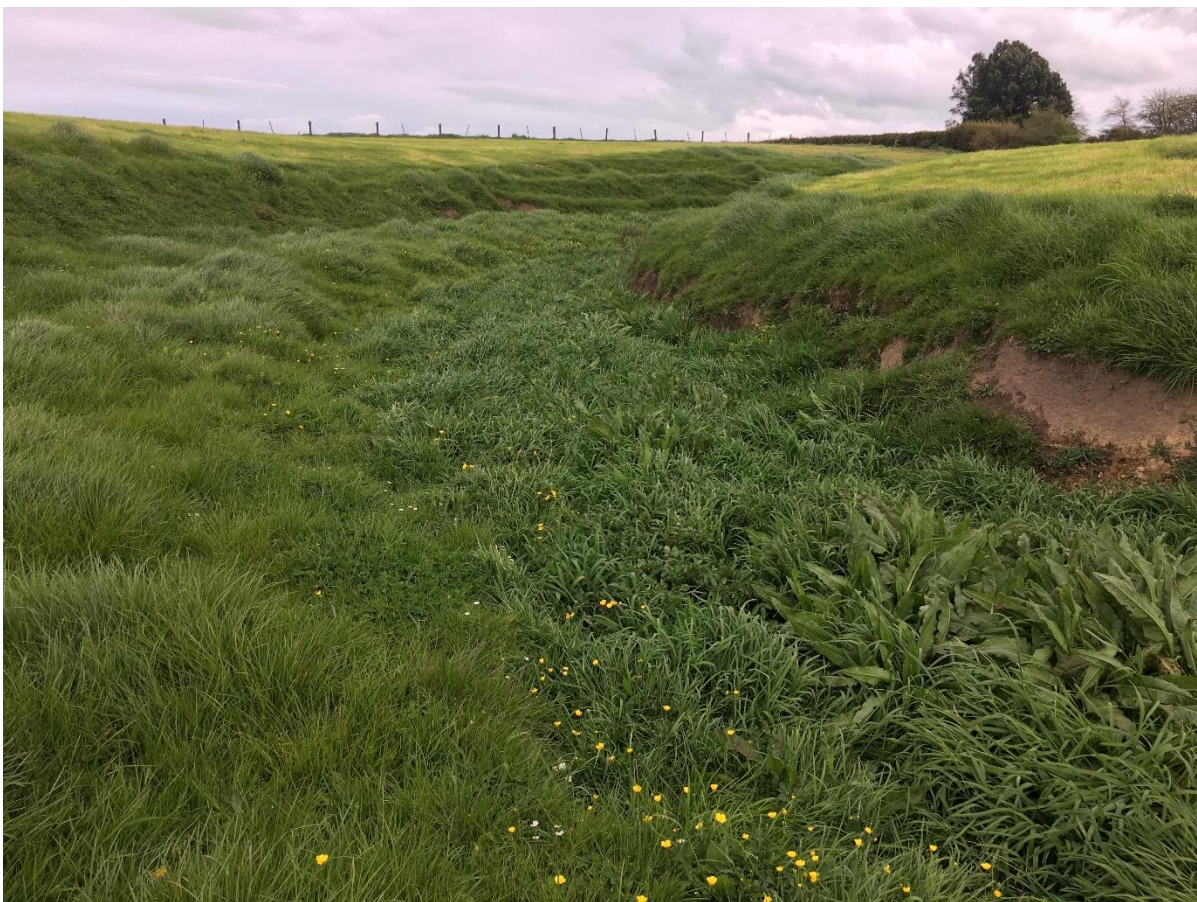
Figure 10: Habitat along upper ephemeral section of S3.

Watercourse S3 is 263 m in length and originates on the neighbouring property to the west. The upper ephemeral section within the site is 157 m in length and is located within a broad gully (2–5 m wide) and has an estimated mean wetted width of 0.5 m (Figure 10). The gully narrows into a slightly higher gradient sections within a V-shaped gully before transitioning into the lower perennial reach. The ephemeral section was unfenced, grazed, lacked a defined channel and held a small amount of shallow and diffusely spread surface water at the time of the survey. There were two culverts on the ephemeral section (9 and 10 = 4 m and 6.5 m in length) with the lower culvert 10 being perched and a barrier to fish passage. The ephemeral section had similar characteristics to the upper reaches of Watercourse S2 and provided marginal habitat.

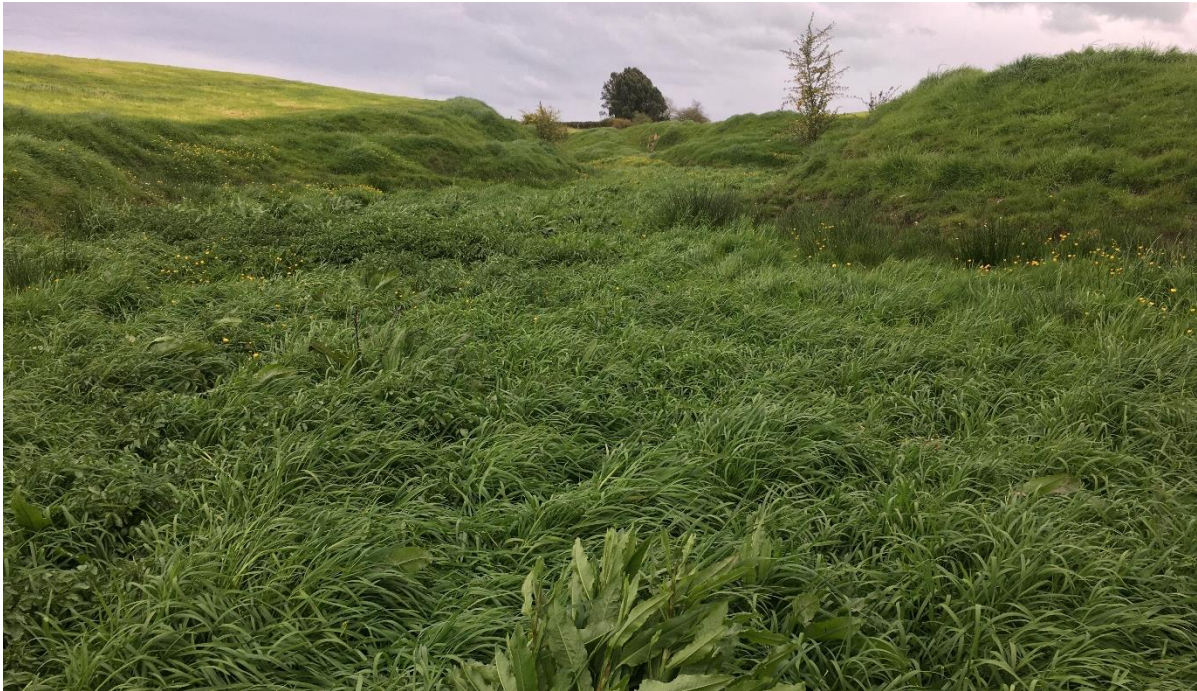
Figure 11: Habitat along lower perennial section of upper S3.

The lower perennial section of Watercourse S3 is approximately 106 m in length has similar characteristics to the upstream ephemeral section but with more surface water diffusely spread across the broad gully base (Figure 11). The floodplain is wide (5–10 m) and there was no defined channel due to a long history of grazing damage. The floodplain was choked with grass and emergent macrophytes (e.g., *Glyceria*, willow weed, watercress). The watercourse was not fenced, lacked riparian vegetation and was poorly shaded.

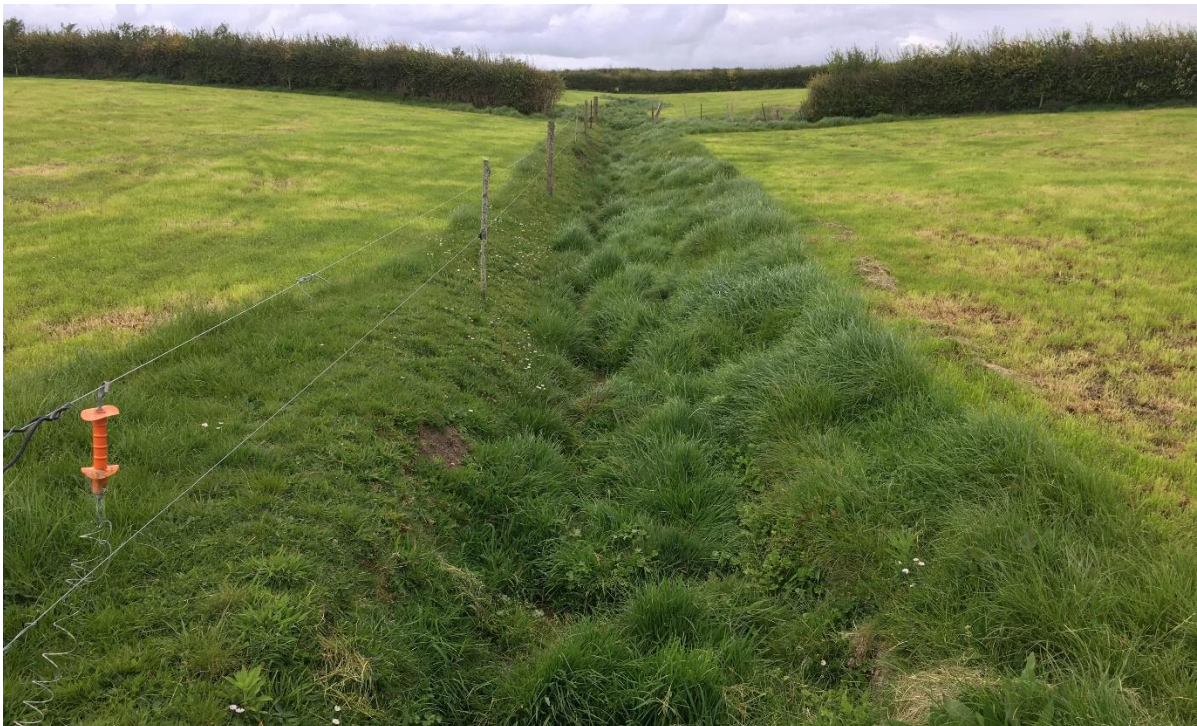
Figure 12: Artificial farm drainage canal of Watercourse S4.

Watercourse S4 is an artificial farm drain that originates within the site and is 157 m in length (Figure 12). The channel is narrow, lined with exotic grass/weeds and did not hold surface water at the time of the survey.

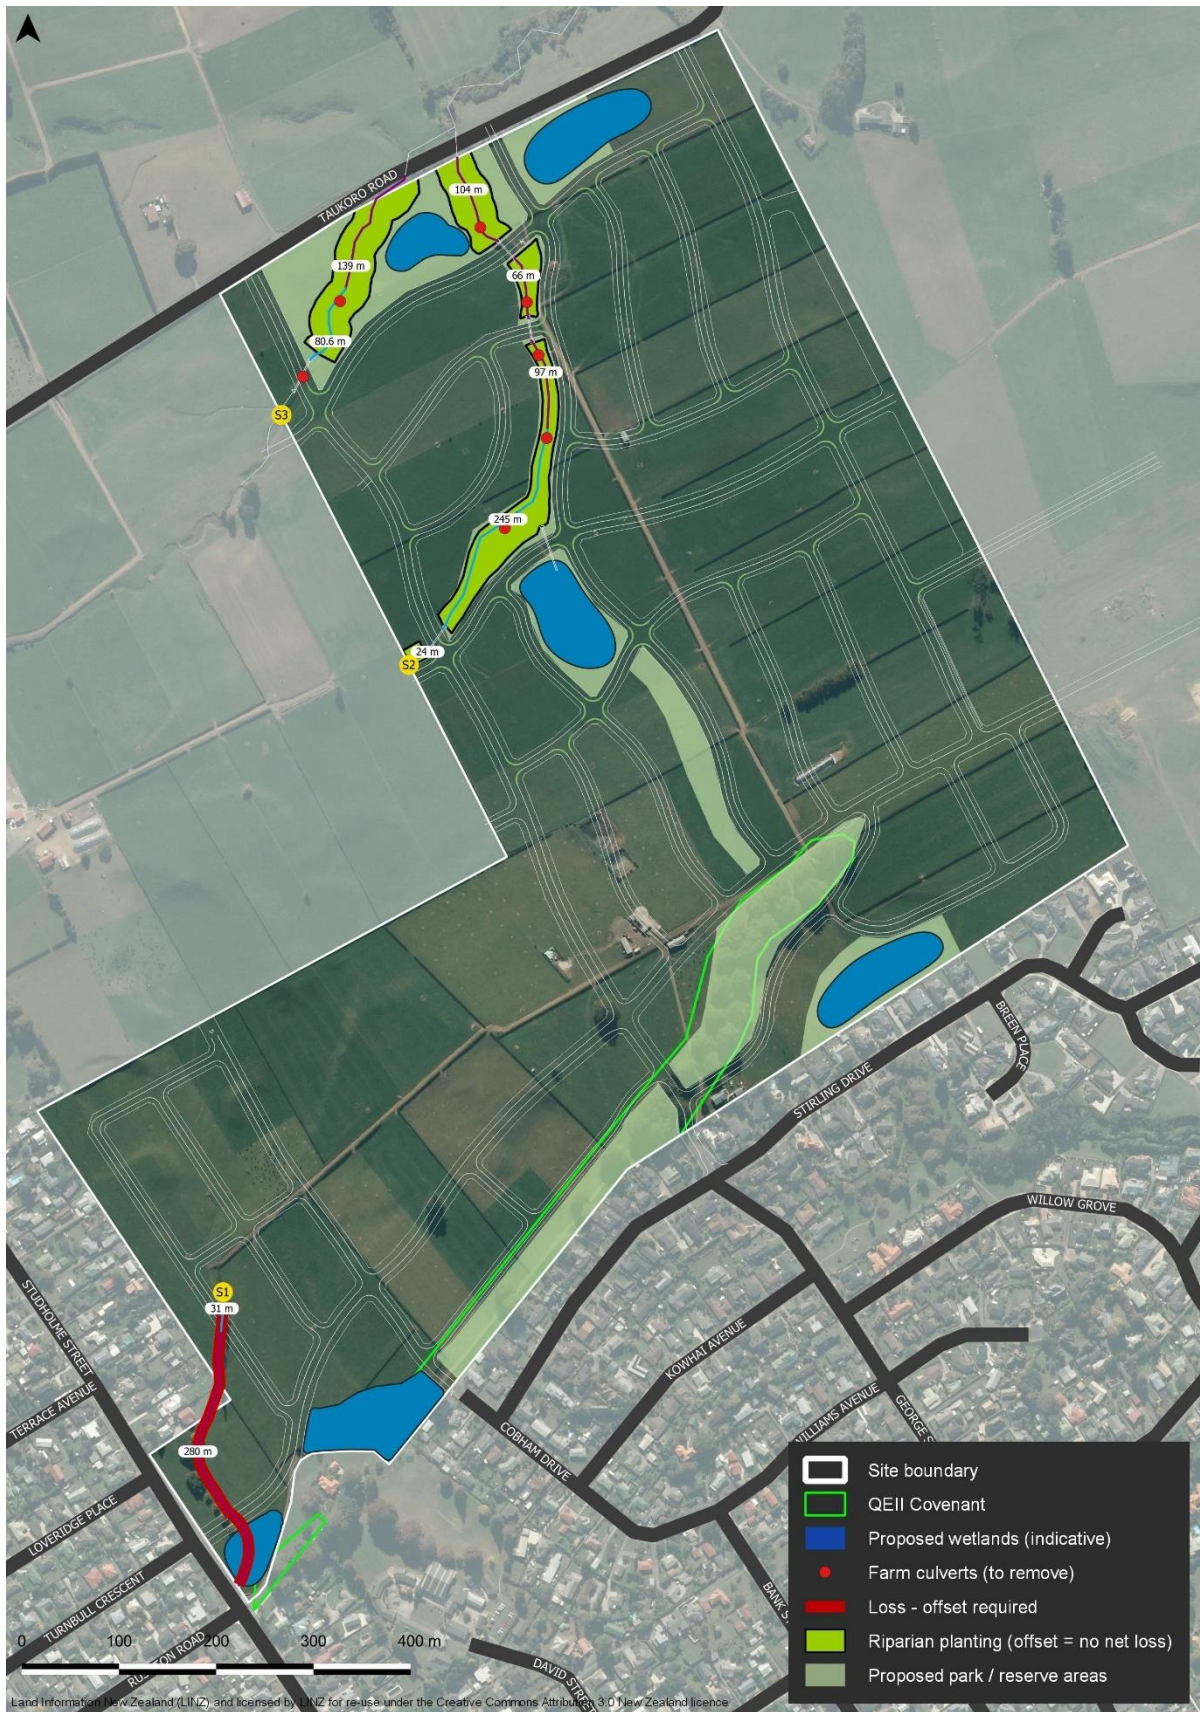
Figure 14: Proposed stream reclamation and restoration required as an offset.

- (*) Culvert lengths shown in table are the proposed culverts minus the length of proposed daylighted stream by removing the existing farm culverts (i.e., S2 perennial culvert to offset is 45 m - 18 m = 27 m; S2 ephemeral culvert to offset is 31 m - 13 m = 18 m; S3 ephemeral culvert to offset is 39 m - 10.5 m = 28.5 m)

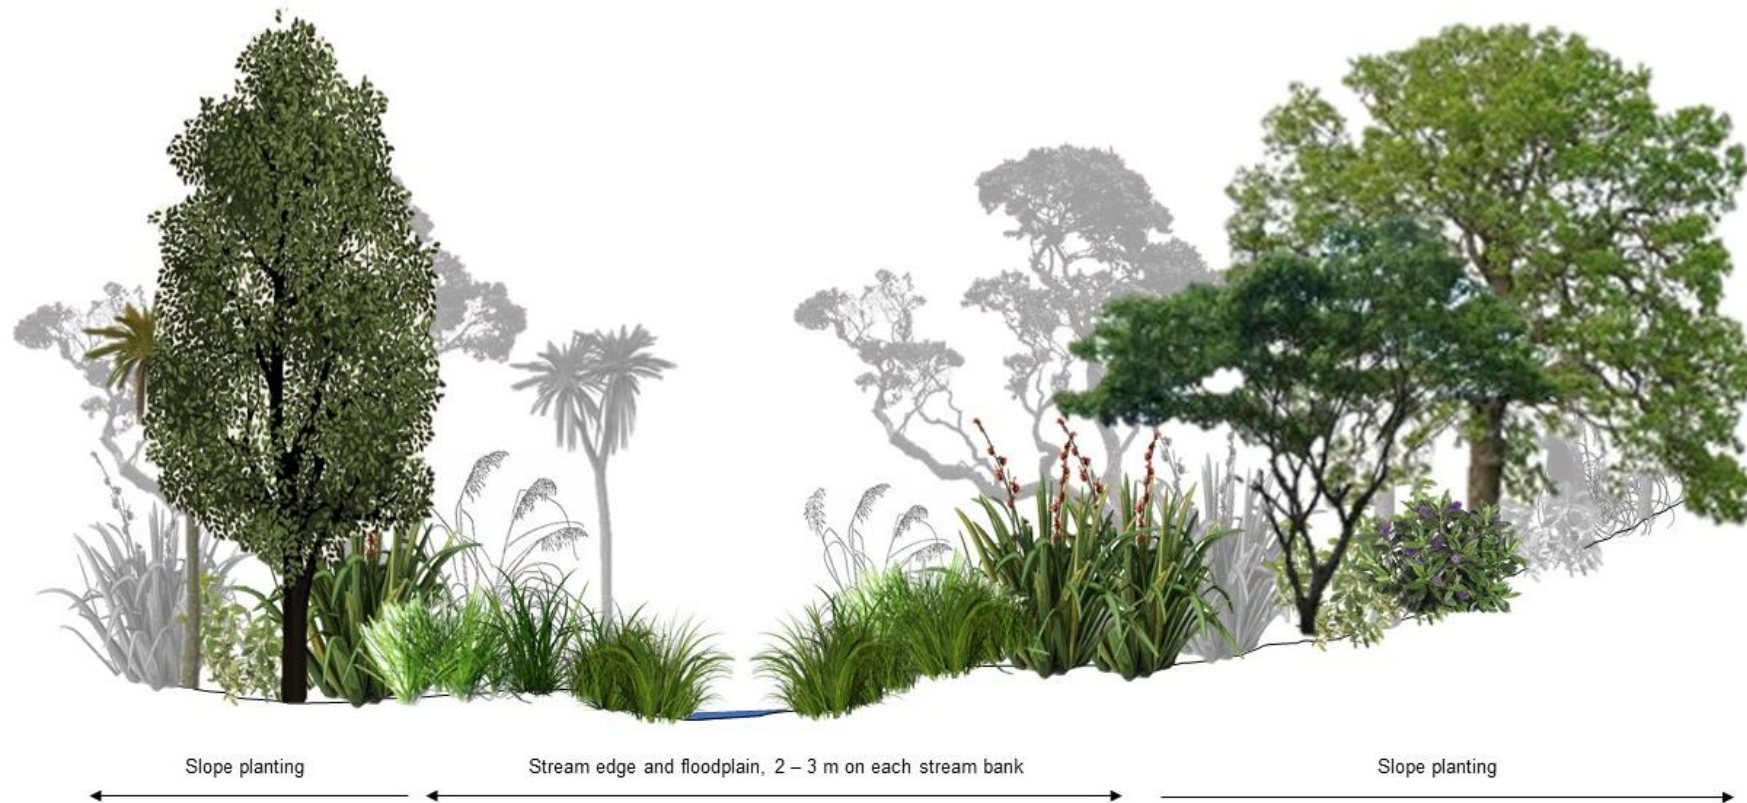
Figure 15: Indication of proposed planting when mature.

Plants should be planted in the appropriate microclimate to reflect soil moisture and inundation along with exposure. Two zones are recommended, one zone to capture the stream edge and flood plain (species tolerant of regular inundation and flooding) and one zone to capture those more suited to drier soils without inundation i.e., drier slope areas) (refer to Figure 15).

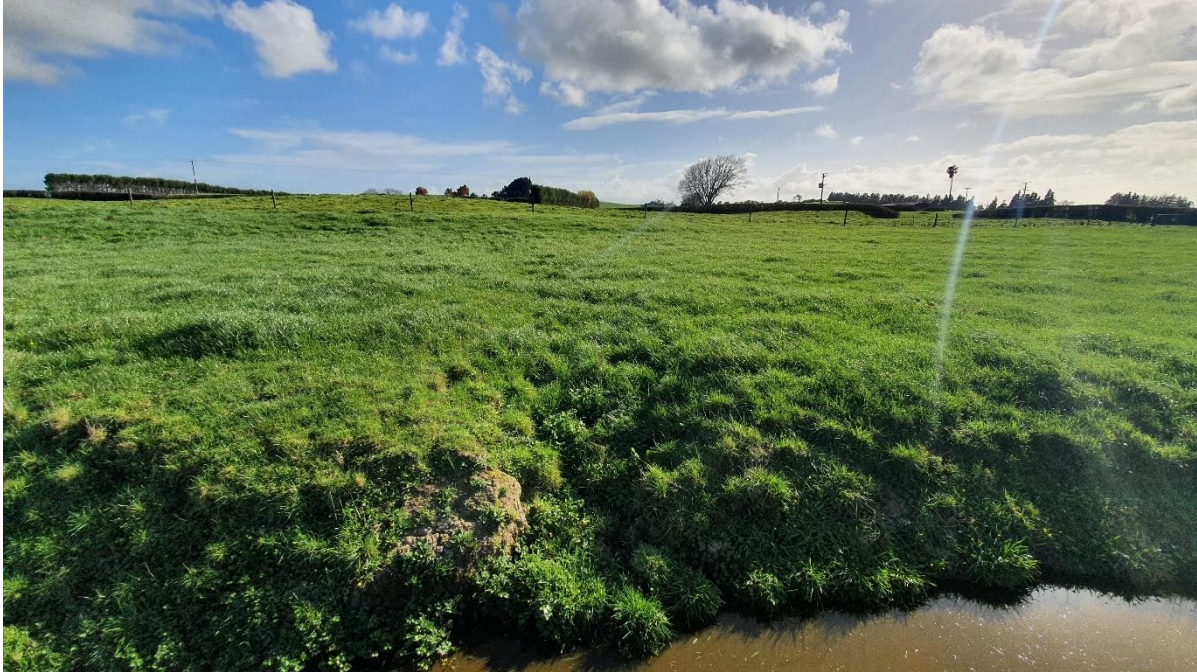
Figure 3: View of typical pastoral vegetation on the site.

The site is dominated by pasture grasses for grazing stock (Figure 3). Shelterbelt trees, dominated by *Cassuarina* sp. (she-oak), are present in the paddocks north of the milking yard and to the south of the residence. A small stand of exotic trees including tree privet (*Ligustrum lucidum*), oak (*Quercus robur*), willow (*Salix* sp.) and she-oak are located in the artificially induced basin towards the western site boundary on watercourse S3.

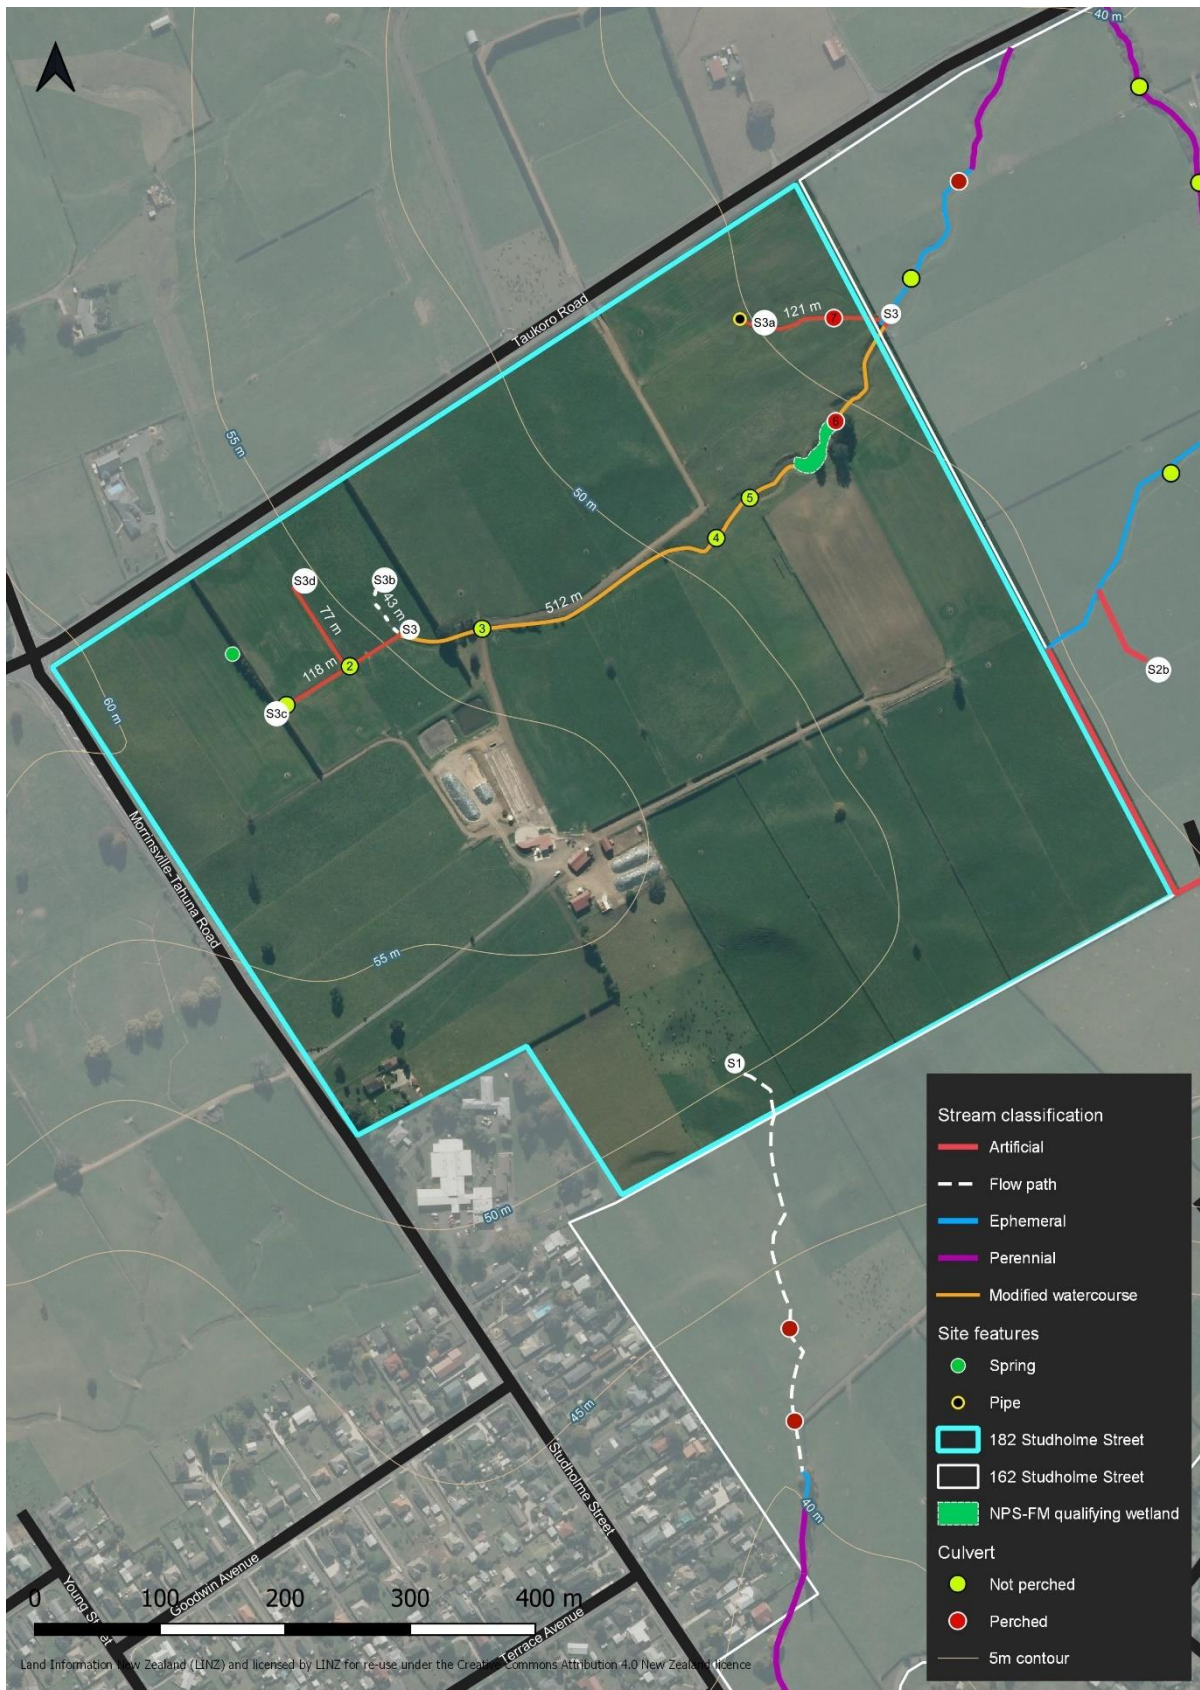
Figure 5: Stream classifications based on WRC definitions.

Watercourse	WRP status	Length (m)	Comment
S1	Flow path*	55 m	Flow path that is fed by a small spring. The flow path lies in a shallow gully.
S3a	Artificial	121 m	Short flow path branch that drains into S3 mainstem, in the adjoining property - has been artificially widened and deepened, farm drain characteristics. Pipe at the head of the drain and a perched culvert in the middle section.
S3b	Flow path*	43 m	Flow path that was historically fed by a small spring.
S3c	Artificial	118 m	Farm drain that feeds into the head of S3 mainstem, extends beyond the western shelterbelt and to the south of a spring head.
S3d	Artificial	77 m	Farm drain that feeds into S3c.
S3	Modified Stream	512 m	Lower section, wider channel, formally stable surface water for 3-5 months per year. Moderate emergent macrophyte cover, channel widened and deepened in places. No water in channel at the time of the survey. Some substrate sorting in the upper reaches.
