162 Studholme Street Development Ecological Assessment

Submitted to:
Lockerbie Estates Limited

182 Studholme Street Plan Change Ecological Assessment

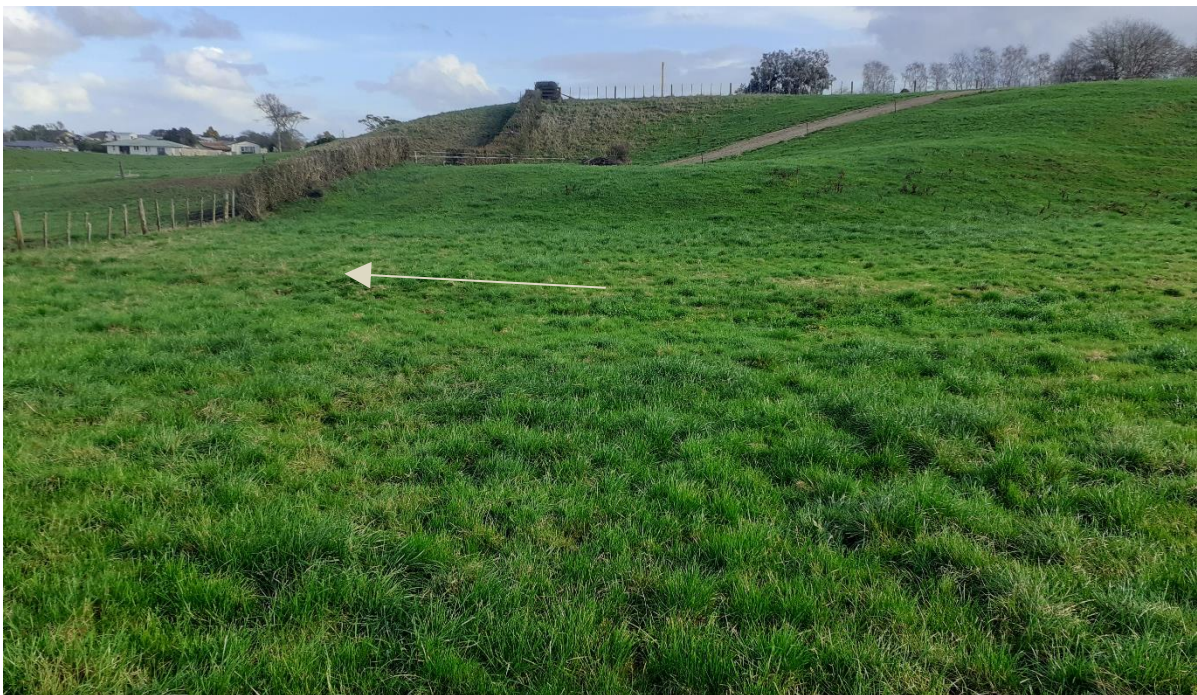
Figure 6: Flow path in upper reaches of Watercourse S1.

The flow path originates at the base of a gully in a low-lying depression (Figure 6). There are two perched culverts (1 and 2) on the off-site section of the flow path.

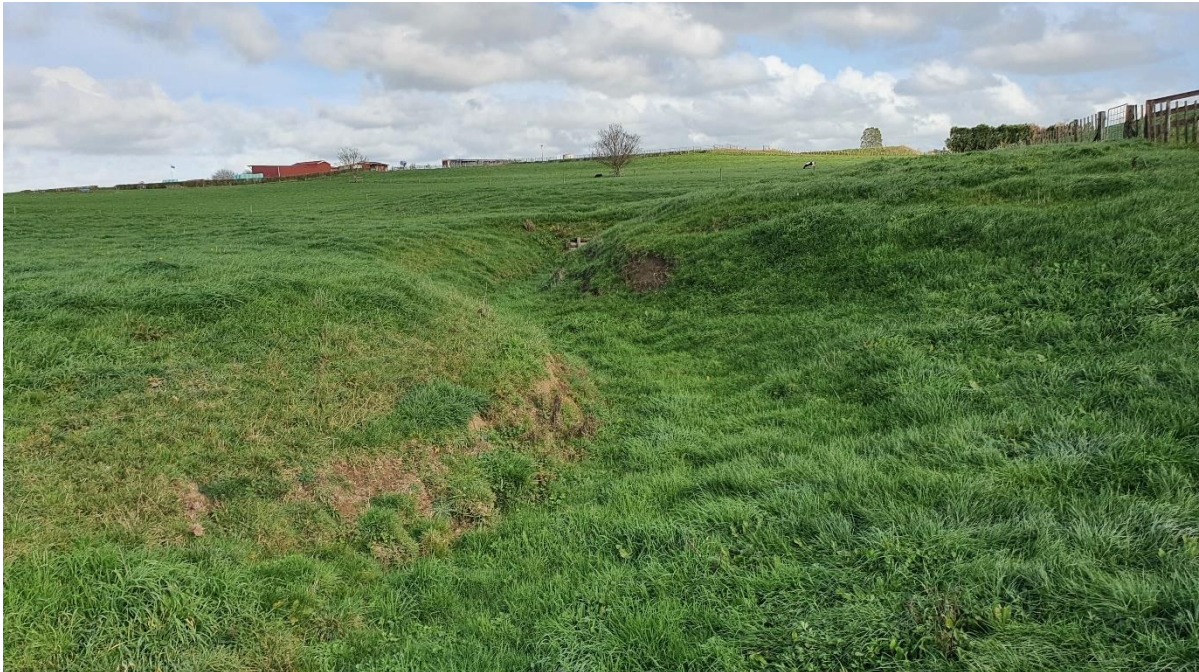
Figure 7: View of the lower section of Watercourse S3.

At the time of the survey there was no water in the channel, which appeared to have been dry for some time due to the vegetation growth and low soil moisture (Figure 7). The banks of the channel are eroded and support mainly pasture grass and weed species.

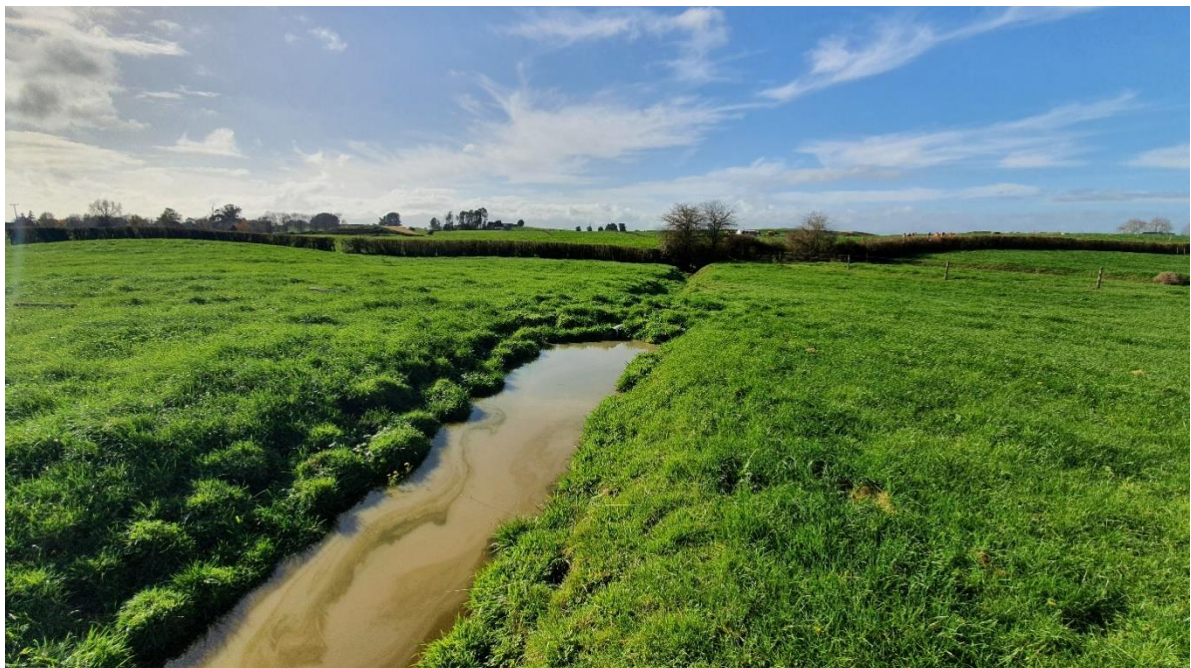
Figure 11: View of Watercourse S3a.

The drain was the only watercourse on the site with water in the channel, which was pooling (Figure 11) between the perched downstream culvert and the pipe entering the drain upstream. Riparian vegetation along the drain was entirely in pasture and was open to grazing stock, resulting in trampling and pugging.

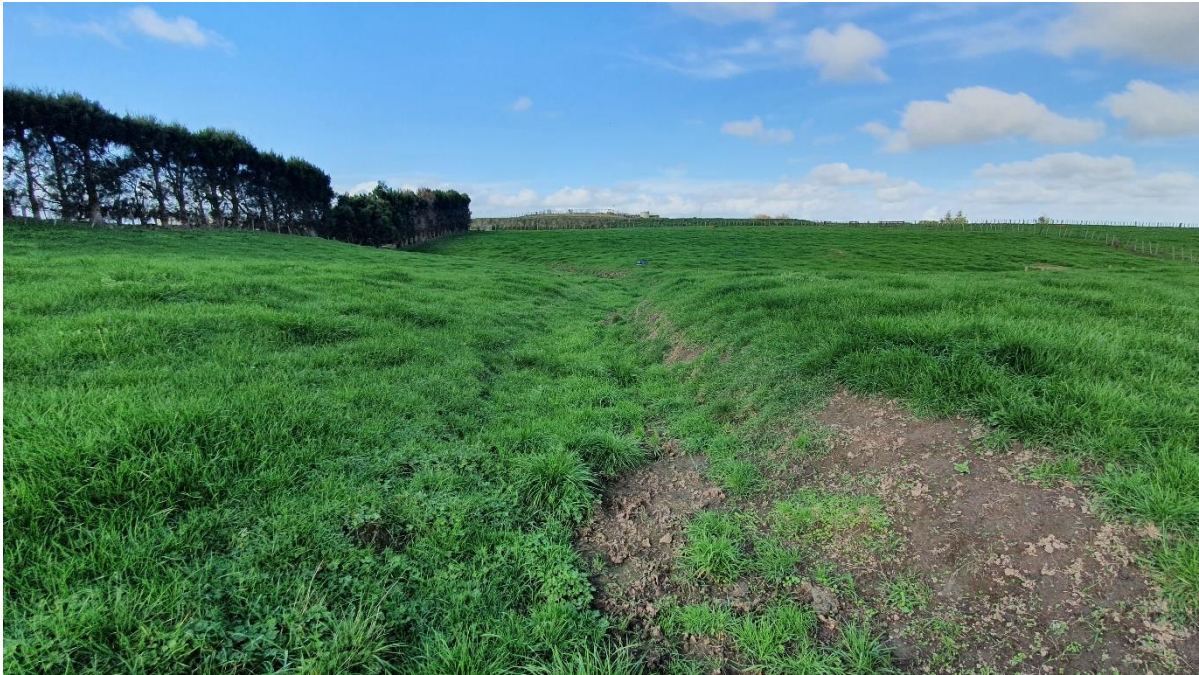
Figure 12: View of Watercourse S3b.

There was no surface water in Watercourse S3b at the time of the survey. The flow path is 43 m in length and has a mean width of 1.5 m, and connects to Watercourses S3c and S3d and appeared to be actively grazed. Riparian vegetation along the drain was entirely in pasture and was open to grazing stock, resulting in trampling and pugging.

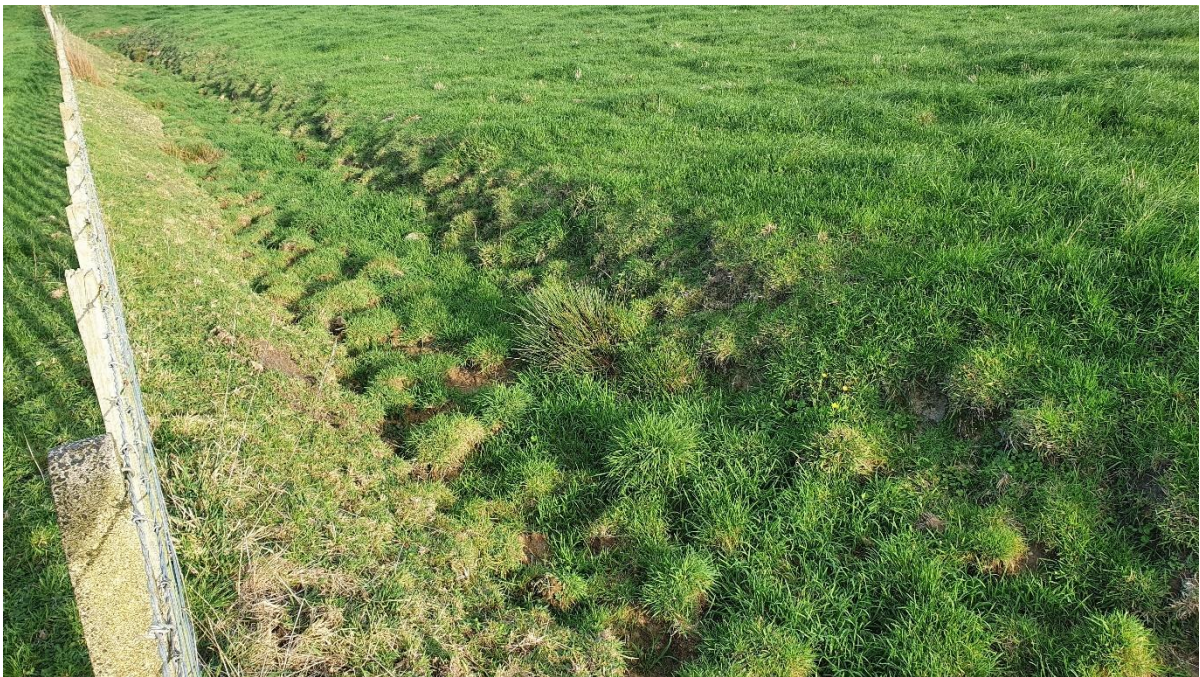
Figure 14: View of Watercourse S3d.

Watercourse S3d is an artificial watercourse that originates towards the western boundary of the site (Figure 14), and is 77 m in length and has a mean channel width of 2.2 m. At the time of the survey there was no surface water in the channel. The channel is vegetated with pasture and has been actively grazed as there is evidence of trampling throughout the length of the drain. Riparian vegetation along the drain was entirely in pasture and was open to grazing stock, resulting in trampling and pugging. Culvert number 1 is located at the head of the drain, and is unperched. Drain metal has been backfilled into the length of the drain.

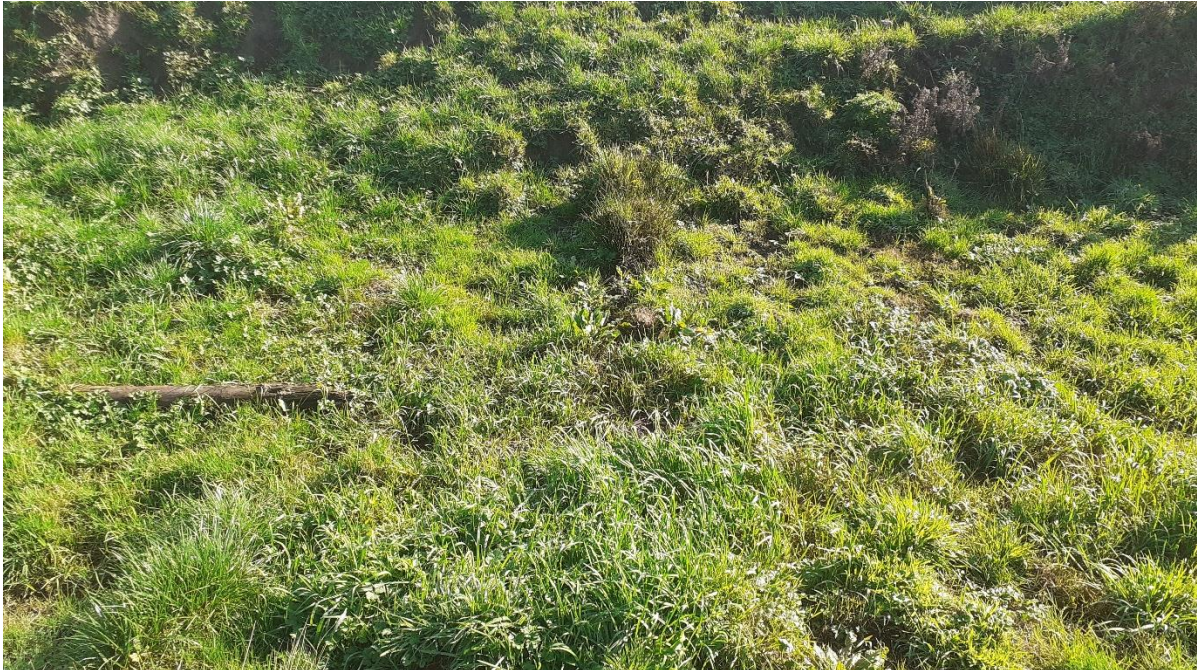
Figure 15: View of vegetation in NPS-FM wetland on Watercourse S3.

leaved buttercup), *Persicaria hydropiper* (Water pepper), *Rumex conglomeratus* (dock) and *Juncus* sp. (rush) (Figure 15). The wetland has been induced by the culverts upstream and downstream of the area, is highly degraded and affected by regular grazing.
