# Appendix I - Geotechnical Investigation Reports prepared by CMW Geosciences

**Lockerbie Farm Development  
Studholme Street, Morrinsville**

**GEOTECHNICAL INVESTIGATION REPORT**

Lockerbie Estates Limited  
HAM2018-0139AB Rev 0

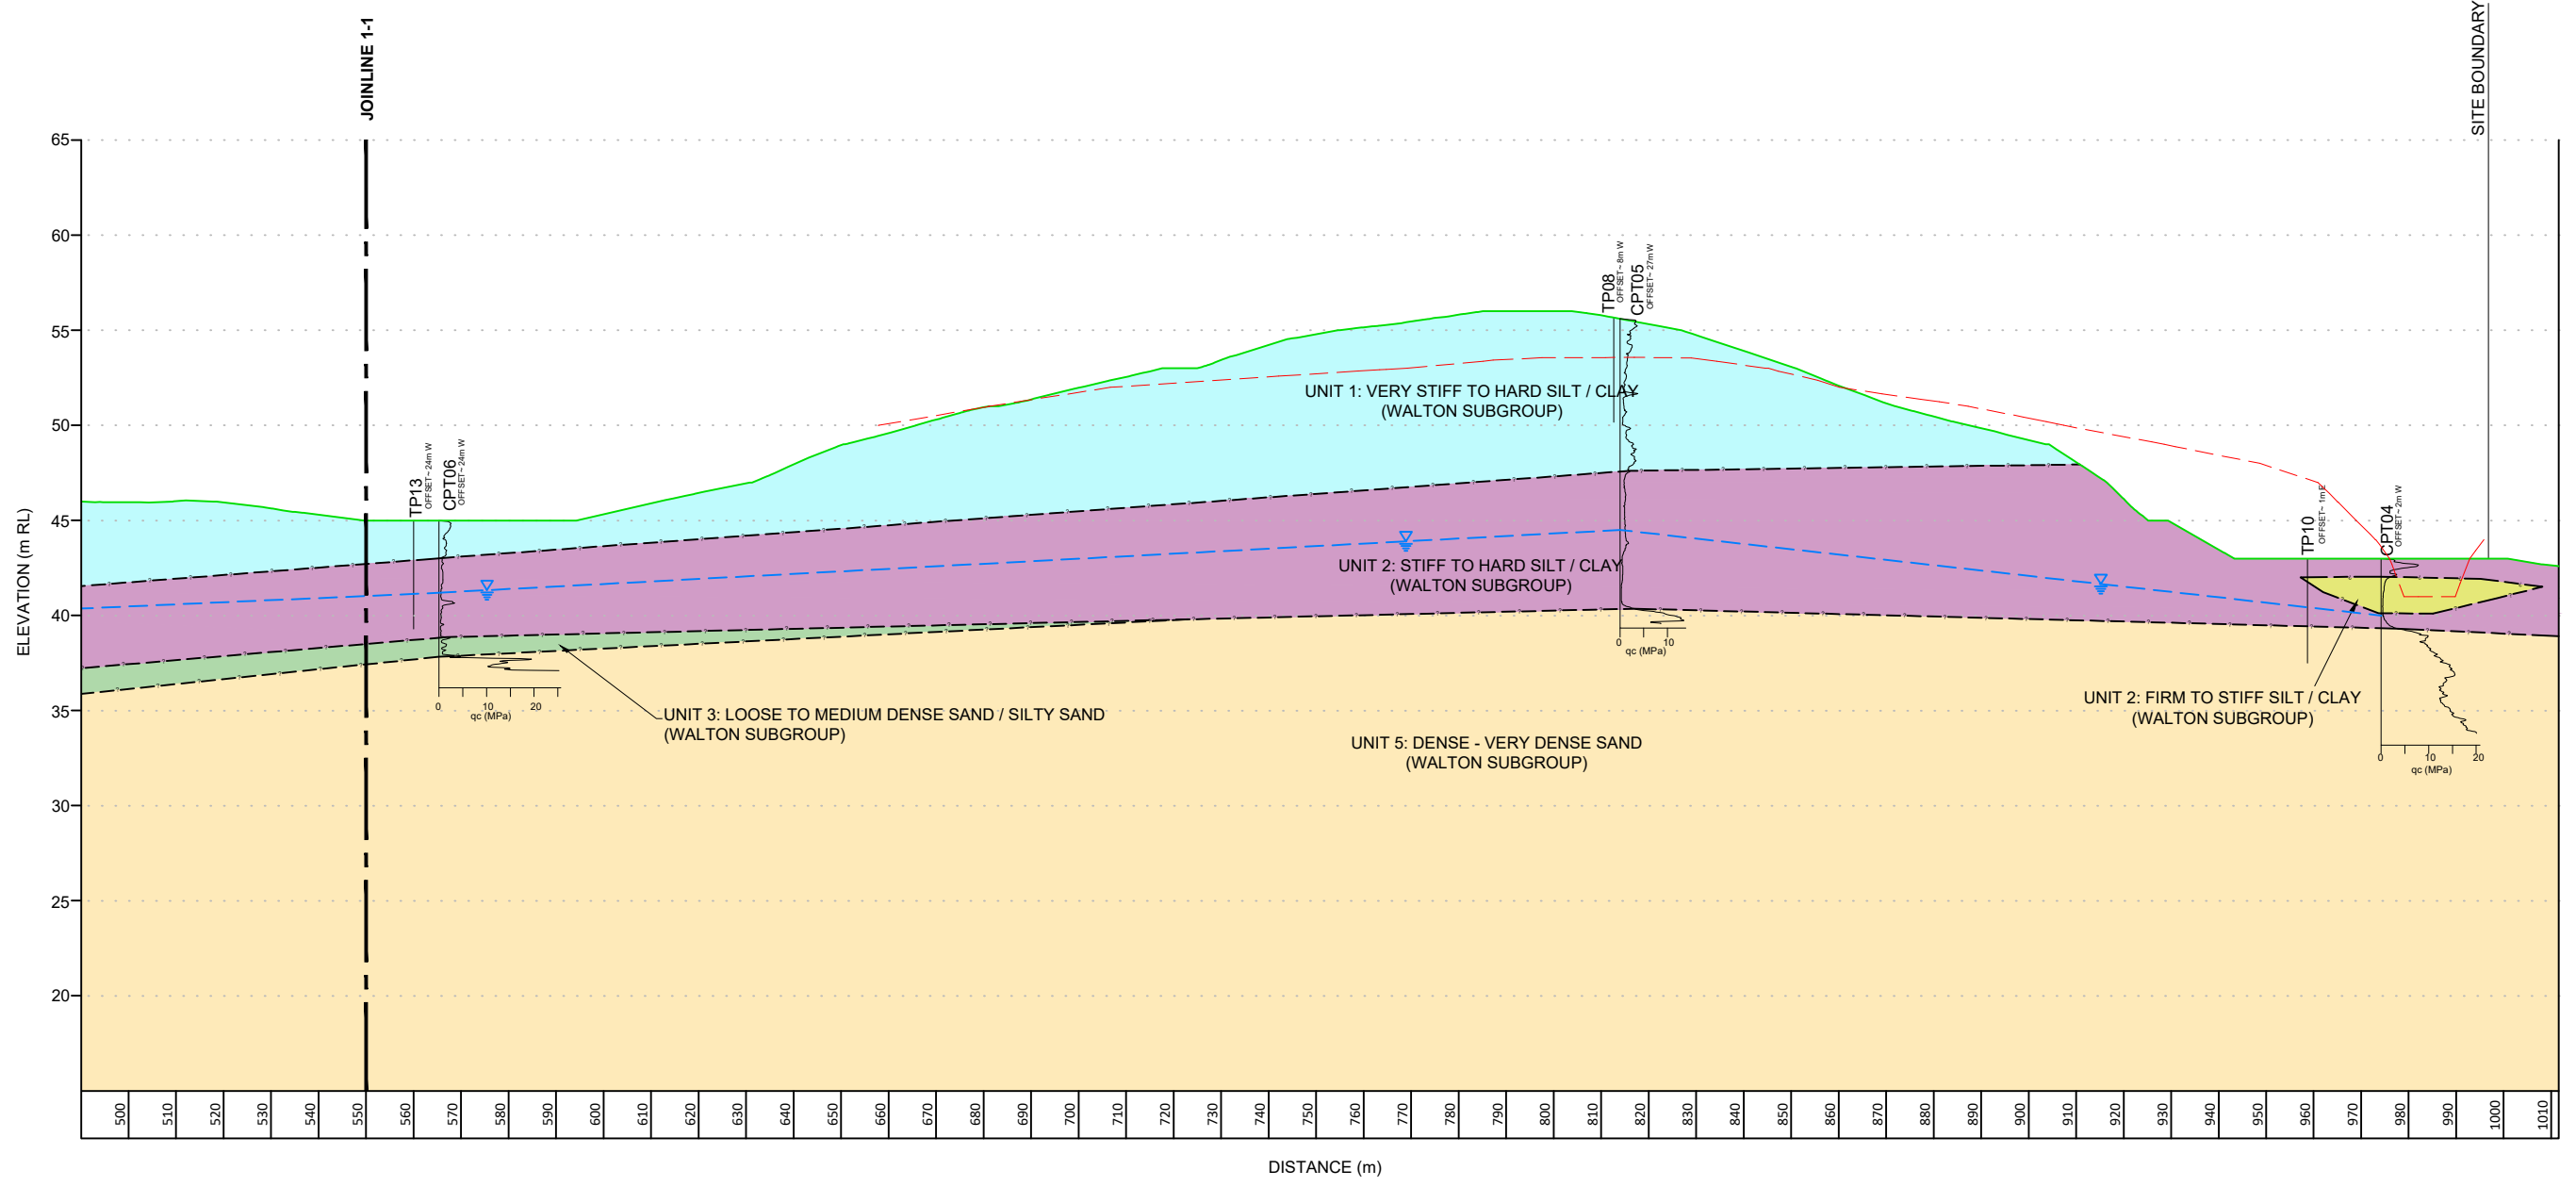
**SECTION A**  
 V: 1:375  
 H: 1:1500

CLIENT:	<b>LOCKERBIE ESTATES LTD</b>	DRAWN:	WPJ	PROJECT No:	HAM2018-0139
PROJECT:	<b>LOCKERBIE FARM DEVELOPMENT STUDHOLME STREET, MORRINSVILLE</b>	CHECKED:	EJE	DRAWING:	03B
TITLE:	<b>GEOLOGICAL SECTION A-A</b>	REVISION:	C	SCALE:	AS SHOWN
		DATE:	17/04/2019	SHEET:	A3

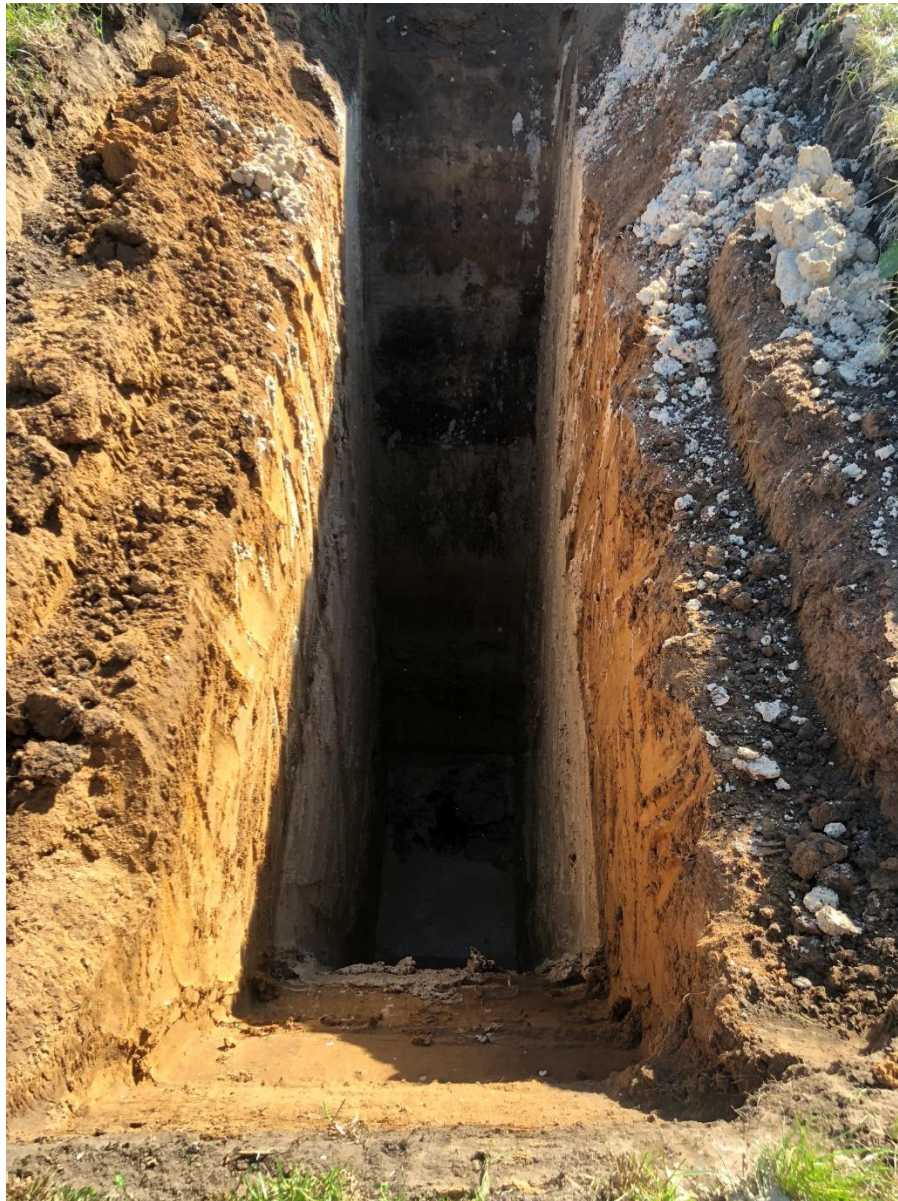
TP01 – TEST PIT EXCAVATION

Position: E.467070.3m N.714627.1m  
Elevation: RL 44.0m

Dimensions: 1.0mx3.0m  
Termination Depth: 5.5m

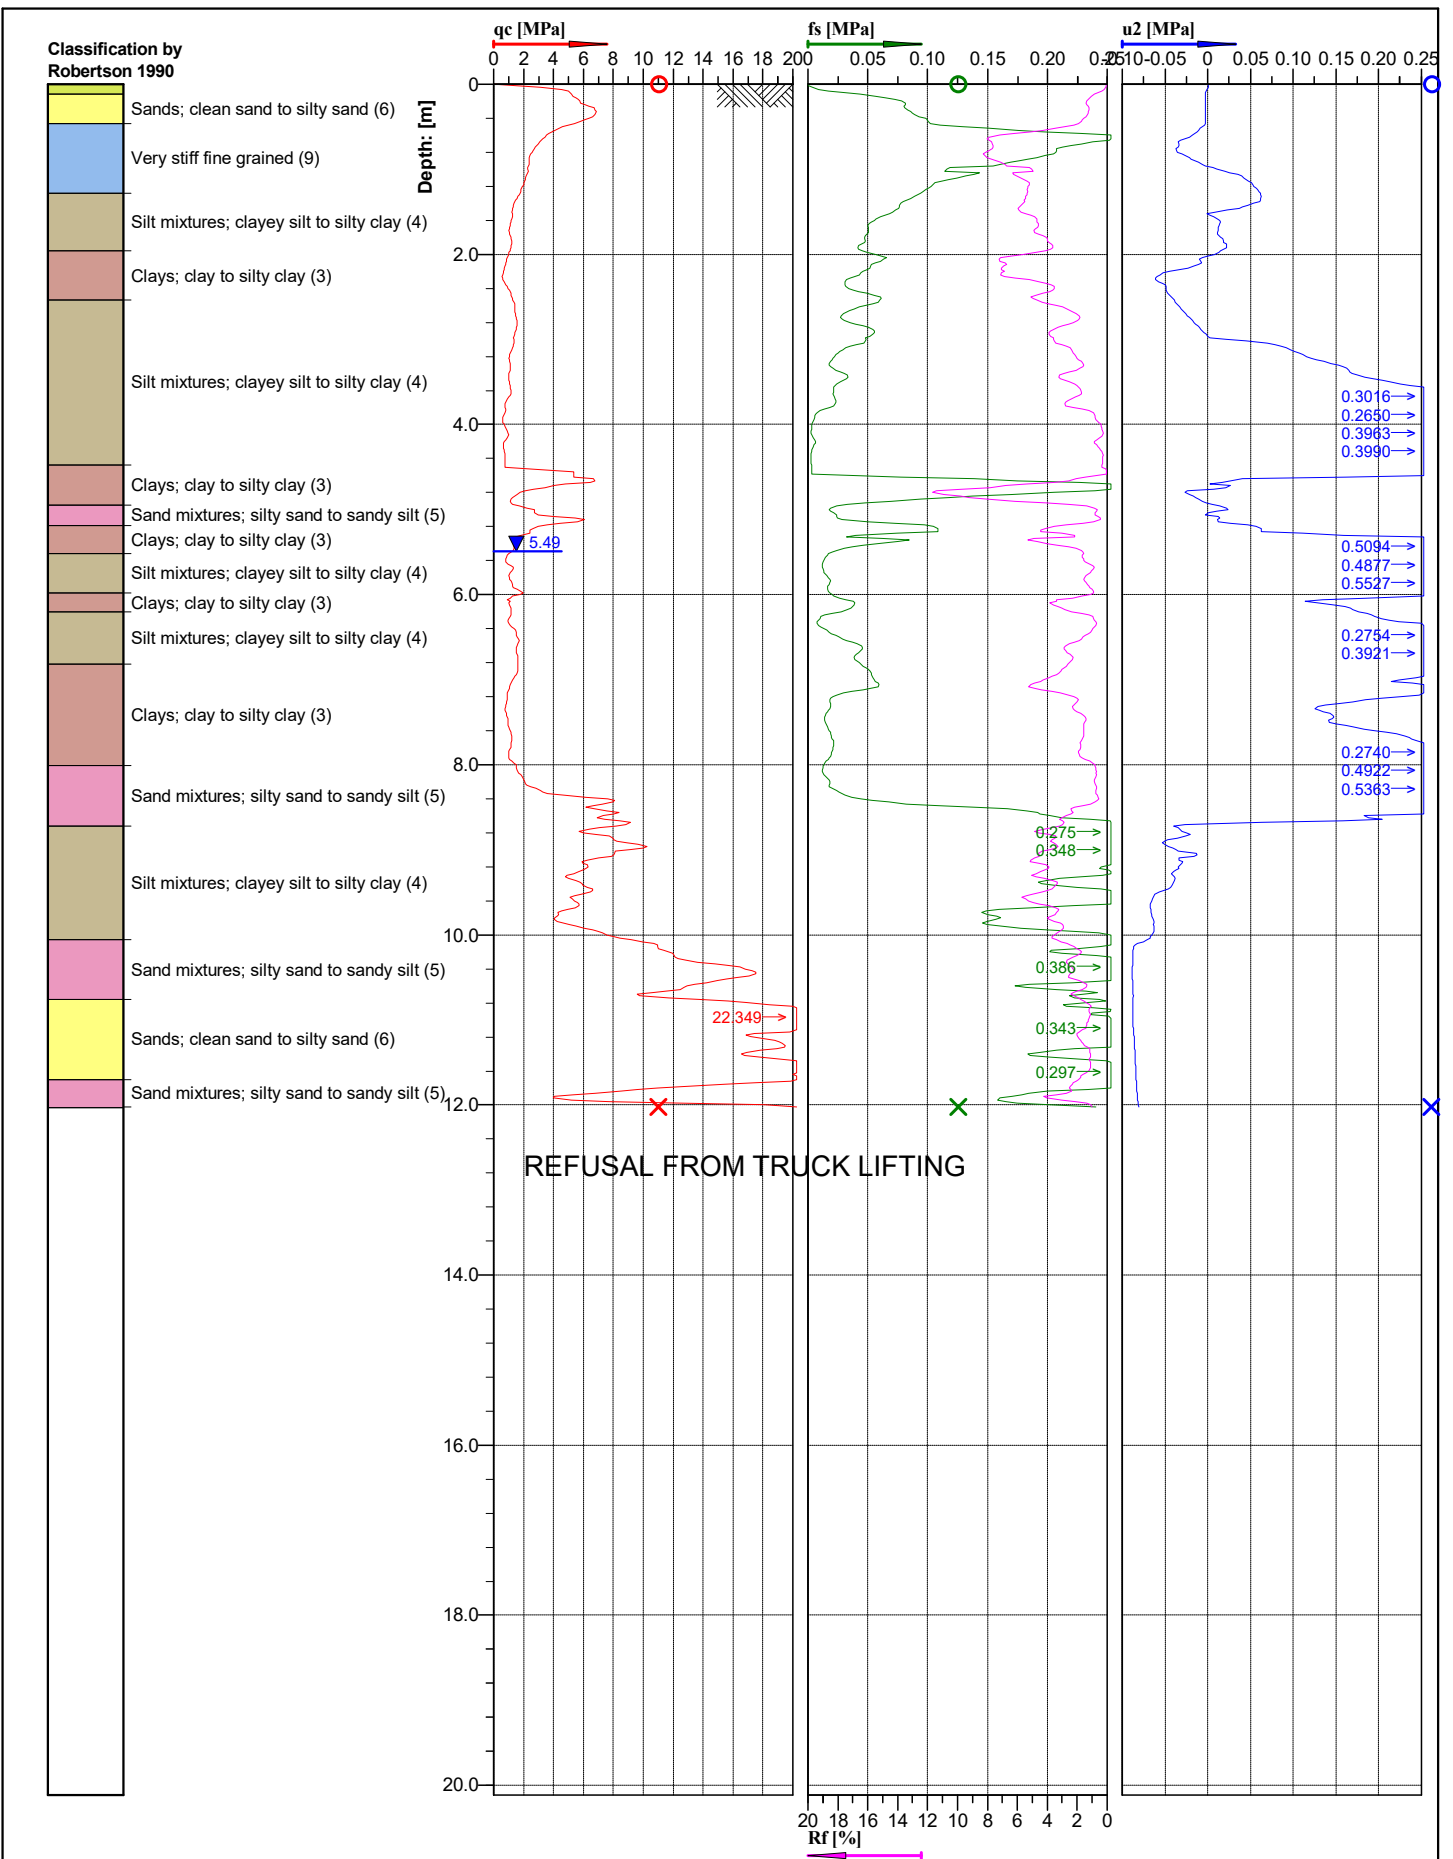
Location: MORRINSVILLE	Position: X: 0.00 m, Y: 0.00 m	Ground level: 0.00	Test No.: CPT03
Project ID: HAM104562	Client: CMW GEOSCIENCES	Date: 22/01/2019	Scale: 1 : 89
Project: 162 STUDHOLME ST		Page: 1/1	Fig.:
S 37.64417 E 175.52171		File: CPT03.cpt

Cone No: 4696  
 Tip area [cm<sup>2</sup>]: 10  
 Sleeve area [cm<sup>2</sup>]: 150

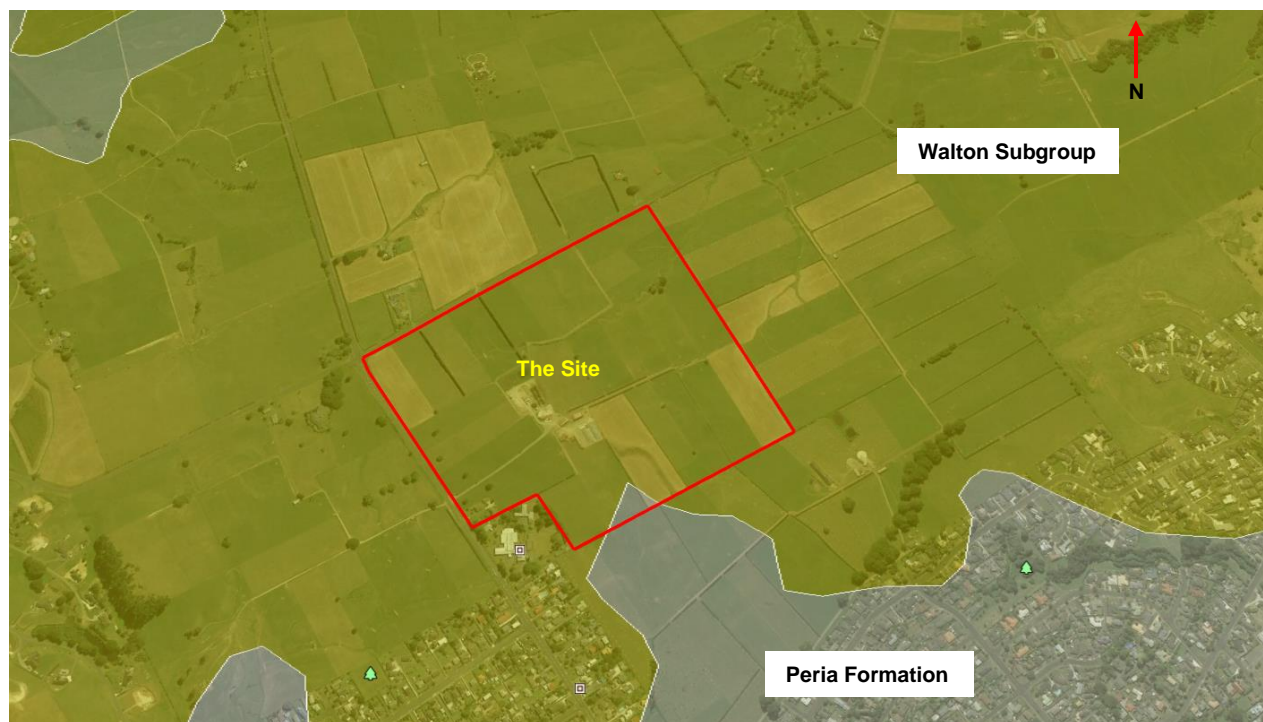
Figure 2: Local Geology (Source: GNS 1:250K geological units map)

*“Alluvium dominated by primary and reworked, non-welded ignimbrite”* of the Early to Middle Pleistocene aged Walton Subgroup. The published distribution of these is illustrated in **Figure 2** below. Weathered volcanic ash deposits are also known to mantle the older Walton Subgroup soils.
