Proposed Quarry Hill Road Te Aroha – Transportation Assessment.

Harrison Transportation has prepared a Transportation Assessment Report for a proposed quarry at 153 Hill Road Te Aroha. That report is dated September 2017. Council has, in their letter of 31 October 2017, requested further information. This report provides the requested information on traffic matters.

CARO LTD
Hill Road, Te Aroha
Proposed Passing Bays

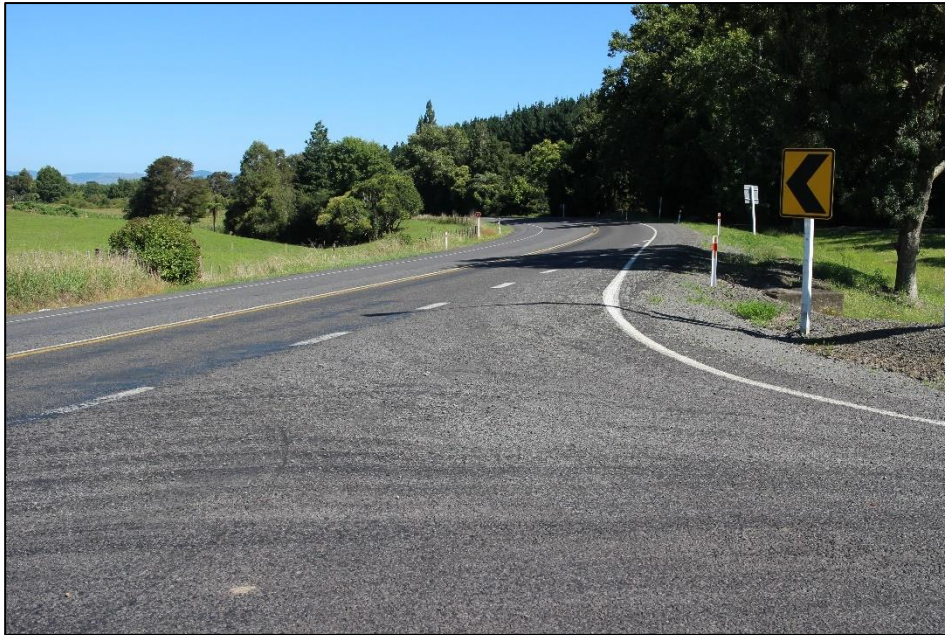
Photograph 1: Sight Line to the North.

Table 1 shows the available sight distances at the intersection do not comply. The sight distance to the north is however within practical measuring tolerances while the sight distance to the south could be increased to approximately 230m with the removal of a tree located on the inside of the curve. The available sight lines at the intersection are shown on the following photographs.

The photographs show that the sight lines are limited by the trees located on the inside of the curve.

An assessment using the Austroads EDD criteria, with an observation time of 1.5s and a reaction time of 2.0s, identifies that a minimum sight distance of 183m is required. The available sight distances of 247m to the north and 201m to the south comply with this requirement. It is therefore assessed that the available sight distances are sufficient to ensure the safe operation of the intersection.

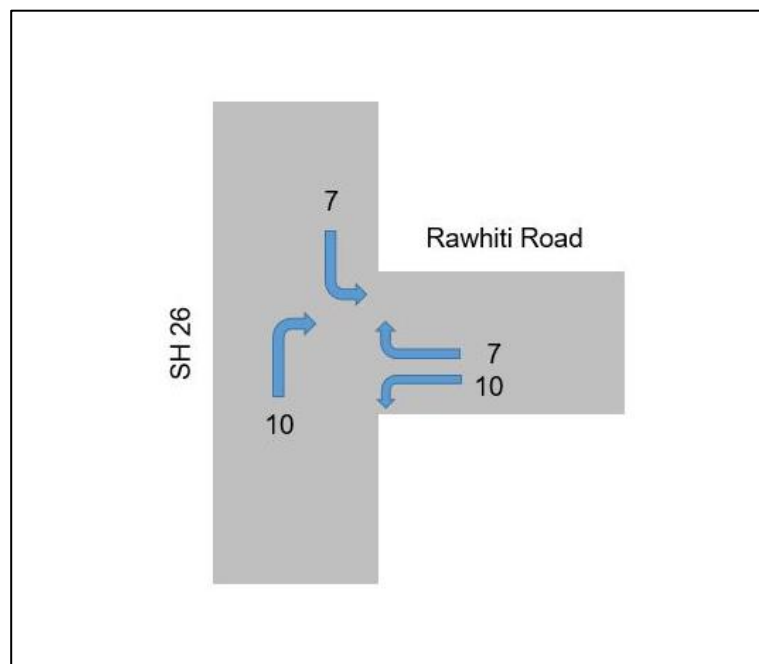
Figure 1: Expected Peak Hour Turning Movements (veh/h).

The expected turning movements are given in the following figure.

Figure 1 shows that the predominant turning movements are expected to be the right turn in and the left turn out of Rawhiti Road.

The expected peak hour operational performance of the intersection has been assessed on the basis of the turning movement volumes given in Section 1.2 of this report. The expected operational performance is summarised in the following table.

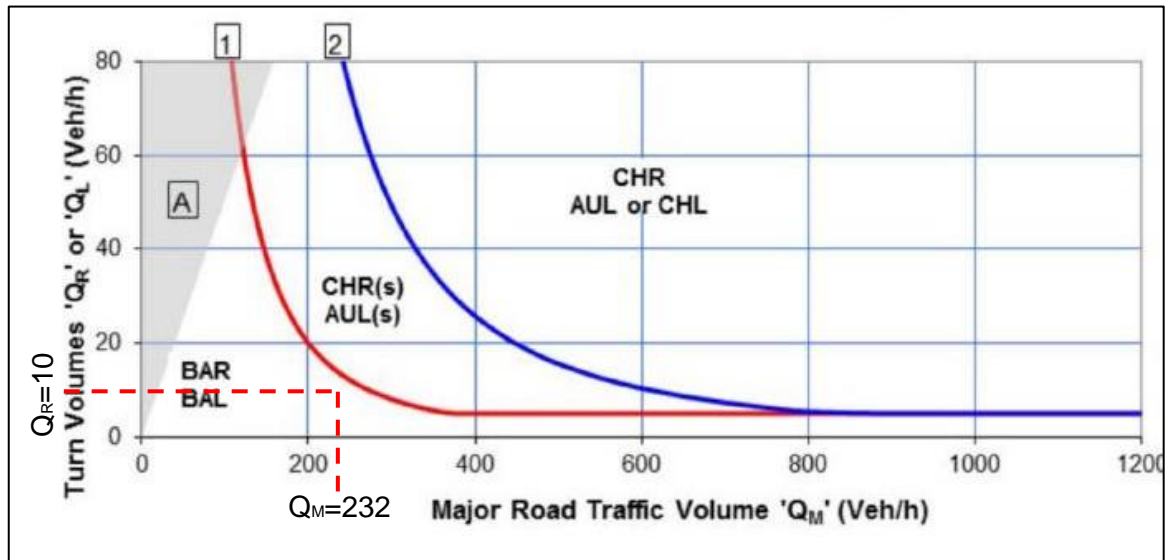
Figure 2: Warrant for Right Turn Bay.

The intersection does not presently have a right turn bay provided. Recommendations for the provision of right turn bays at intersections are given in the Austroads *“Guide to Road Design Part 6: Intersections, Interchanges and Crossings”*. The assessment of the requirements for a right turn bay during the peak period is shown on the following figure.

Figure 2 shows that the provision of a right turn bay is not warranted.

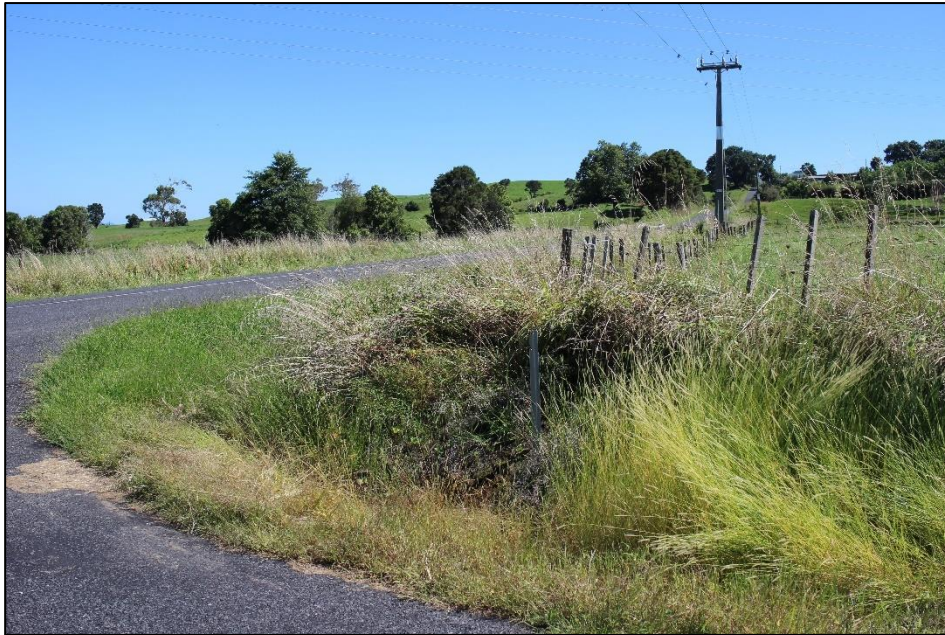
Photograph 3: Sight Line to the North.

On the basis of an 85th percentile operating speed on Rawhiti Road of 100km/h, then a Stop sign is required when the visibility at a point 9.0m from the limit line is less than 120m. The available sight lines taken at a height of 1.25m are shown on the following photographs.

Photograph 3 shows that, on the day of the site visit, the visibility to the north was partially restricted by tall grass growing on the berm. While the tall grass restricts the visibility for car drivers, it is noted that the majority of vehicles associated with the quarry are expected to be trucks and that the typical eye height for a truck driver, at 2.4m, is higher than that of a car driver. While sight distance measurements were not able to be taken at the eye height of a truck driver, it is expected that the driver will be able to see over the top of the tall grass and will therefore have visibility in excess of the required 120m. It is therefore assessed that Stop Control is not required.

While tall grass at the intersection of Hill Road and Rawhiti Road restricts the visibility for car drivers, the majority of vehicles associated with the quarry are expected to be trucks. It is expected that the additional height of the truck will provide additional visibility for truck drivers. It is therefore assessed that Stop Control is not required.

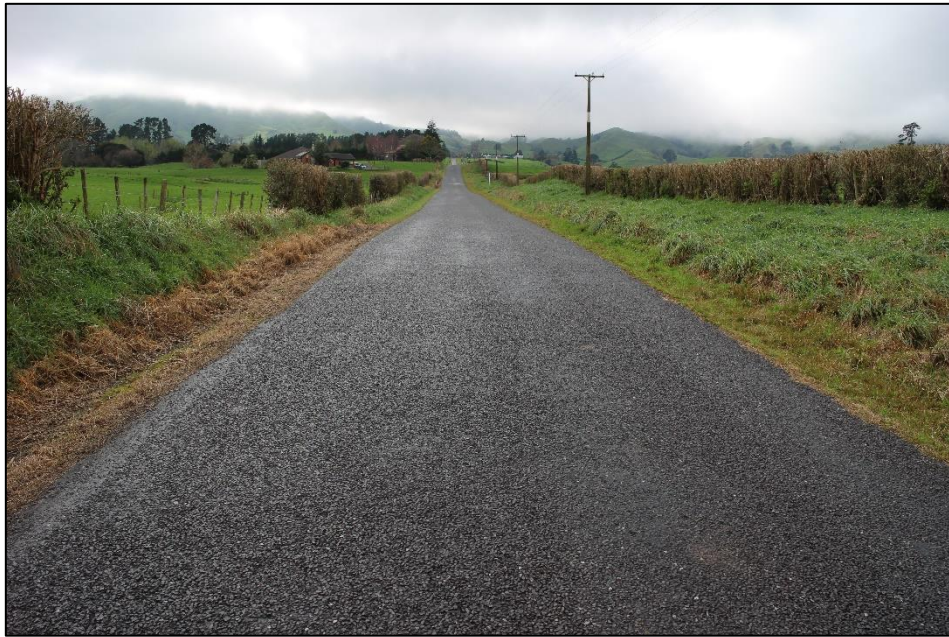
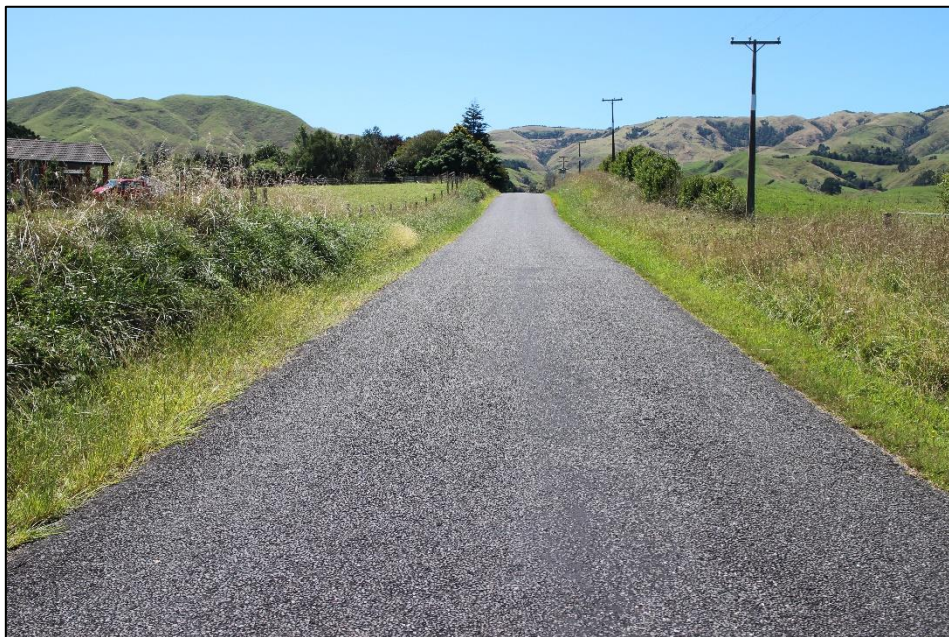
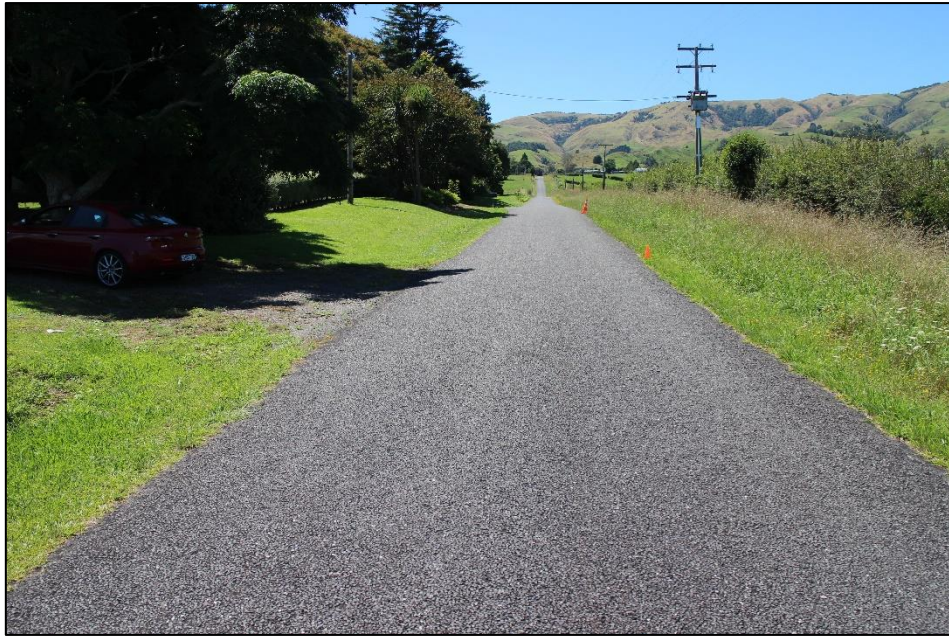
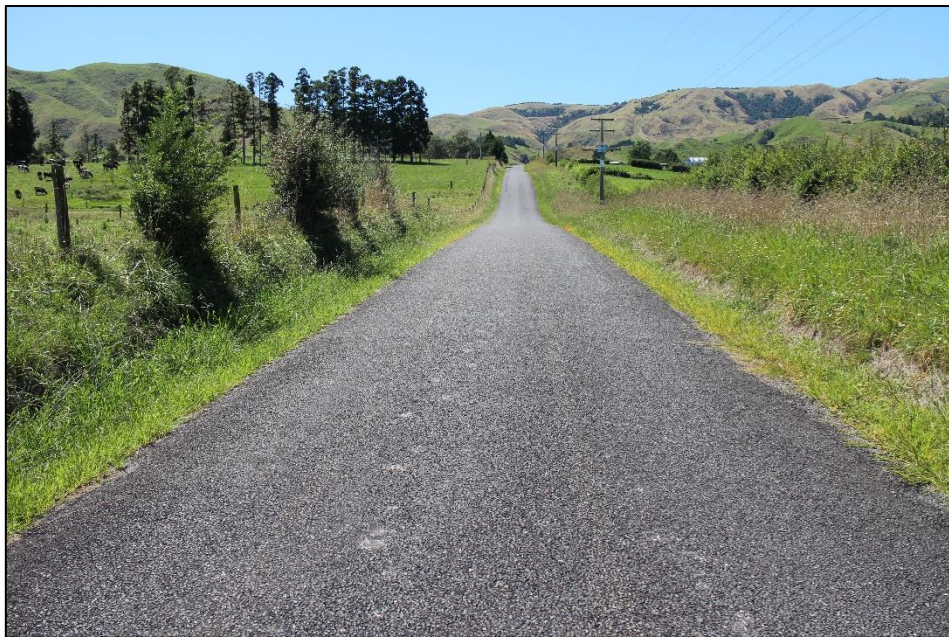
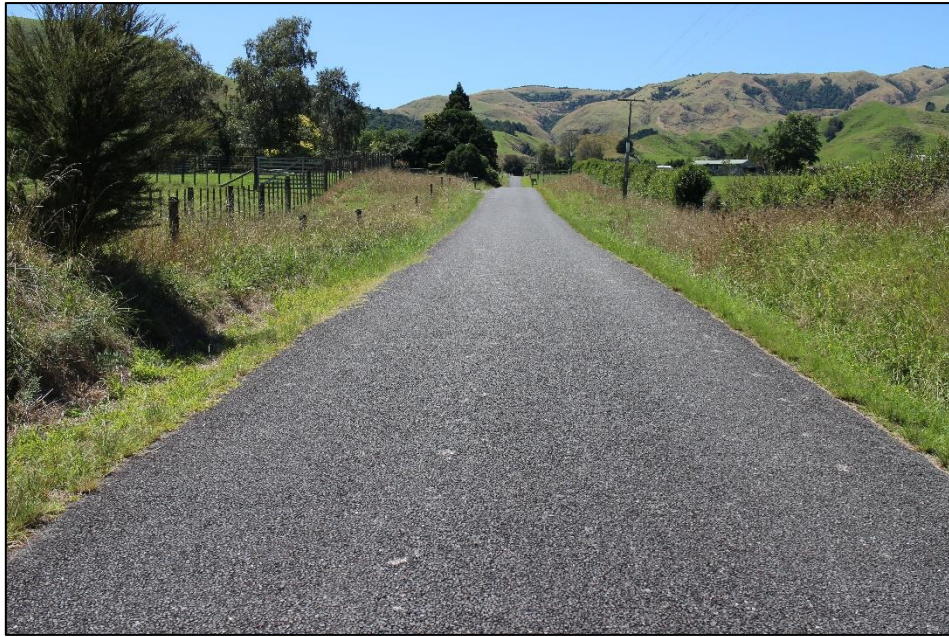
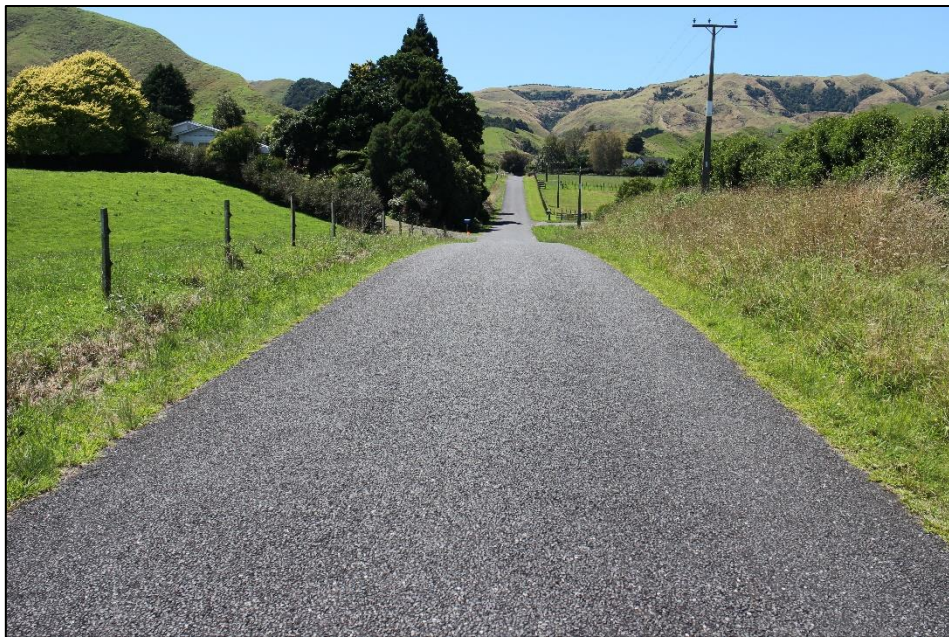
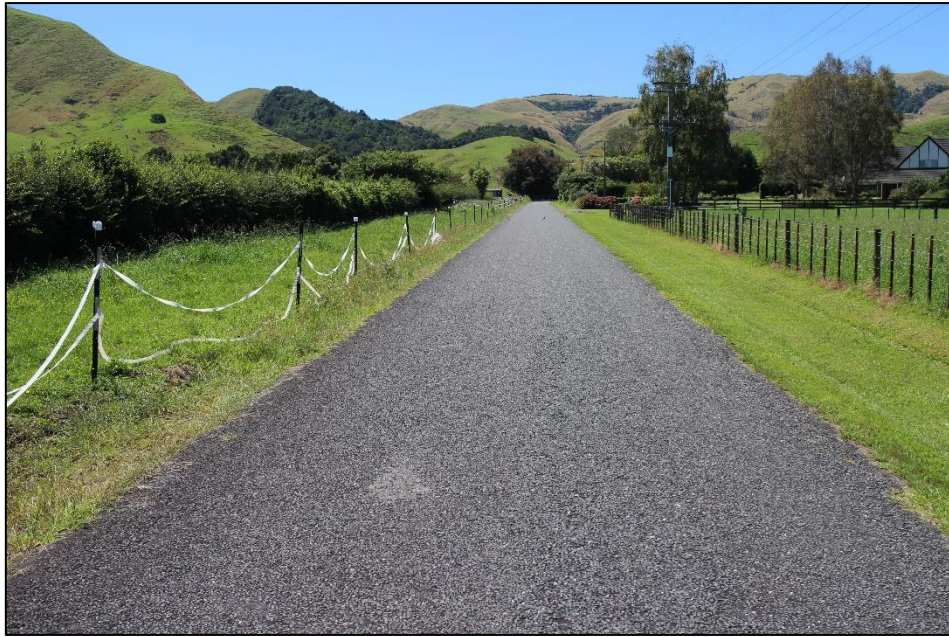
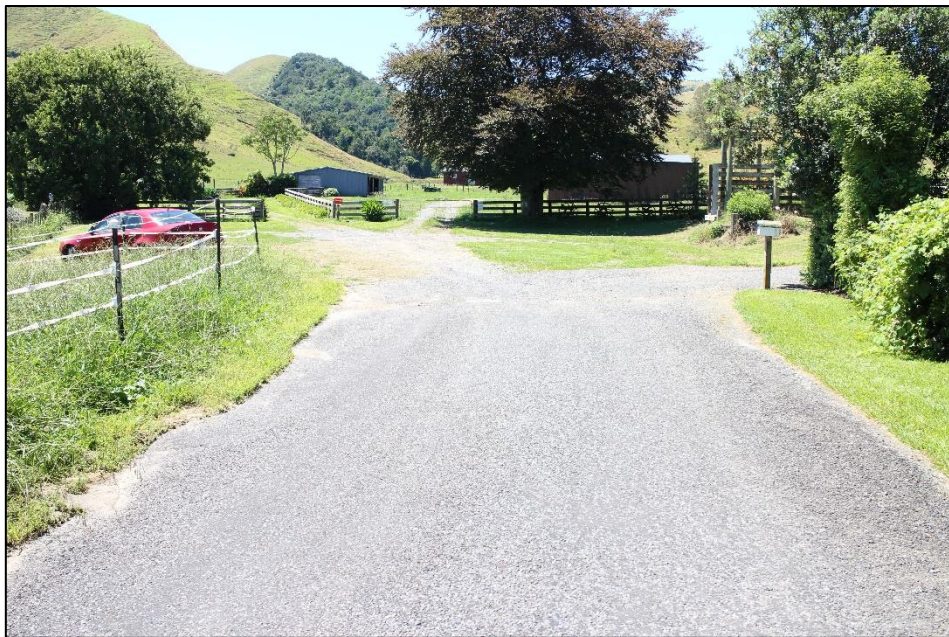
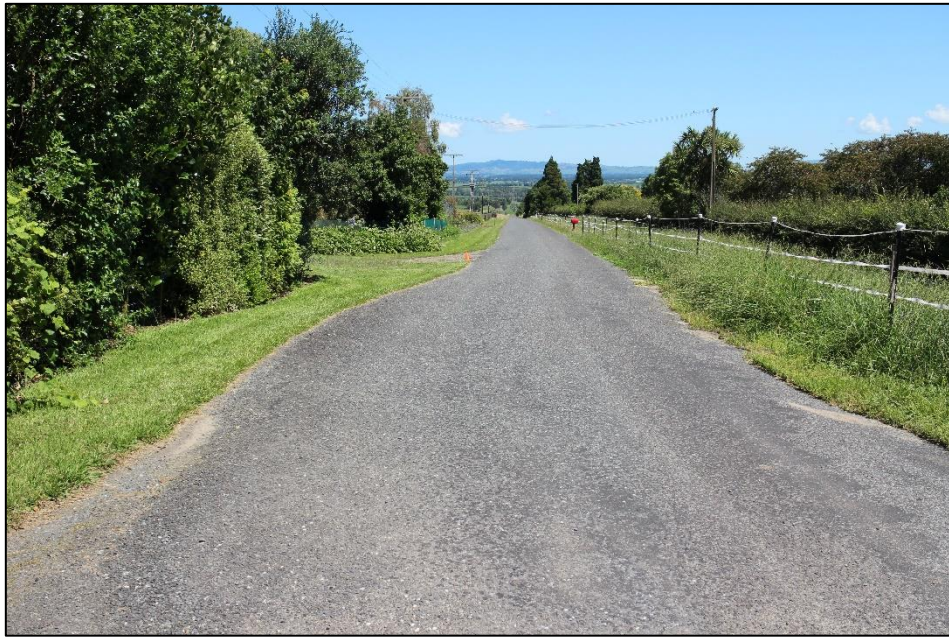
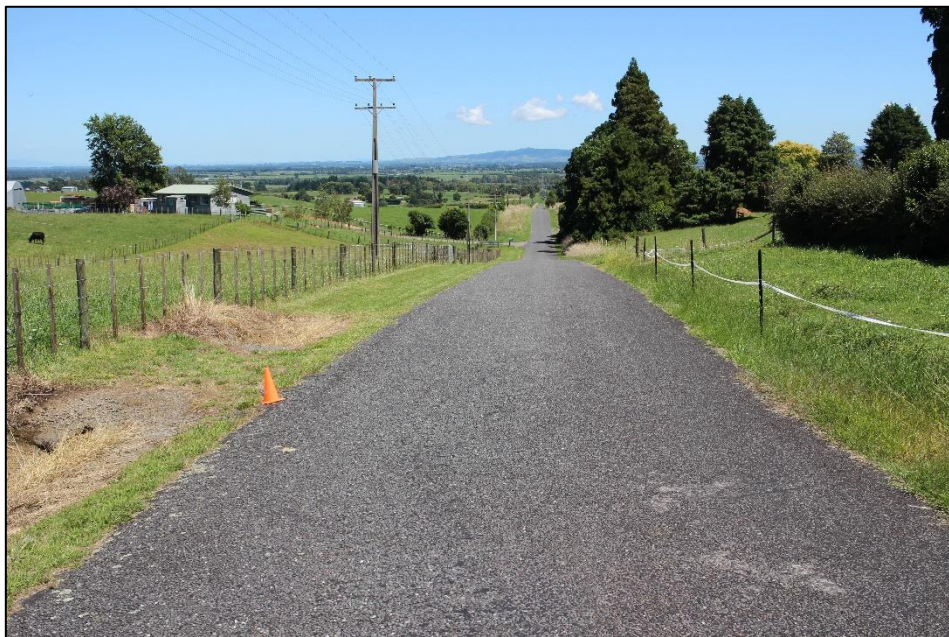
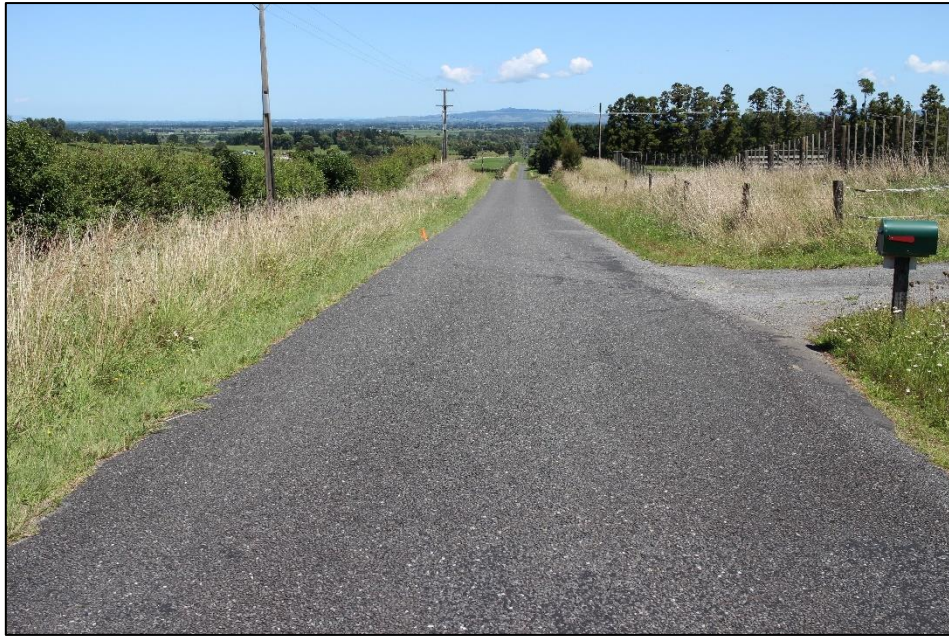
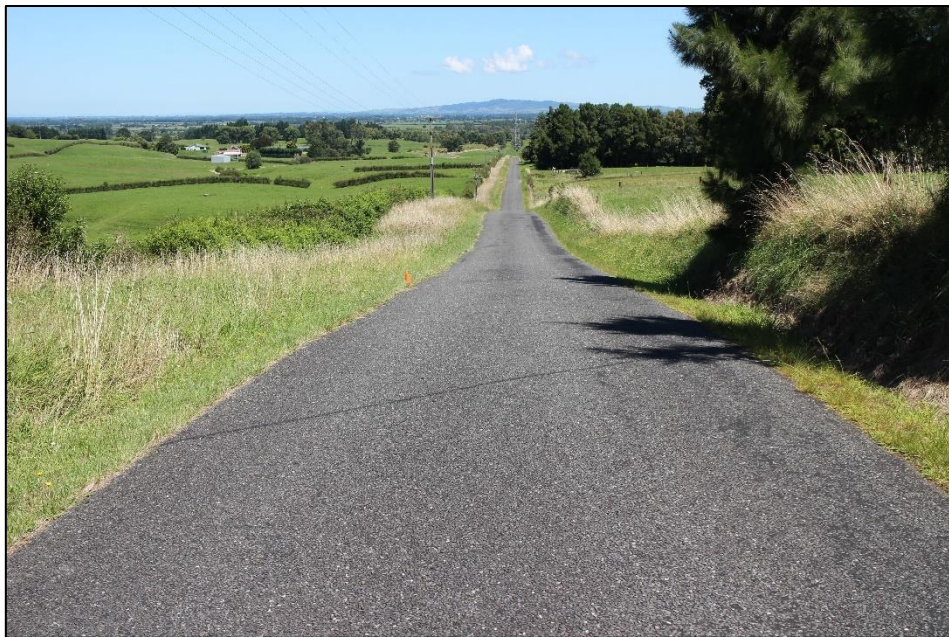
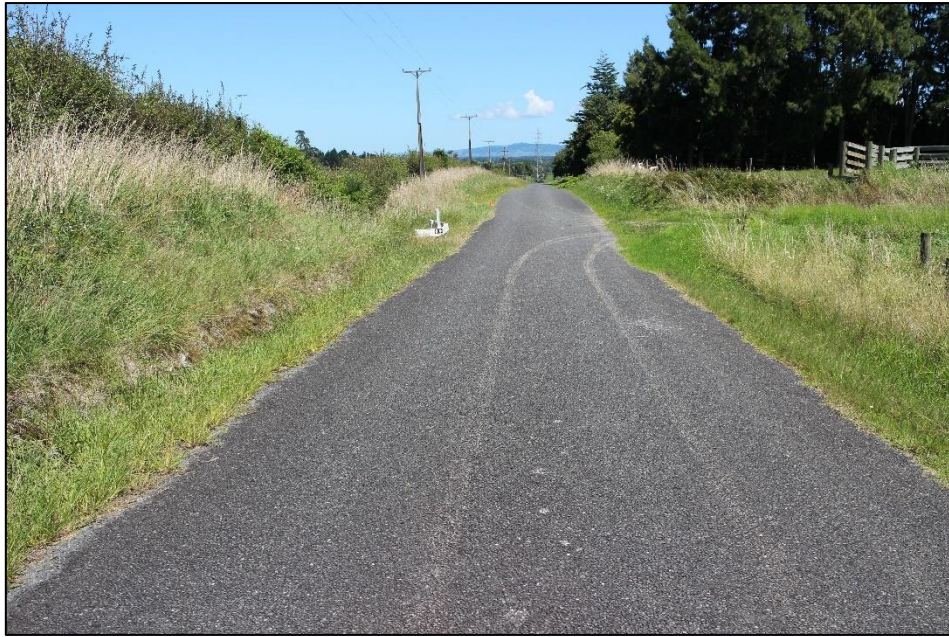
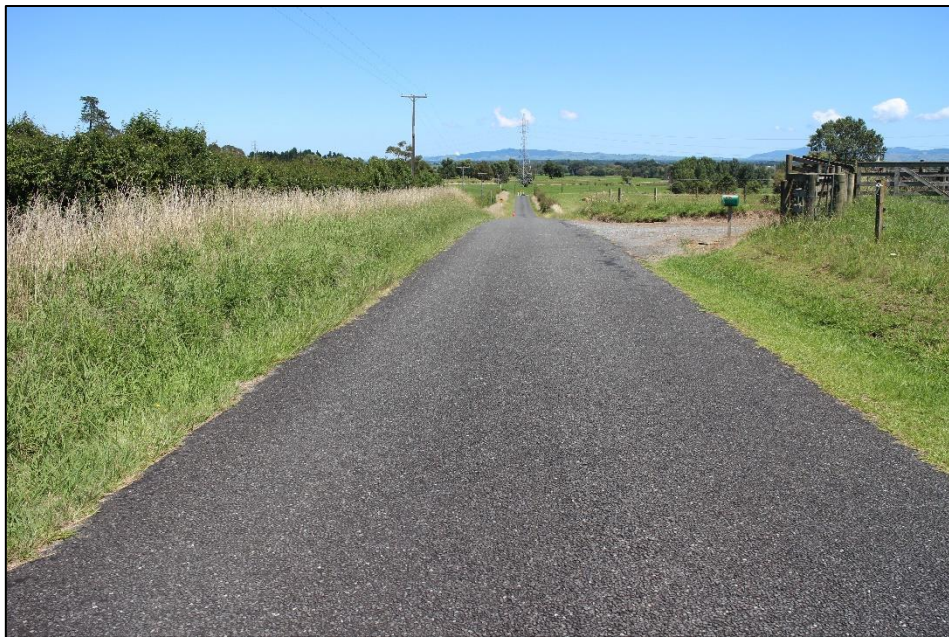
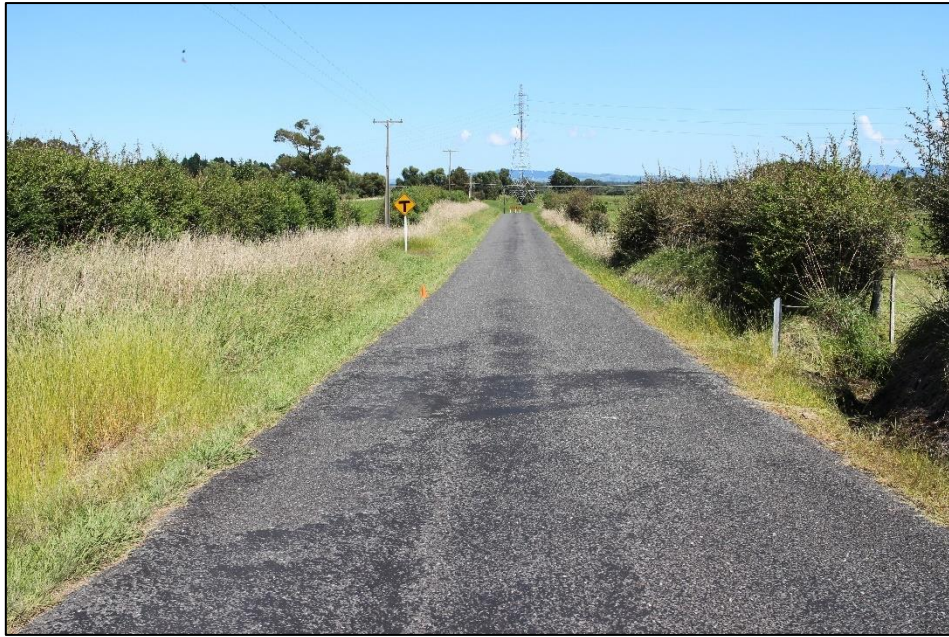
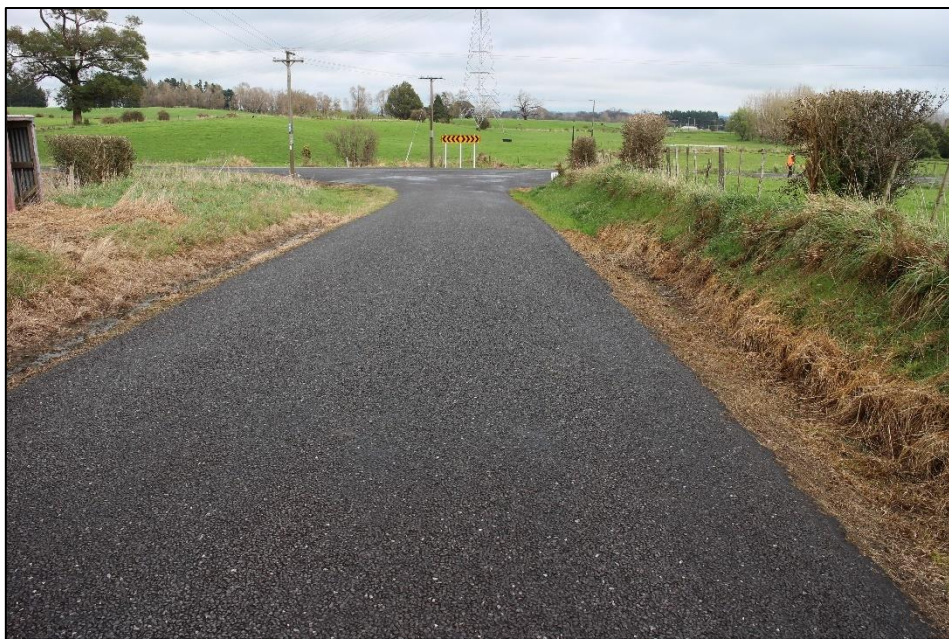
Eastbound Photographs

Photographs looking both eastbound and westbound from each passing bay are appended to this report.

- RP0.0, right hand side, on the approach to the intersection with Rawhiti Road. This will allow a vehicle to enter Hill Road while a vehicle is waiting to turn out.
- RP225, right hand side, as previously proposed.
- RP380, right hand side. This was previously at RP430 but has been moved to provide better visibility into the dip.

- RP650, right hand side, as previously proposed.
- RP920 and RP1025, right hand side, combined into a single passing bay.
- RP1310, right hand side, an additional passing bay.
- An additional passing bay immediately within the site.

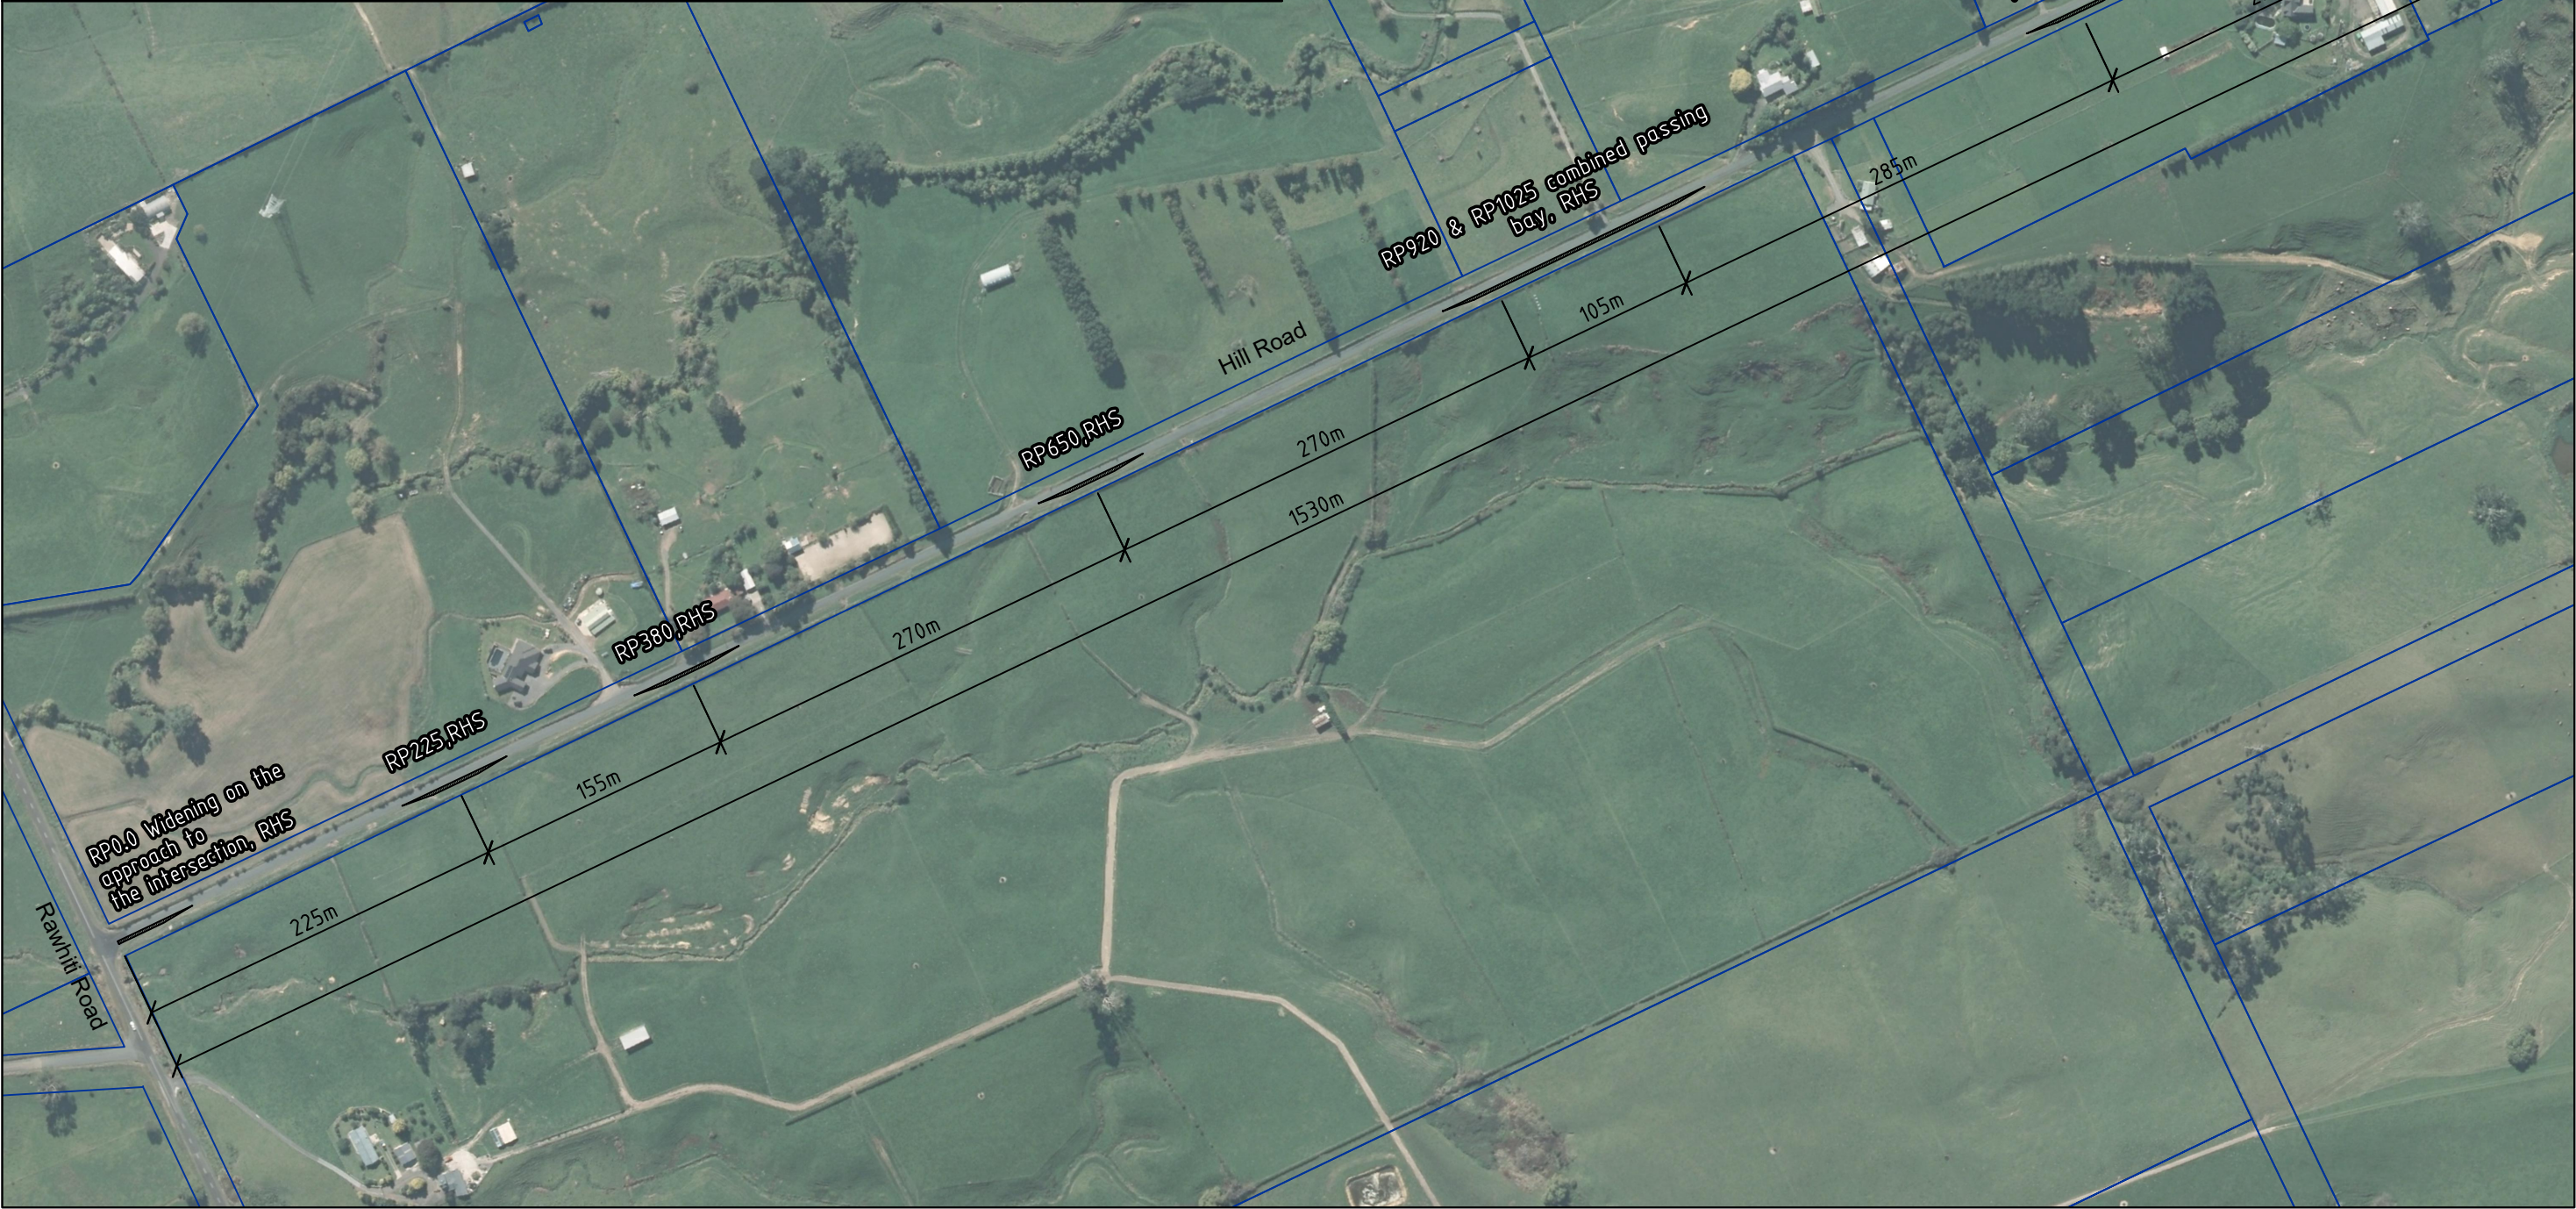
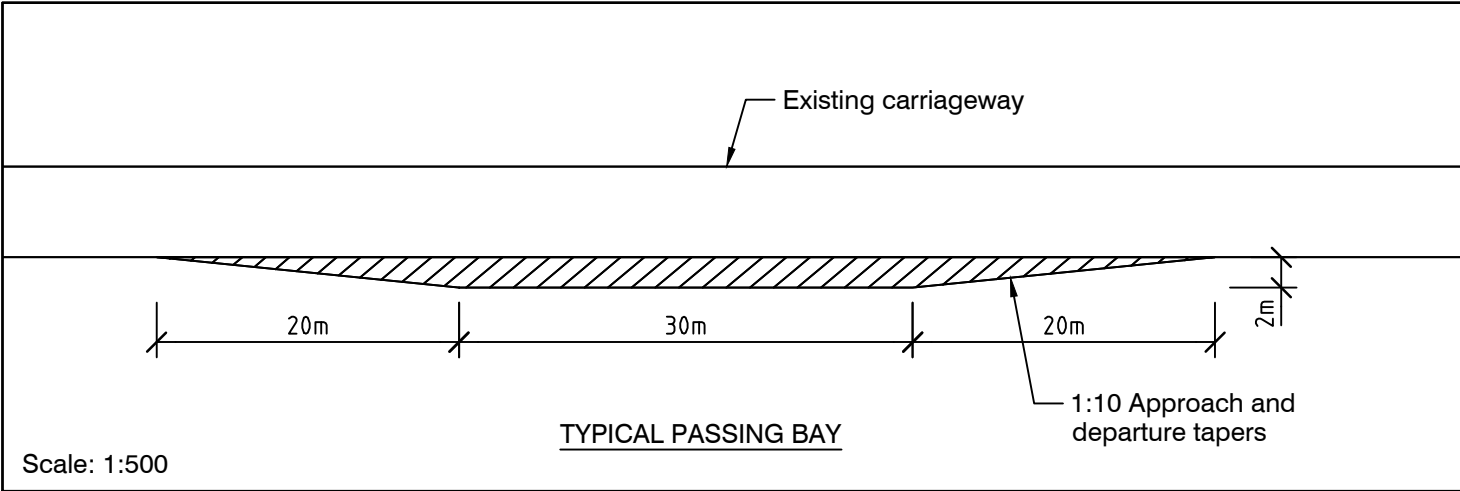
Council has requested that the entry and exit tapers to the passing bays be shown and that the passing bays at RP920 and RP1025 be connected. A review of the proposed passing bays has been carried out, with two additional passing bays now proposed, as well as incorporating Council's comments. The revised passing bays are as follows:

All passing bays are proposed to be provided on the right hand side of the carriageway, for use by westbound trucks. As Hill Road generally rises towards the east, this will provide priority to the uphill movement, which will typically require the laden trucks to give way to the empty trucks.

It is also noted that the proposed passing bays are generally located either on the crest of a vertical curve or on a relatively flat grade. This will minimise any need for trucks to undertake a hill start, with any consequent damage to the pavement.
