Appendix J – Land Contamination Reports prepared by 4Sight Consultants

Preliminary Site Investigation
162 Studholme Street, Morrinsville

For Lockerbie Estate Limited

August 2019

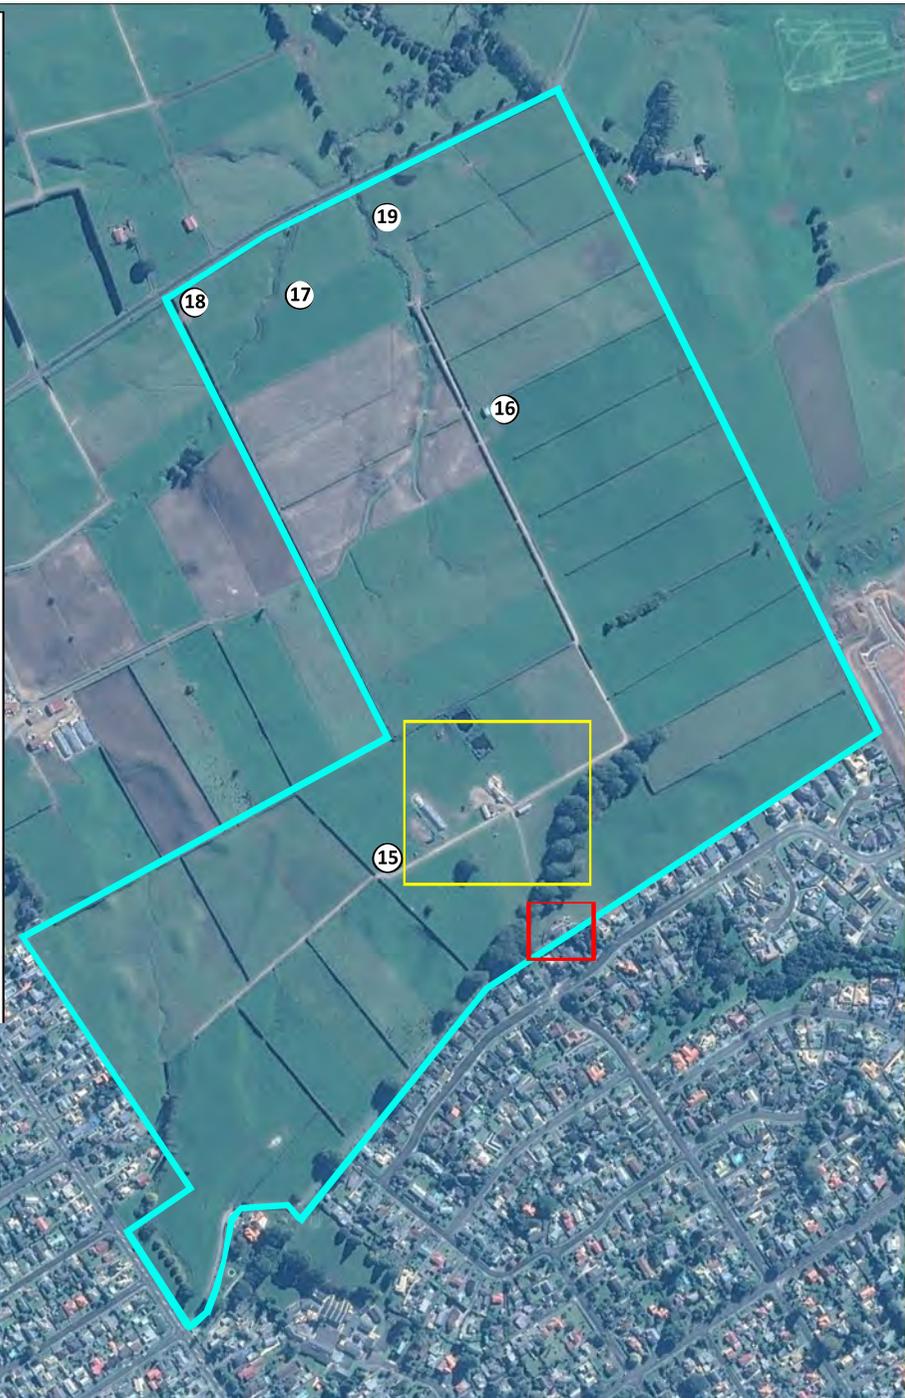
- Approximate Site Boundary
- Indicative Removal Area
- 1 Residential dwelling
- 2 Garage
- 3 Storage for firewood
- 4 Wood chip stockpile
- 5 Metal farm shed
- 6 Extension off farm shed
- 7 Water tank
- 8 Milking shed
- 9 Milking parlour
- 10 Feed pad
- 11 Metal shelter 1
- 12 Gravel stockpile
- 13 Tyre stockpile
- 14 Feed stockpile
- 15 Metal shed
- 16 Metal shelter 2
- 17 Area of potential sheep dip
- 18 Area of former dwelling
- 19 Small clay stockpile

- As part of the proposed development, it is recommended soils from the vicinity of DS01 and LP01 ("piece of land") are excavated and disposed of off-site to a suitably licensed facility. That is, the soils to approximately 1 m out from the dwelling will be require removal (see Figure 1);

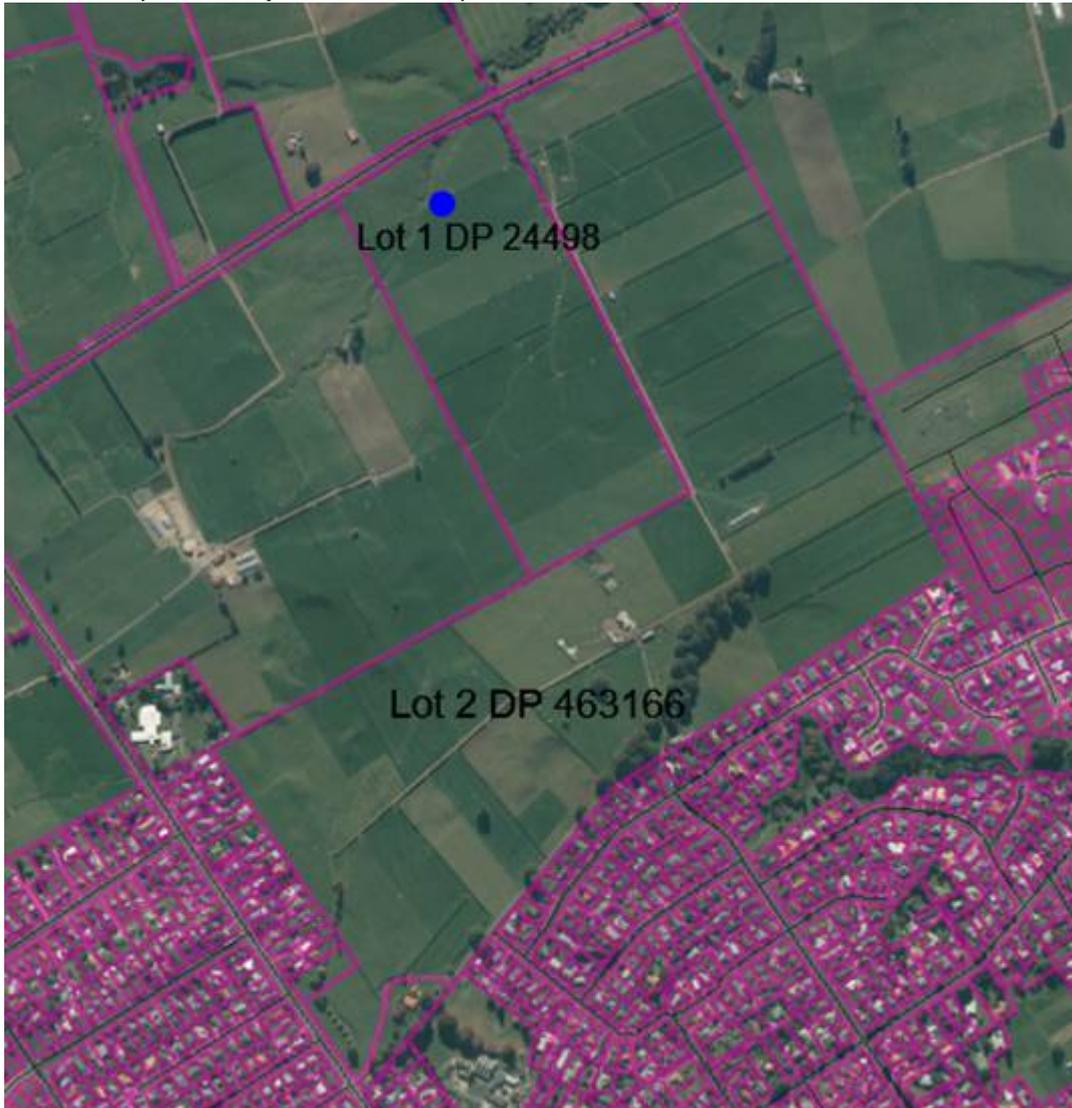
- I can confirm that one of your sites of interest **does** appear on the Land Use Information Register, as indicated by the **blue point** on the map below.

The blue point above (LUI11446) appears on the Land Use Information Register with a classification of 'Unverified HAIL' due to past land use for HAIL activity 'A8. Livestock dip or spray race operations' associated with a Potential Sheep Dip on 0 Taukoro Road, Morrinsville.

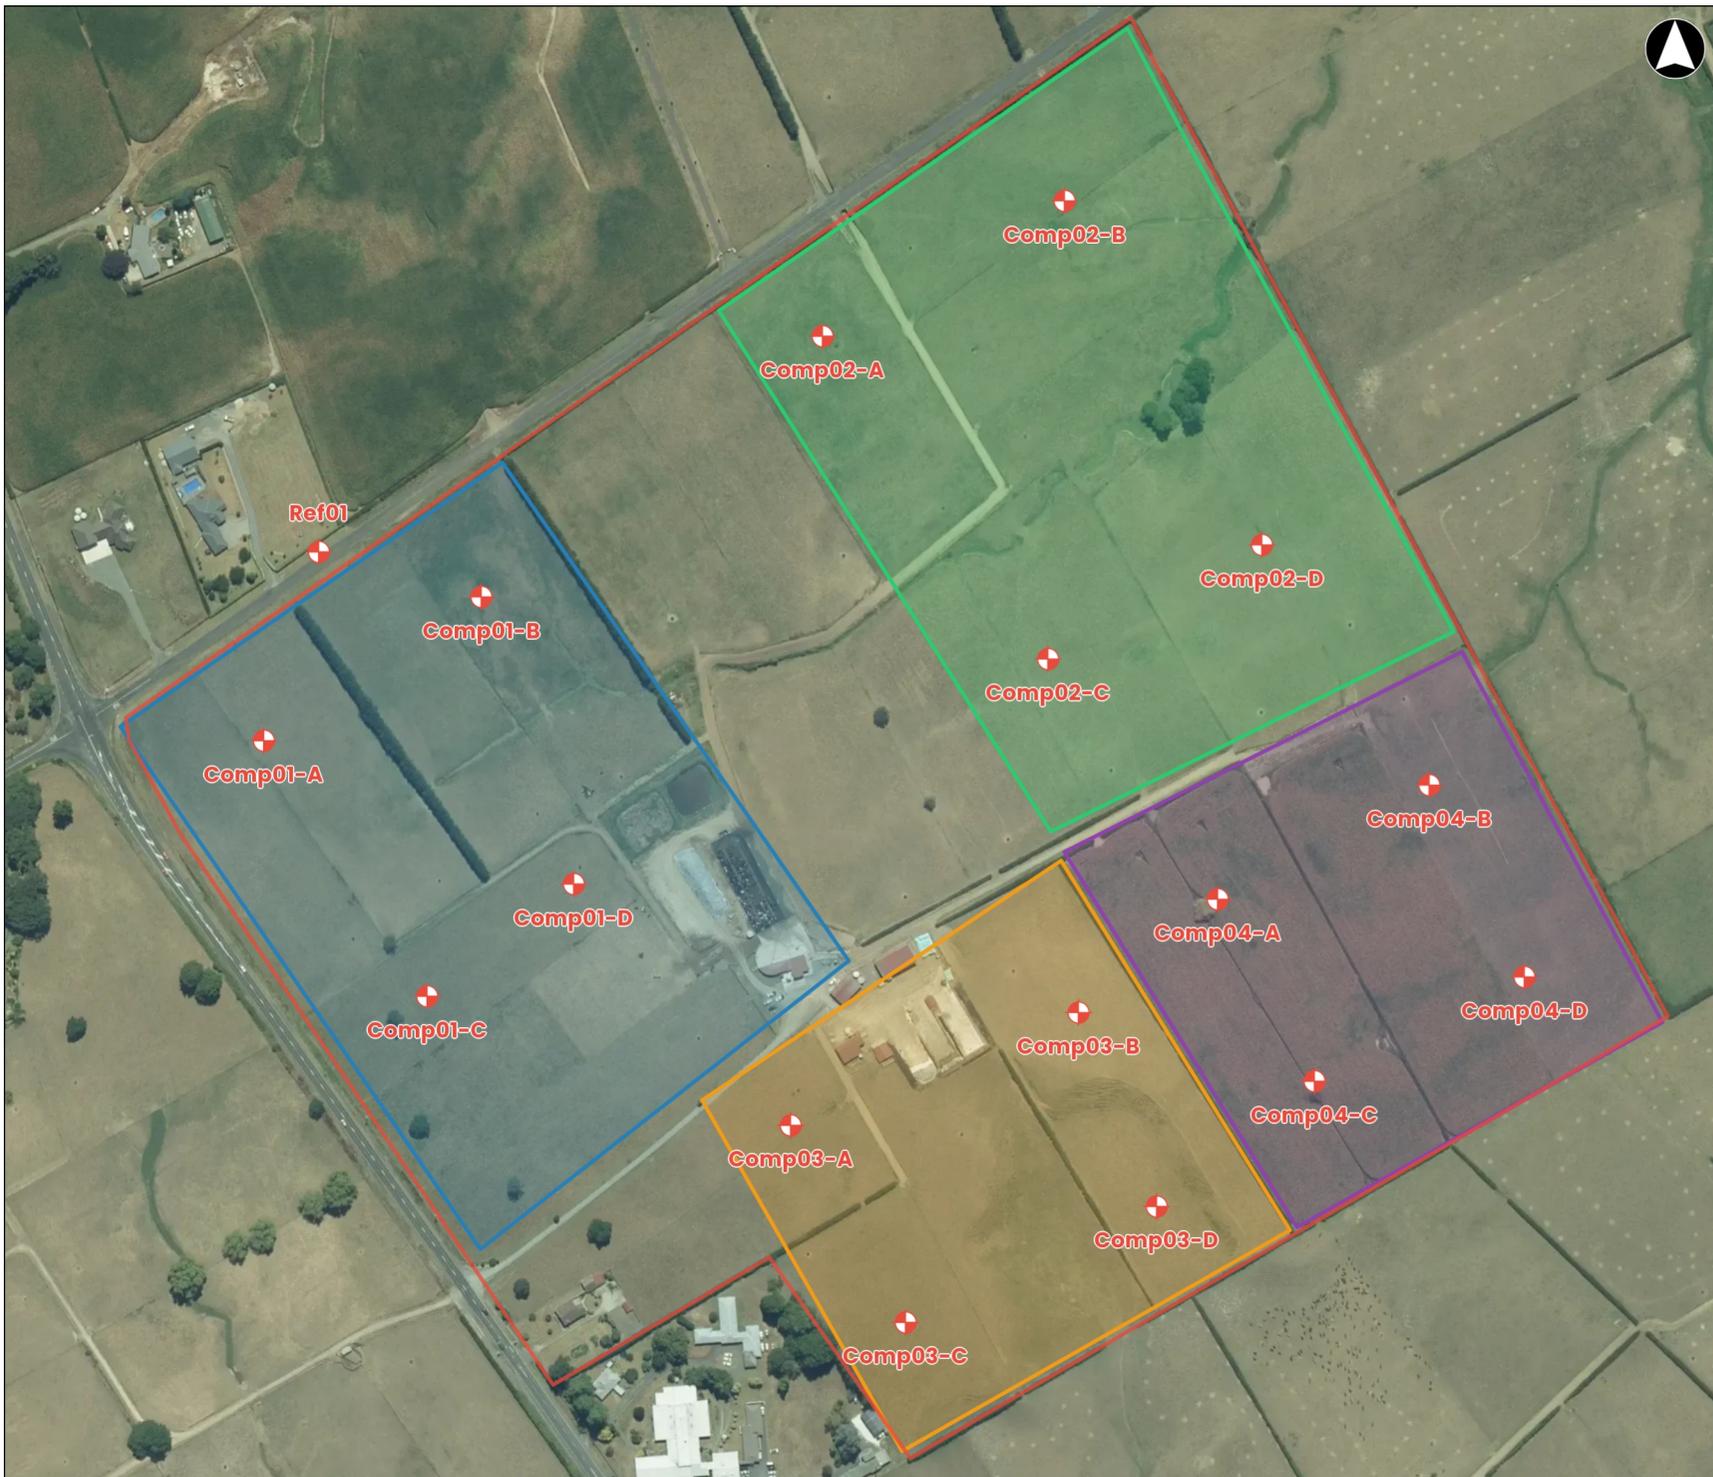
Client: Lockerbie Estate Limited		Figure No: 2 Size: A4
Project: 182 Morrinsville-Tahuna Road	Drawn: AB	
Date: 09-11-2021	Checked: NM	Version: 1.0
Proj No: 10006	Scale: 1:5500

Sample ID	Depth (m bgl)	Soil Type	Lab Analysis
Comp01 A-D	0.0 - 0.10	Topsoil (dark brown)	Cadmium & pH
Comp02 A-D			
Comp03 A-D			
Comp04 A-D			
Ref 01			
MTR-01_100		Topsoil (dark brown), potential paint flakes visible	Lead
MTR-02_100			
MTR-03_100			
MTR-05_100			
MTR-06_100			
MTR-01	-	Bulk Sample	Asbestos (presence/absence)
MTR-06_100	0.0 - 0.10	Topsoil (dark brown)	Asbestos (semi-quantitative method)

- Legend**
- Site Boundary
 - ⊕ Approximate Sample Locations
 - Composite Area 01
 - Composite Area 02
 - Composite Area 03
 - Composite Area 04
