Preliminary Site Investigation (PSI) & Detailed Site Investigation (DSI) Report

SH24 Matamata Industrial Plan Change and
Future Subdivision

For Veros Ltd

November 2021

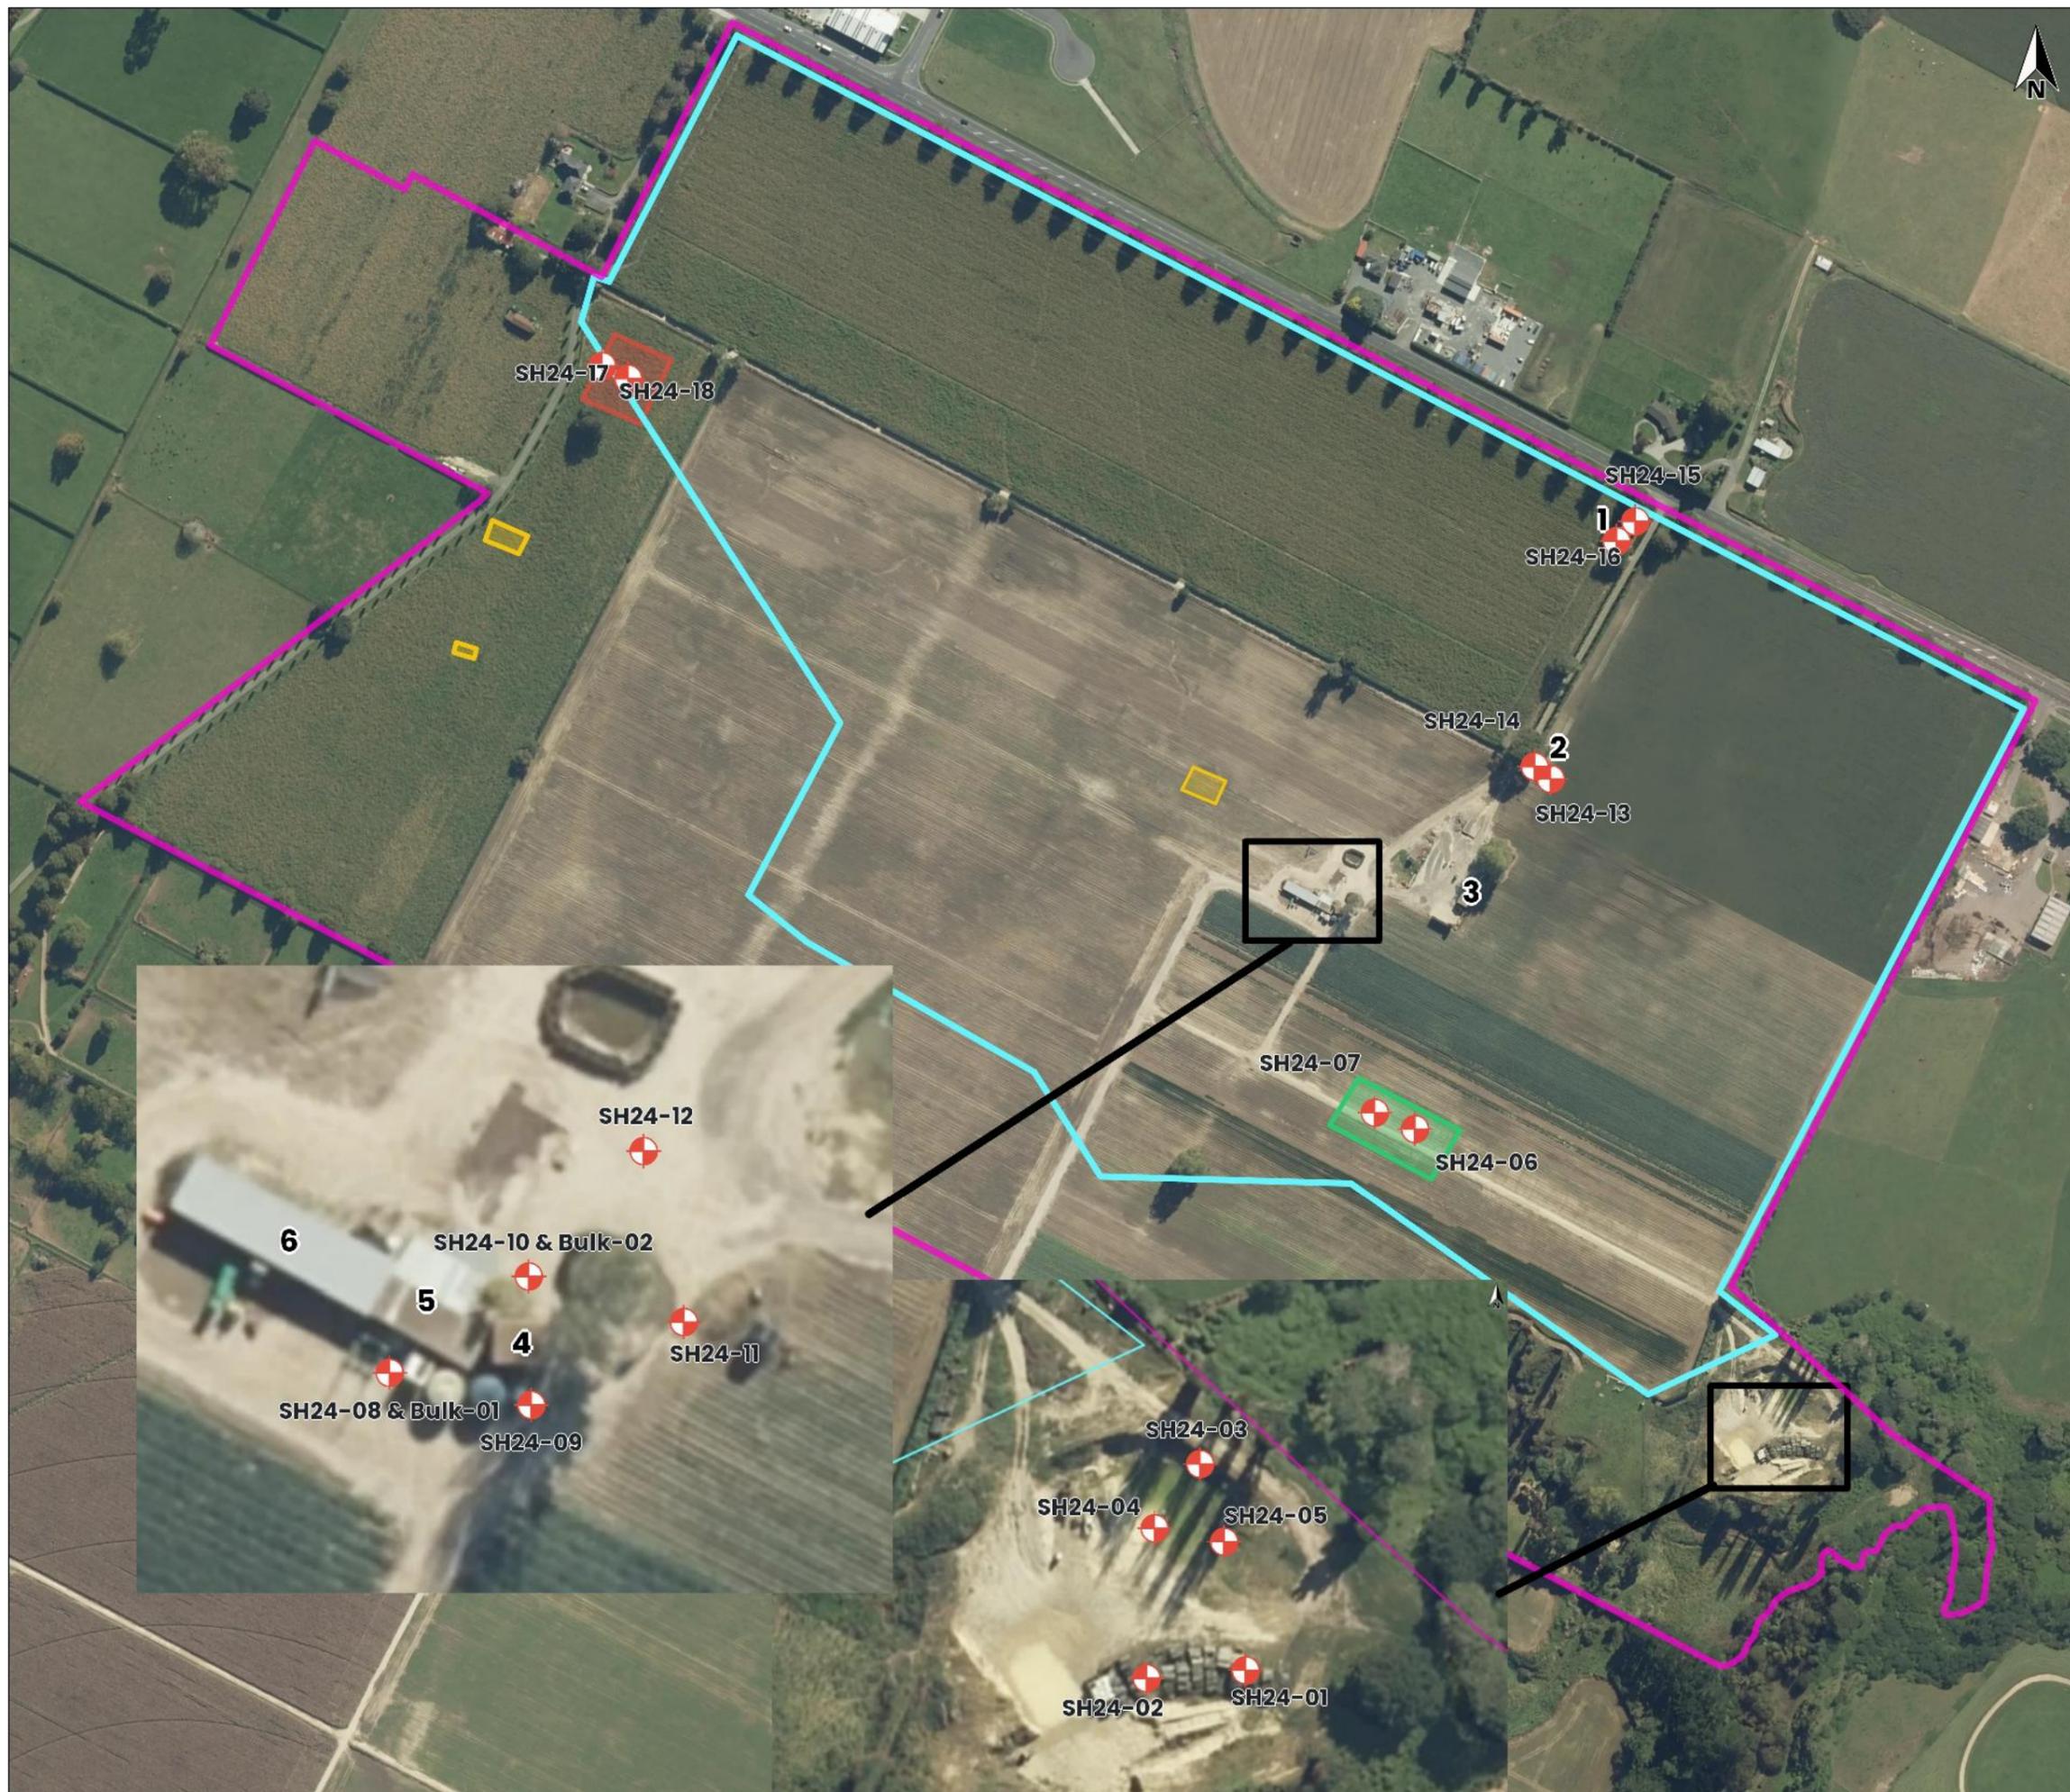
- 1. Dwelling
- 2. Stock Loading Yards
- 3. Implement Shed
- 4. Vat Room
- 5. Shed
- 6. Four Bay Lean To
- 📍 Approximate Soil Sampling Locations
- 🟪 Property Boundary
- 🟩 Site Boundary
- 🟡 Former Depression
- 🟢 Former Intensive Grazing
- 🏠 Former Farm Building and Adjoining Animal Pen Area

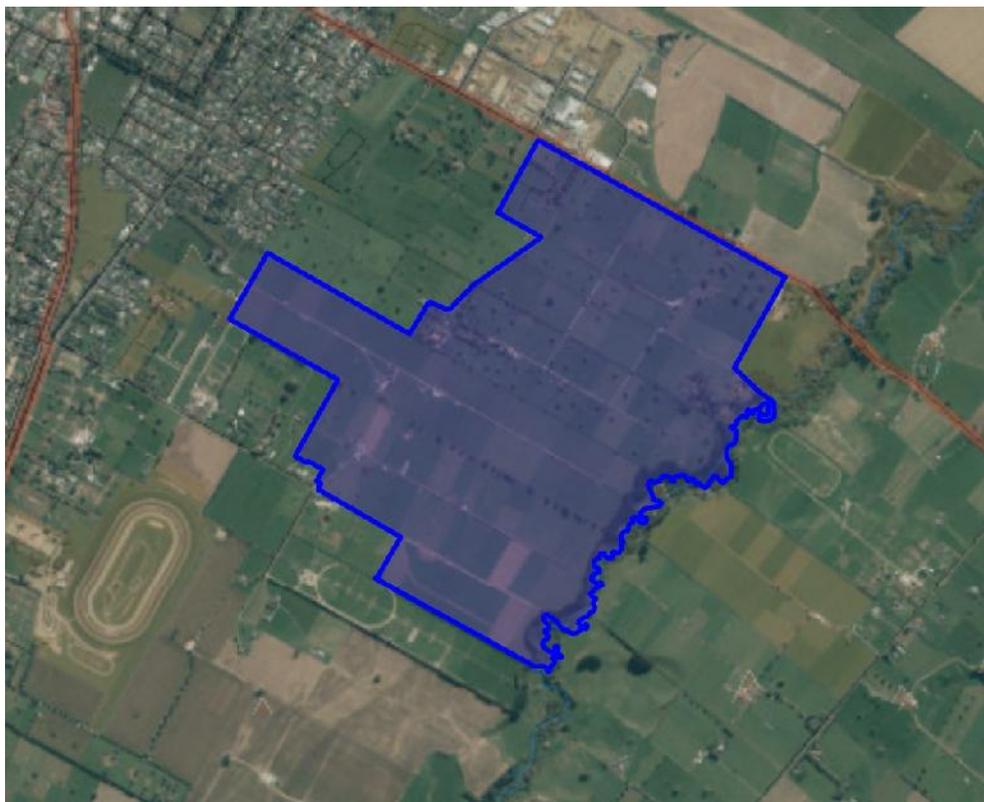
The area outlined by blue above appears on the Land Use Information Register as **LUI11961** with a classification of 'Unverified HAIL – no sampling' due to current land use for HAIL activity 'A10. Persistent pesticide bulk storage or use' associated with Kaimai Fresh Limited.

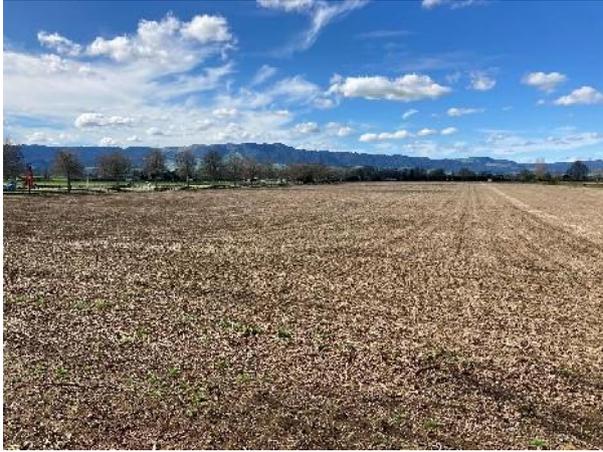
Photo 1: Western section of the Site looking east

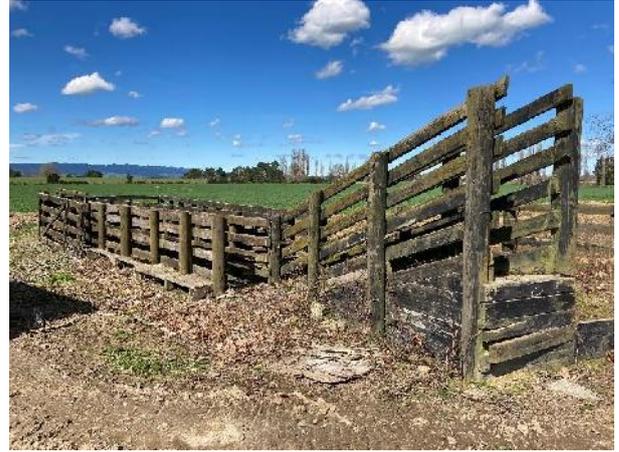
Photo 2: Stock loading yards

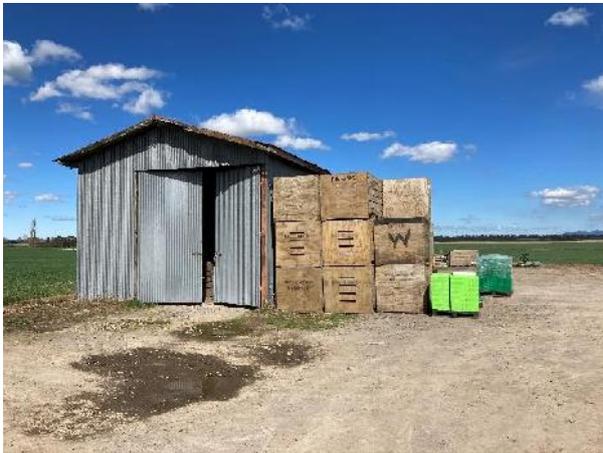
Photo 3: Implement shed

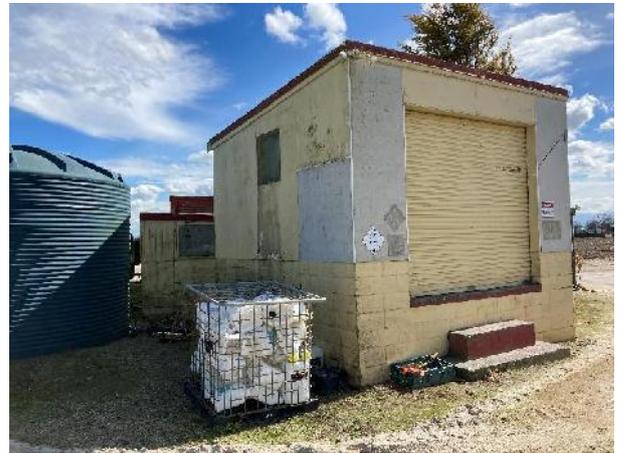
- A small concrete water trough was present west of the implement shed, with burnt rubbish contained within;
- A vat room (feature 4) was identified west of the implement shed. The exterior displayed toxic and flammable warning signs, and contained a range of fungicides (difenoconazole containing) on a concrete floor in good condition. Empty fungicide bottles were stored directly outside the vat room;

- Fibre cement sheeting (PACM) was identified on the exterior of the vat room, with broken fragments on the ground across a small area (~2 m²) on the northern side;

Photo 4: Vat room

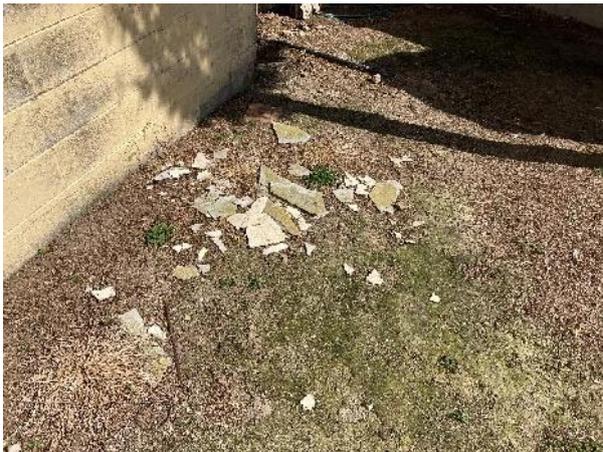
Fibre cement sheet fragments were confirmed to contain chrysotile (white asbestos) in a small discrete area on the ground directly north of the vat room at the Site associated with some minor damage/degradation to the vat room cladding. A soil sample collected in the general vicinity of the ACM fragments did not detect asbestos. Due to the number of ACM fragments, the amount of damage to the buildings and the soil sampling results soils are considered highly unlikely present a risk to human health associated with the proposed industrial landuse and development. It is recommended that an asbestos survey undertaken prior to demolition of the vat room and shed (if required), and any fragments are removed by a licenced asbestos removalist or competent person along with any other ACM identified within the buildings.

Photo 5: ACM fragments on the north side of the vat room

- Minor ACM fragments on surface soils at the northern side of the vat room should be removed by a licenced asbestos removalist or competent person. Prior to the demolition of the vat room and other farm buildings an asbestos demolition survey should be undertaken to identify all potential ACM present within the buildings;

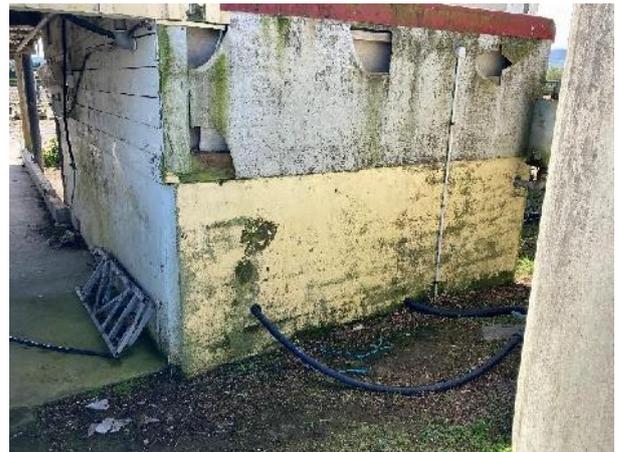
- A shed (feature 5) was present directly west of the vat room, containing several small (500ml-5L) bottles of motor oil, on a concrete floor in good condition, while a portable sprayer and small bags of herbicide were also present. This shed also contained small wooden holding pens;

- Fibre cement sheeting (PACM) was identified on the southern side of the shed, with minor broken fragments on the ground;
- A four bay corrugated iron Lean To (feature 6) was attached to the shed, containing machinery associated with the cropping land use (i.e. tractors with sprayers);

Photo 6: Shed to the west of the vat room

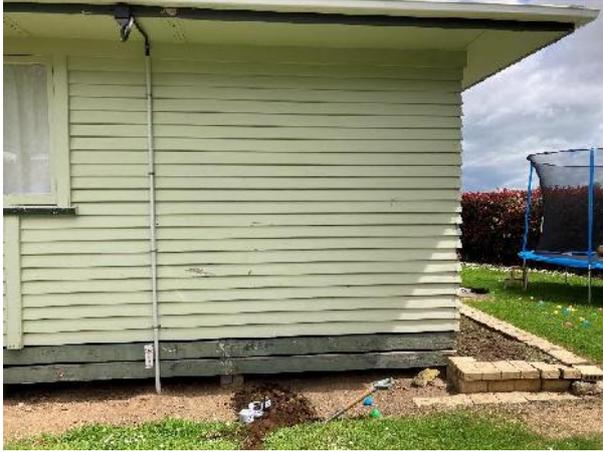
- The Site is currently in use for asparagus an oat production, with majority (90%) of the Site being tilled soil associated with these activities;
- A dwelling was present in the north of the Site (feature 1), adjacent the road front. The dwelling was constructed of wooden boards with a corrugated iron roof. Potential asbestos containing material (PACM) was identified on the dwelling as soffits, identified to be in good condition. Some minor damage to exterior paint was also identified on the dwelling;

Photo 7: Dwelling in the north of the Site.

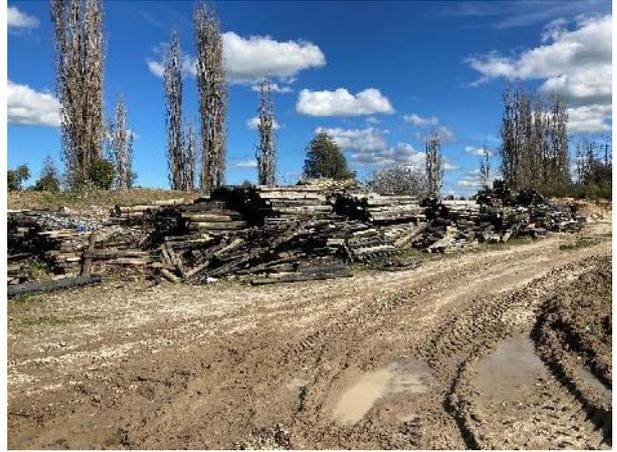
Photo 8: Large piles of treated fence posts / timber

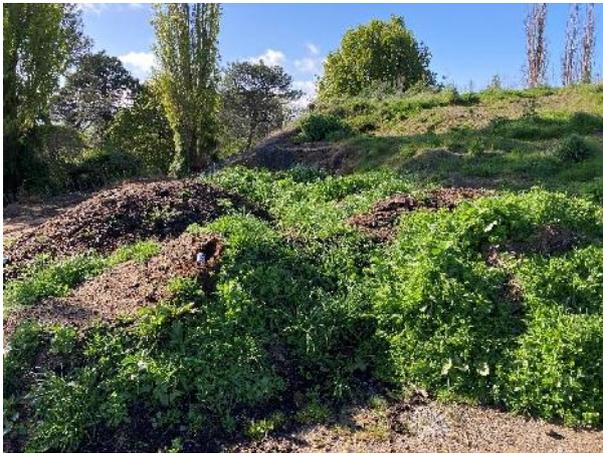
- A range of polycyclic aromatic hydrocarbon (PAH) compounds were detected in the composite sample SH24-03 taken from fill material (sourced from beneath SH24), with total PAH at 0.5 mg/kg;

Photo 9: Small stockpiles of fill material from beneath the road

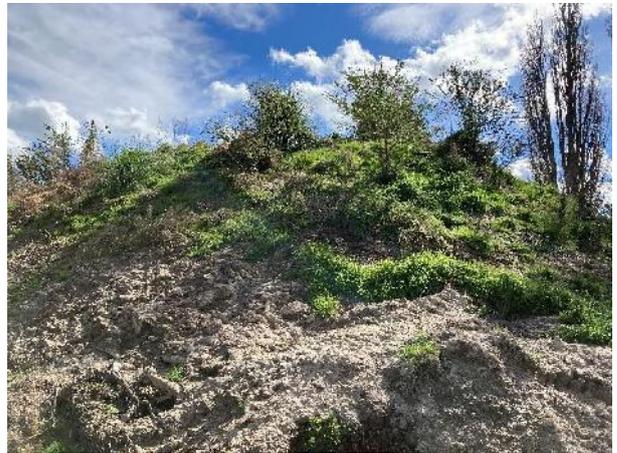
Photo 10: Large stockpile of sand material
