**ARCHAEOLOGICAL
ASSESSMENT**

**PROPOSED
SUBDIVISION
DEVELOPMENT
CALCUTTA FARMS LTD
MATAMATA**

LOTS 2, 3 & 4 DP 486913

AUGUST 2020

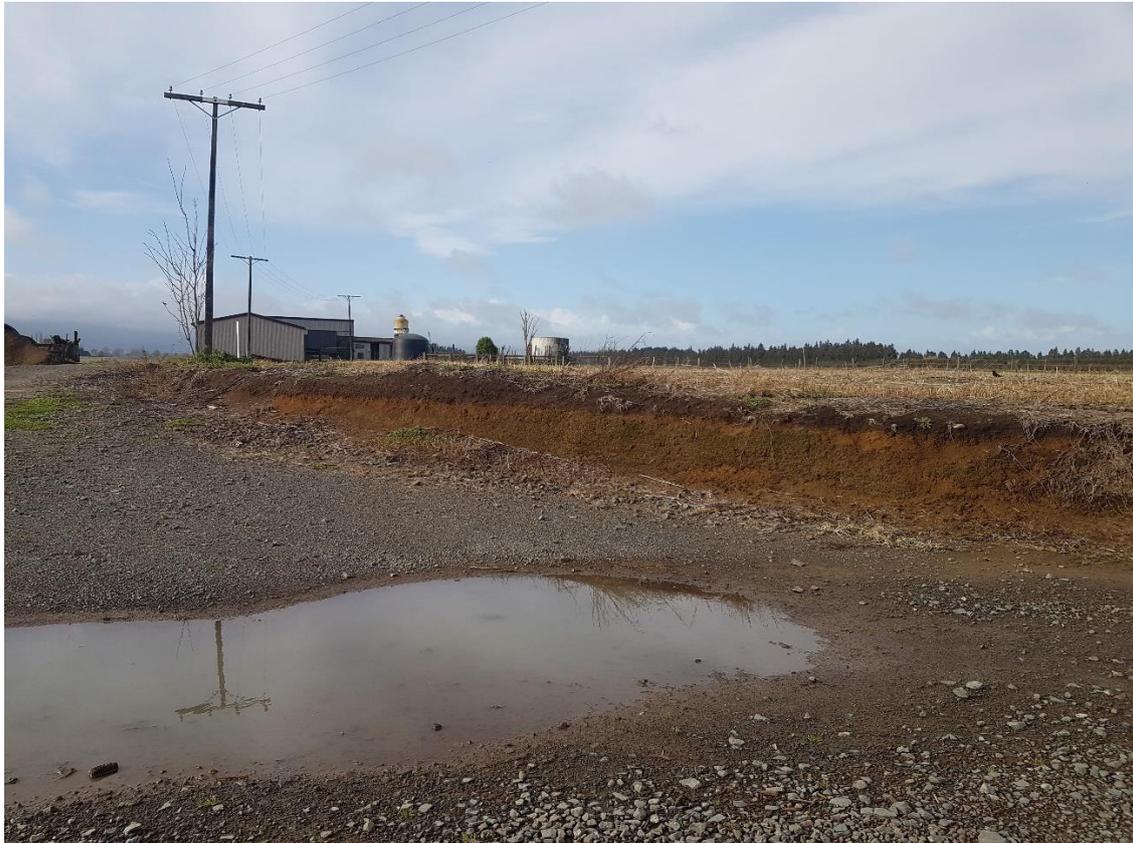
No previously unrecorded archaeological sites with surface expression were identified within the property and no evidence for the presence of unrecorded subsurface archaeological sites were identified within spade test pits and exposed soils profiles during the July 2020 archaeological survey of the property. In addition to spade test pitting, recently ploughed areas were inspected for evidence of artifacts midden or modified soils however none were identified.

Figure 4. Photo showing typical soil profile within the property.

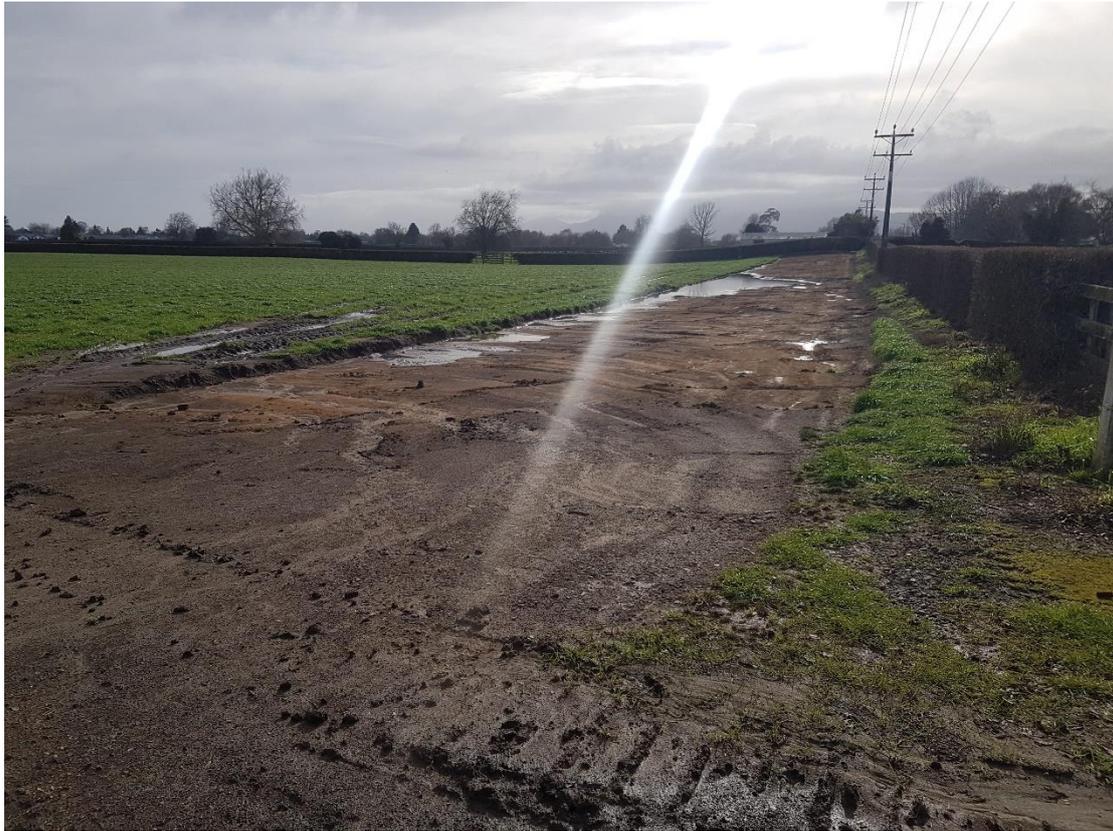
Figure 5. Photo showing area recently stripped of topsoil inspected during the July 2020 survey.

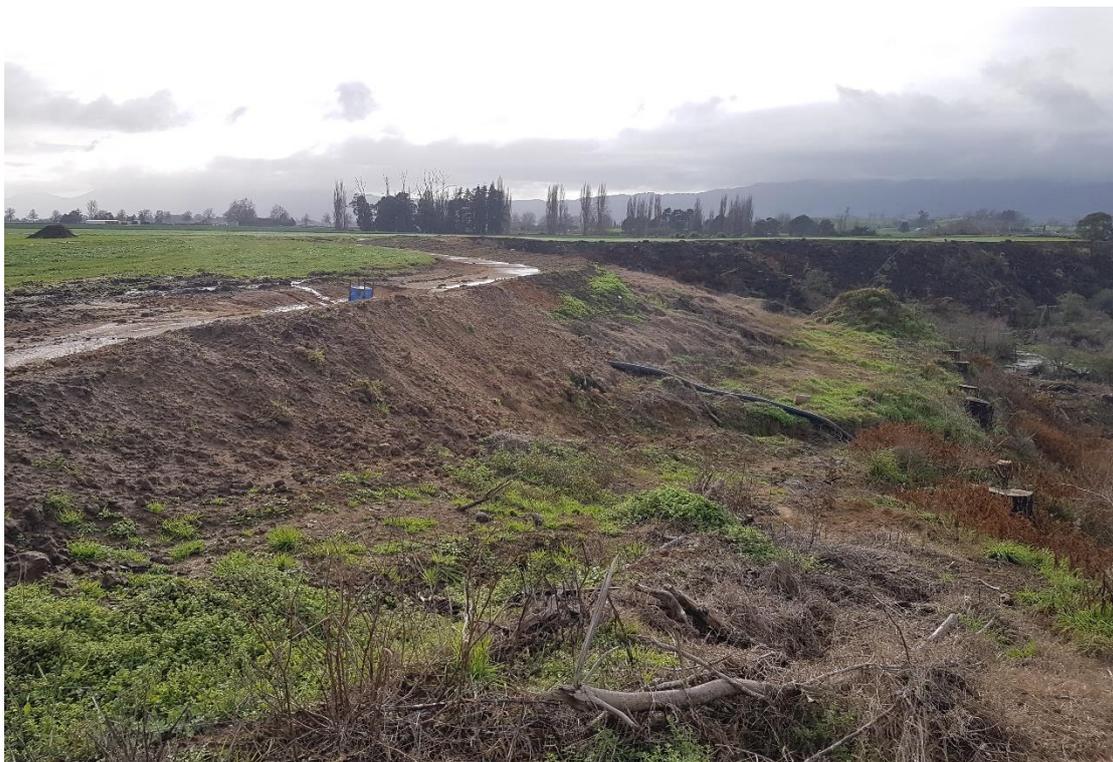
The property is situated on the Hinuera formation comprising fluviatile pumice, rhyolite and ignimbrite sands and gravels which characterise the broad Waihou River valley to the north. It encompasses flat to gentle undulating land bounded to the west of the Matamata township and to the east by the Mangawhero Stream being a tributary of the Waihou River. It has been used for pastoral grazing and more recently cropping. Modifications to the natural topography and soil profiles are primarily limited to successive ploughing since 2015. Some recent earthwork has occurred during the harvesting of pines on the Mangawhero Stream escarpment and an area recently stripped of topsoil (Figure 6)

Figure 6. View looking north east showing recent earthwork during the harvesting of pines from the western Mangawhero Stream escarpment.

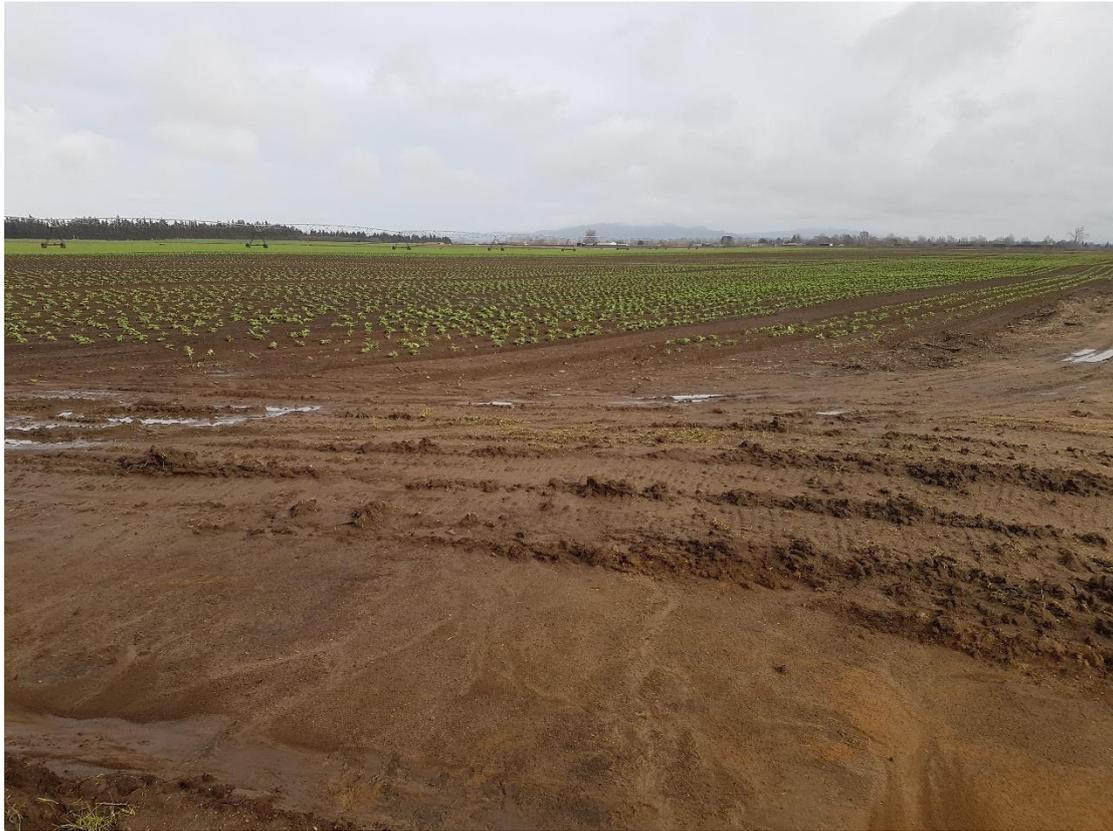
Figure 7. View looking west showing the level contour of the property and recent ploughed and planted areas inspected during the July 2020 survey.
